HNAT 737 技术问题说明

提示单编号	撰写	校定	批准/日期
TIP737-2020-27-005	曾晶	张桃	羊全流/2020.2.7

前缘襟翼牛鼻组件连接螺栓丢失导致的襟翼收不上

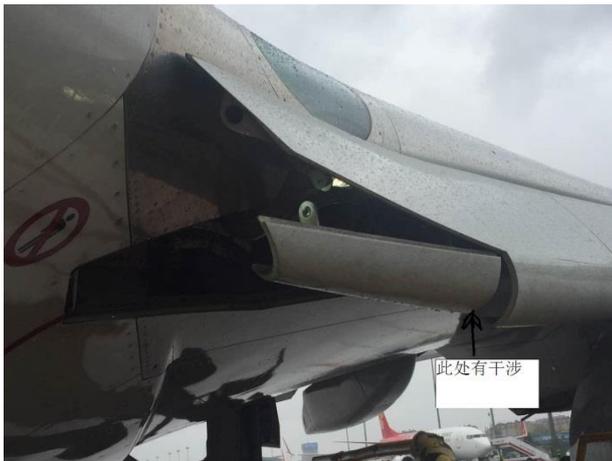
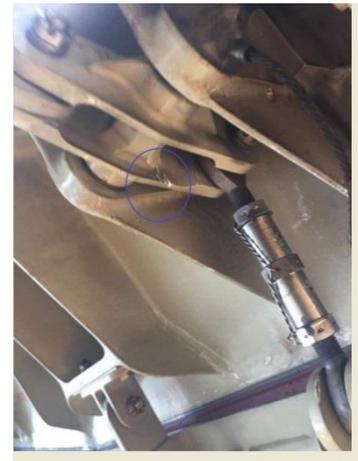
2016 年某日，空中机组反馈左二号襟翼收不上，前缘过渡灯灯常亮，大连落地后检查发现 2#前缘襟翼结构上一接耳螺栓不在位，周边部件有干涉损伤。航材到料后恢复 2 号前缘襟翼接耳螺栓，收放测试正常。

1, 结合 PC 数据和现场检查情况分析, 虽然螺栓脱落, 但在紧配合的力作用下, 连杆机构并未脱开, 但襟翼由于失去了三点支撑, 在气动力的作用下, 会出现一定情况的偏转。收起时牛鼻组件不能完全折叠入腔, 传感器不能完全临近, 导致出现过渡灯亮。地面时因无气动力作用, 牛鼻组件可以完全折叠入腔, 前缘指示正常。FITTING 组件的损伤与牛鼻组件的缺口相吻合。

此次前缘襟翼牛鼻组件连接螺栓丢失, 导致部件损伤和前缘过度灯长亮。分析为飞机出厂时牛鼻组件安装存在异常, 在空中高振动情况下, 螺帽松脱导致螺栓丢失。

2, 经进一步调查发现, 在全球其他机队也出现过类似的情况。厂家 737NG-FTD-57-15003 表明 15 年 1-8 收到了 7 起同样事件发生。分析认为有多种可能都会导致螺栓丢失的情况发生: 如不合适的力矩、卡销丢失、或者轴承卡滞等原因。厂家建议用户在合适的时机对所有前缘克鲁格襟翼牛鼻组件的固定情况做检查, 以免发生螺栓丢失甚至部件丢失的发生。但这个并未转为机队的普查 E0 下发。
