故障标准处置流程（SOP）

| SOP-737-16-05-001 | 2016.1.8 | 张桃 | 曾晶 |

| 故障名称 | 飞机被泡沫灭火剂污染后的处置流程 | | |

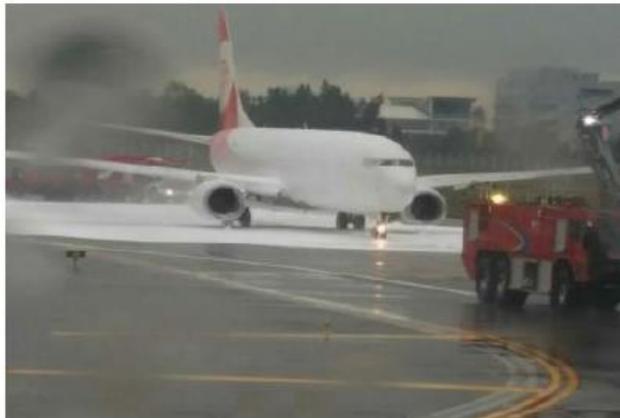
灭火现场

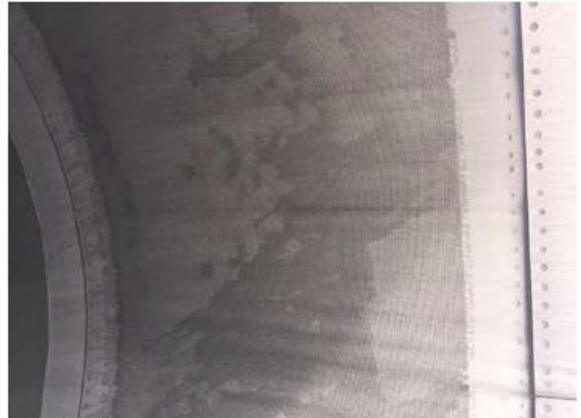
发动机进气道

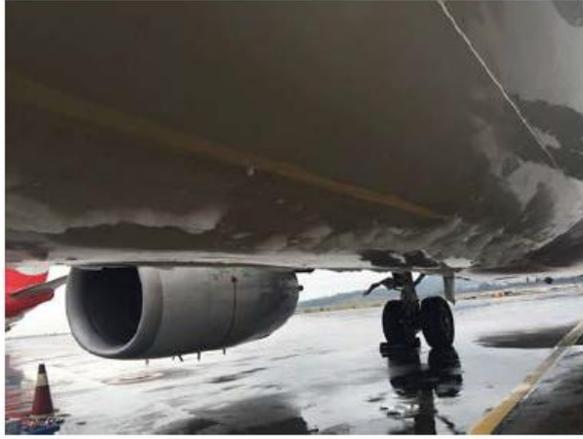
飞机机腹下有大量灭火剂

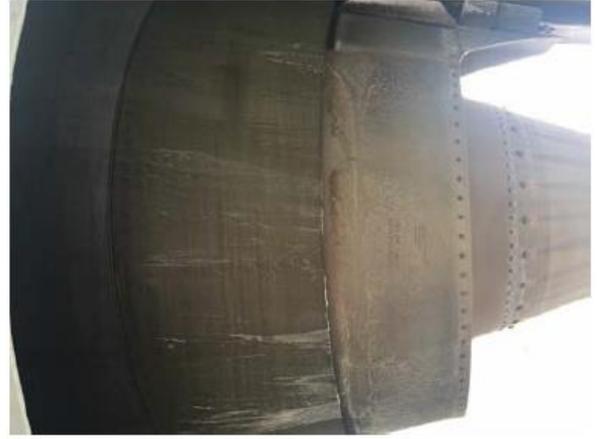
发动机尾喷口

LPT叶片被泡沫灭火剂污染

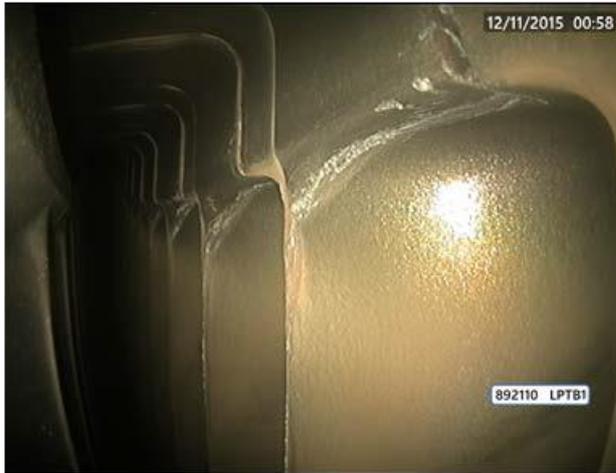
右发孔探结果

Per the description over phone that the two engines kept operational for ~10 minutes after easing of applying extinguishing agent, and gaspath wash was performed, the trace of residual AFFF on LPT stg 1 through stg4 showed in the photos should be the evidence that significant amount of extinguishing agent had been swallowed into the core.

In accordance with the PSE's explanation and recommendation on this case, as well as AMM requirements, the both engines are not serviceable. I would advise engine removals. Sorry for the inconvenience.

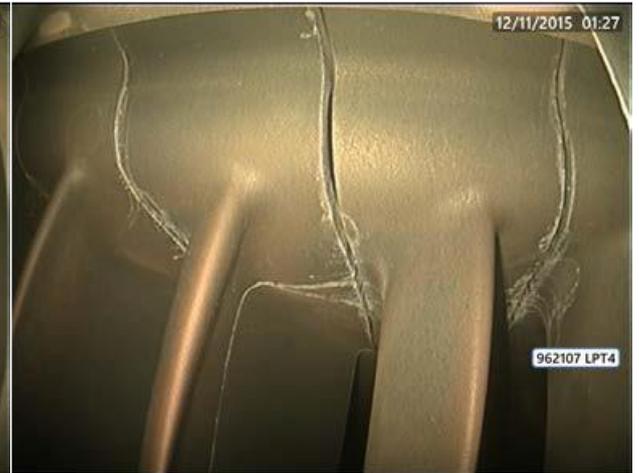
左发孔探结果
