Pitot Probe

Reliability overview May 2020

Pitot probe defects 1.1.2013 to 3.6.2020

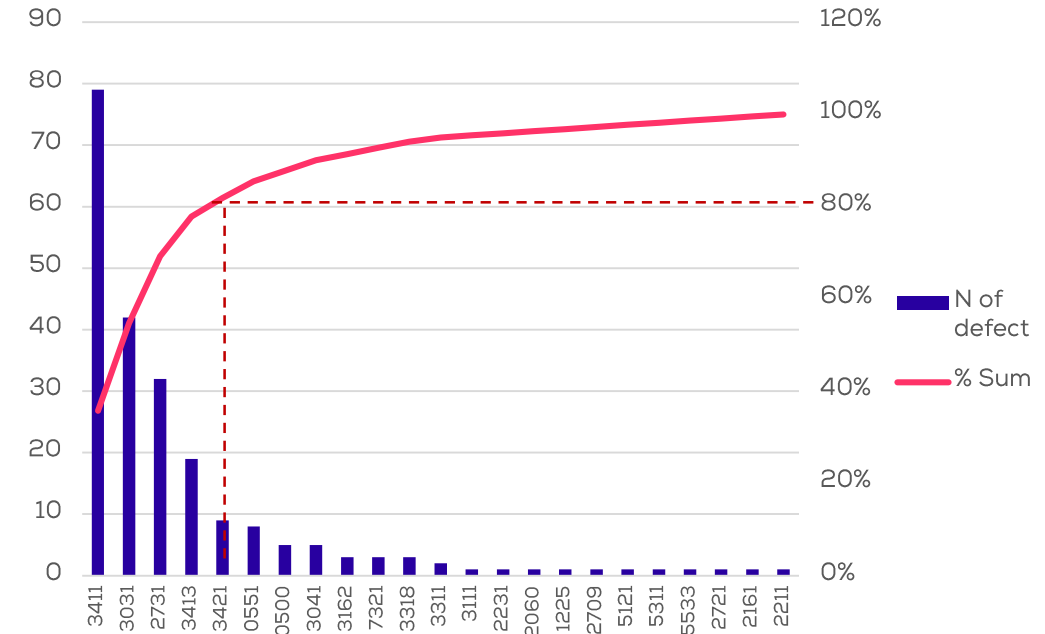
Description	ATA	N of defect	% Sum	Delay >180	Delay 60-180
STATIC AND TOTAL AIR PRESSURE SYSTEM	3411	79	36%	15	13
ICE AND RAIN PROTECTION	3031	42	55%	4	8
ELEVATOR AND TAB CONTROL SYSTEM	2731	32	69%	2	6
AIR DATA INSTRUMENTS	3413	19	78%	1	3
AIR DATA INERTIAL REFERENCE SYSTEM	3421	9	82%	2	2

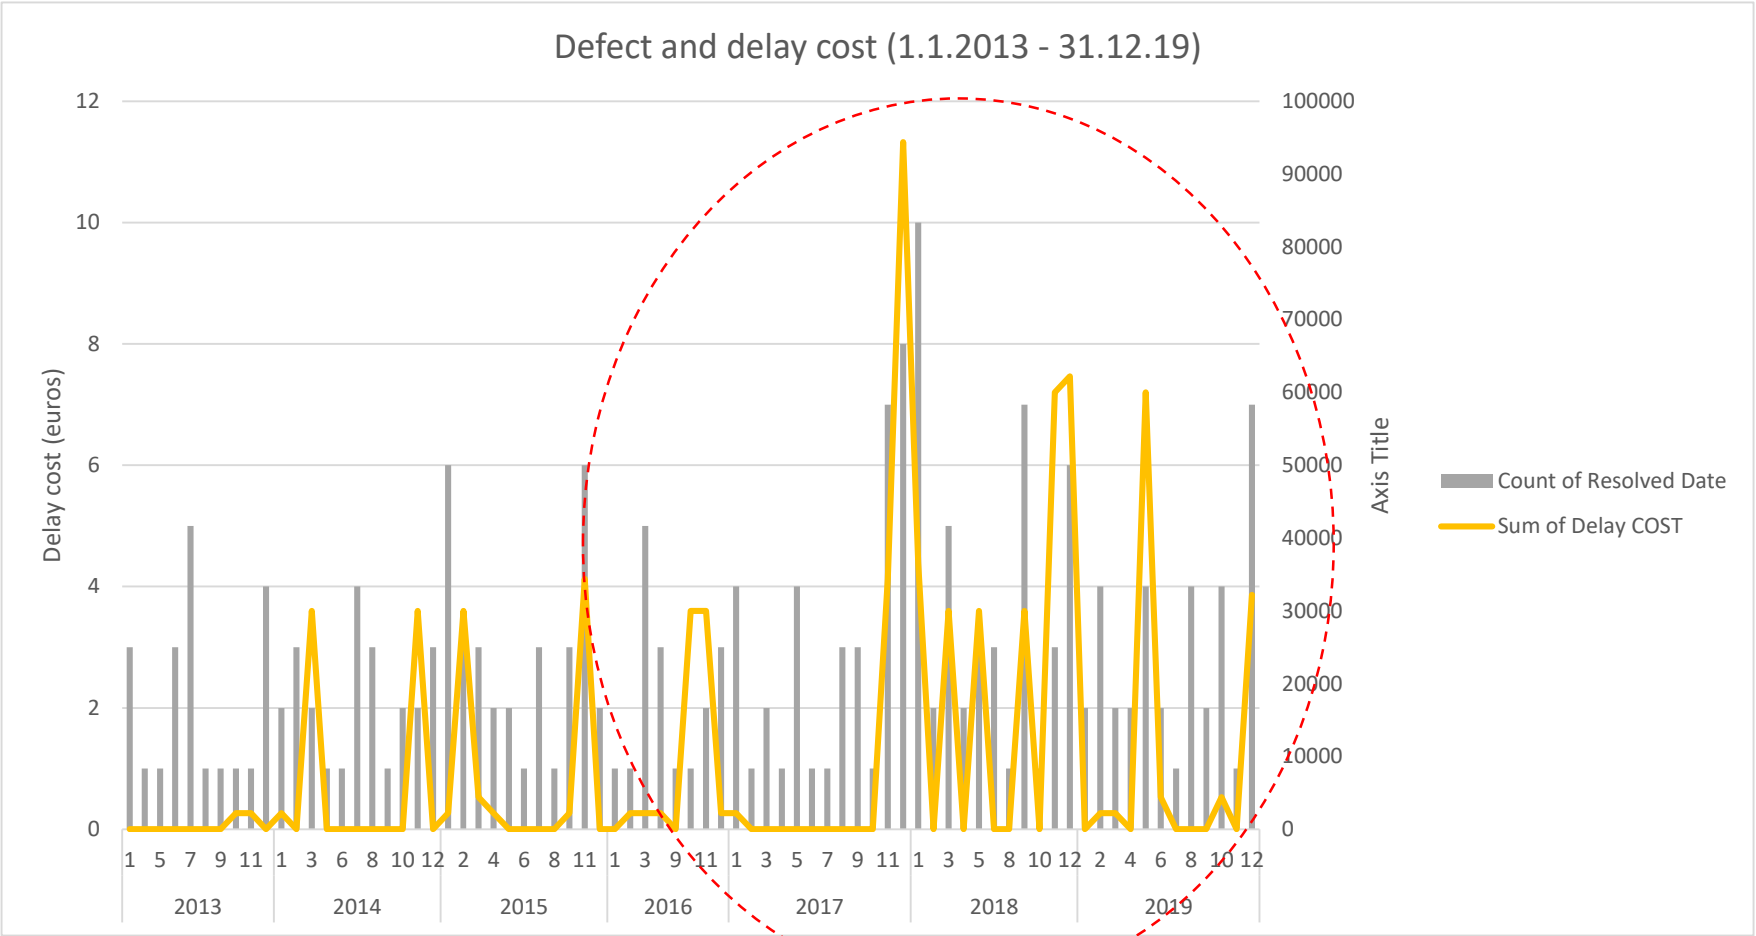
Pitot Probe removal across years

- Looking at defects and delay cost ok to focus analysis on last 3 years only.

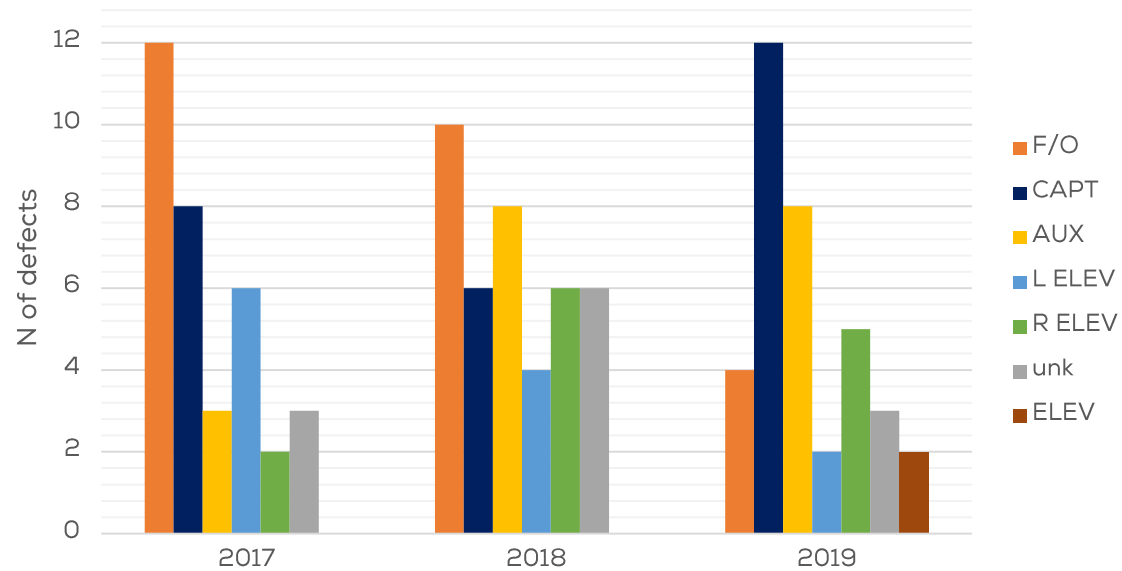
Pitot probe defect by installed position

- Front group probe n of defects/events higher than rear group – to be reviewed with Boeing and other operators
- Maybe front block more exposed to debris – TBC
- SB only performed on front block – effect on removal rates to be reviewed

- ❑ Investigate why front group n of defect/events higher than rear group
- ❑ Check with Boeing if other operators experience high operational disruptions due to Pitot probe

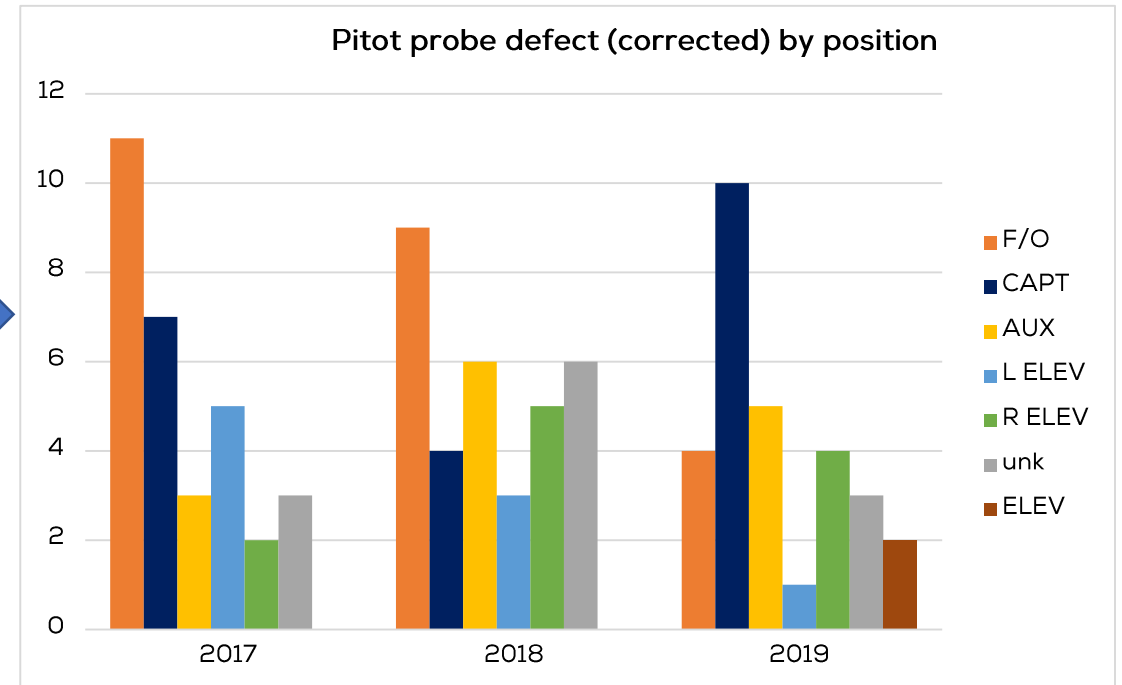
Pitot probe defect (corrected) by position

With data correction (deletion of repeated defects on a single event)
