737NG – ATA 78

Possible Long Primary Exhaust Nozzle Departure Due to Fan Blade Failure

737NG/MAX Fleet Team Meeting, May 5-7, 2020

Affected Models: 737NG with long (pre-PIP) primary exhaust nozzles

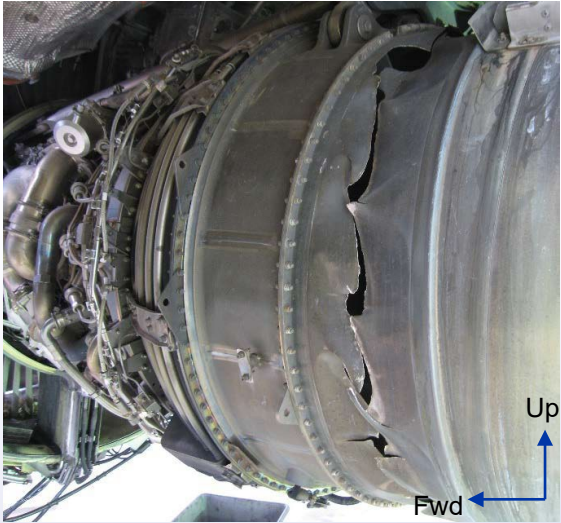
Figure 4: Left Side of Engine 1

- Figures show the Engine 1 primary nozzle exhaust damages from the 2018 event.
- The primary exhaust nozzle exhibited 360° circumferential buckling, was torn continuous from the 5:00 to 12:30 o'clock position and still remained attached to the engine.
- The nozzle also exhibited tears of about 1.00-inches at 1:00, 3:00, 4:00, and 4:40 o'clock positions.
