737NG – ATA 57

Fairing Seal Damage on Inboard Flap, Outboard Track

Rework

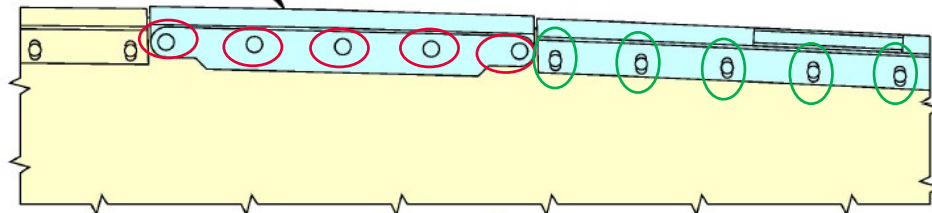
These holes in the fairing are plugged per SRM repair procedure. New holes are located 0.084" lower. No countersink.

These holes in the fairing are plugged per SRM repair procedure. New holes are located 0.207" higher. Holes get countersink for flush screws.
