6355C0001-01 Stabilizer Trim Motor

S/N 4580 Investigation

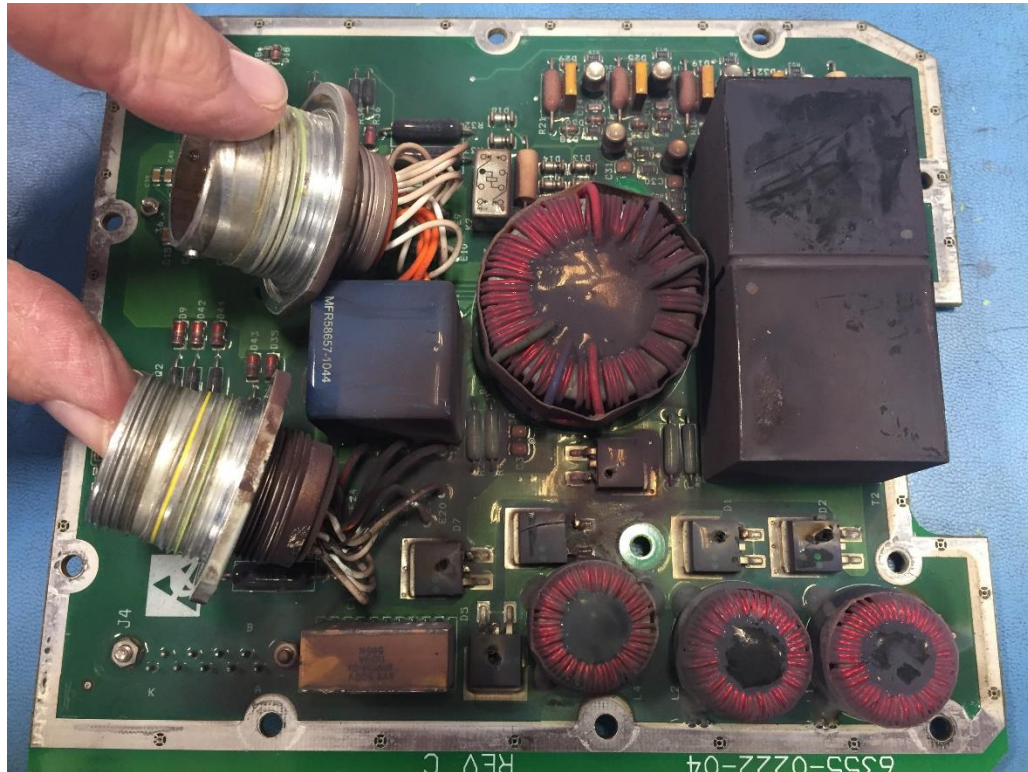
The 6355-0210-05 Brushless DC Motor Assembly S/N AM2736 (Item 1-35A) was removed to gain access to the Printed Wire Assemblies (PWA). No issues were identified with the Brushless DC Motor Assembly. The Control PWA 6355-0230-13 S/N 1824 (Item 1-50J) and Filter PWA 6355-0220-07 S/N 2996 (Item 1-70A) were removed. The Filter PWAs showed visual damaged of electrical over stress, Diodes (Items 2-160, 2-165, 2-235, 2-250, 2-260) were visibly damaged. See Figures 2 and 3.

Figure 2: View of damaged components on the 6355-0220-07 Filter PWA

To determine the cause of the of the failed diodes of the 6355-0220-07 Filter PWA, the motor drive circuit was analyzed. It was determined that the Insulated-Gate Bipolar Transistors (IGBT) 10 & 13 (Items 3A-810, 3A-815) located on the 6355-0230-13 Control PWA (Item 1-50J) were shorted. When the 270 VDC current shorted to ground it resulted in the visual damage to the diodes and render the STM electrically inoperative.

The Filter and Control PWA work together to allow the STM to function properly. Aircraft power and commands are received by the Filter PWA before being supplied to the Control PWA. The Filter PWA also filters and rectifies the power used by the different circuits of Control PWA and the DC Motor itself. The Control PWA then validates the command, the functionality of the STM, supplies the current for the motor to execute the command and records any latching faults. The IGBTs are on the Control PWA as part of the 270VDC motor drive circuit, which failed releasing enough energy to permanently damage the Control PWA as well as damage the diodes of the Filter PWA that are part of that same circuit. In this instance the IGBTs were the root cause and the damaged diodes of the Filter PWA were collateral damage. Due to the extent of the damage to the Control and Filter PWAs, both will be replaced with new.

The IGBTs were determined to be the root cause of the removal and both the Control and Filter PWAs were replaced to return the STM to service.

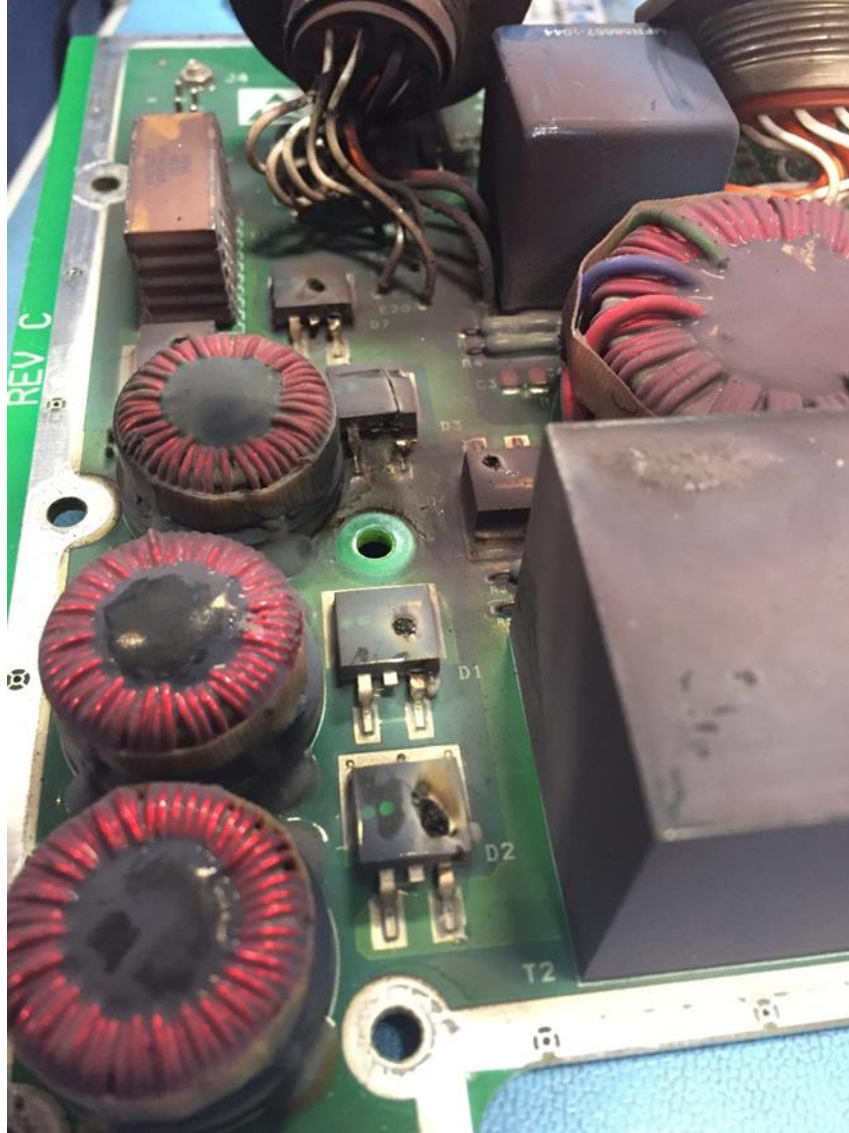
Figure 3: View of damaged components on the 6355-0220-07 Filter PWA

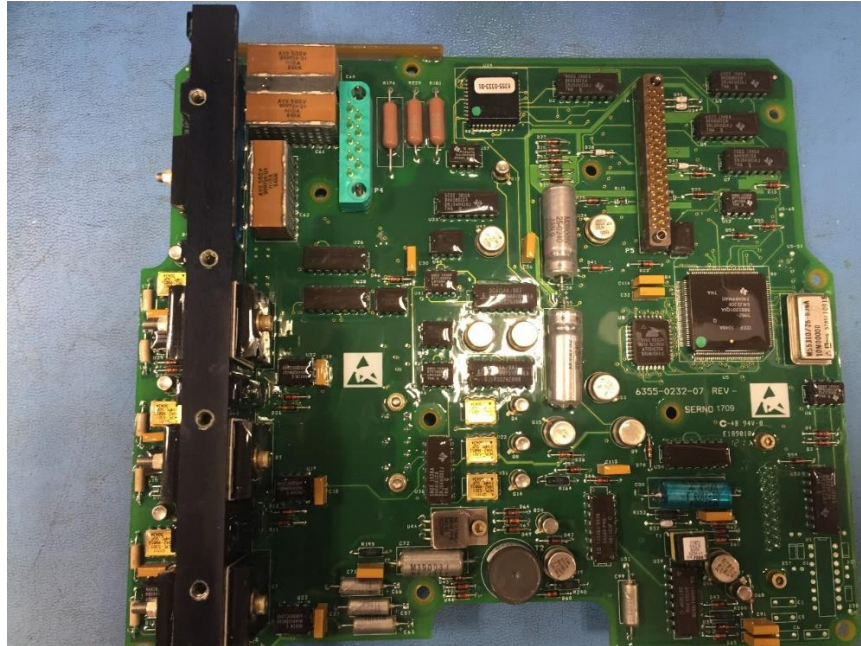
The Control PWA 6355-0230-13 showed no visual sign of damage or deterioration. See Figure 4

Figure 4: View of 6355-0230-13 Control PWA with no adverse visual indication
