# HNAT 737 技术问题说明

提示单编号	撰写	校对	批准/日期
TIP737-2021-34-006	孔坤伦	许敬远	曾晶/2021.4.14

## 标题 关于大气数据系统动压软管胶皮破损的技术问题说明

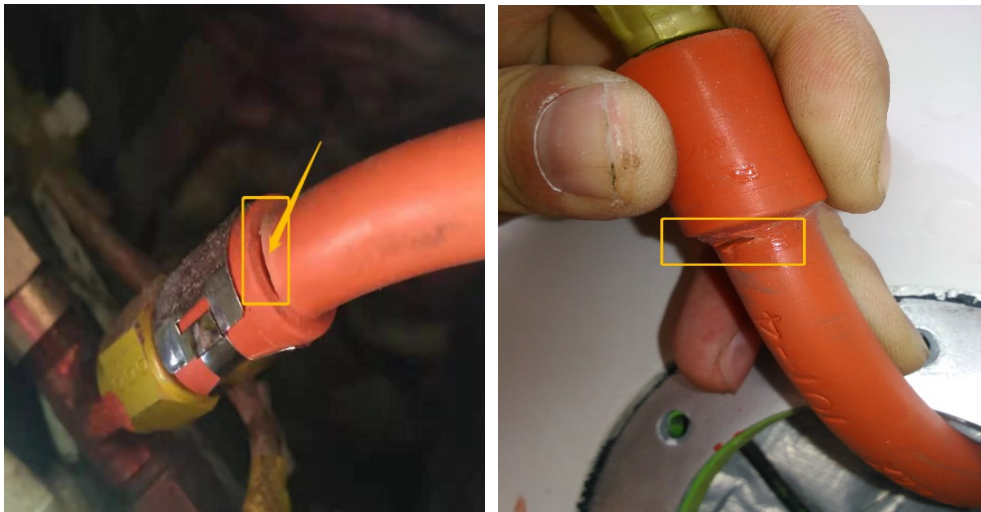
737NG 机队在维护过程经常检查发现 ADM 软管及皮托管后部软管由于长期处于弧形弯折状态，导致软管外部胶皮出现细小破损开裂的情况（如图 1）。维护手册没有给出破损缺陷检查标准及修复方法。经与波音沟通咨询，现对处理方法进行说明，以便后续维护。

图 1. ADM 软管（左）和皮托管软管（右）胶皮破损

经咨询波音，波音认为此软管外部防火胶皮的细小破损不影响功能，在进行渗漏测试结果符合手册标准的前提下，仍可使用。对于 ADM 处的软管破损可以使用少量 RTV3145（玻璃胶）对破损处进行密封处理作为永久修复手段（如图 3）；对于皮托管后部软管，由于距离皮托管较近，当皮托管加温时可能会出现高温，因此波音不推荐使用涂胶方法修复（如图 4），可不做处理。

1. 对于检查发现 ADM 软管和皮托管后部软管胶皮破损的情况，应首先详细目视检查破损情况，确认破损大小和深度是否可能影响软管功能，是否导致软管内层受损，若可能影响软管功能，则需要立即更换软管。并对周边区域进行检查，排除磨损干涉情况。
2. 若初步检查无异常，则应参考 AMM34-11-00 手册进行渗漏测试，确认管路密封性正常。对于渗漏超标，需立即排除故障。
3. 对于管路无渗漏的情况，波音不要求更换胶皮破损的软管。我司考虑可能存在破损进一步扩展延伸的可能性，暂定维护政策为办理 120 天 FC 控制，最终更换破损软管。
