HNAT 737 技术问题说明

提示单编号	撰写	审核	批准/日期
TIP737-2021-27-028	王康业	吕景贺	曾晶/2021.9.6

标题 襟翼手柄位置传感器故障导致客舱异响

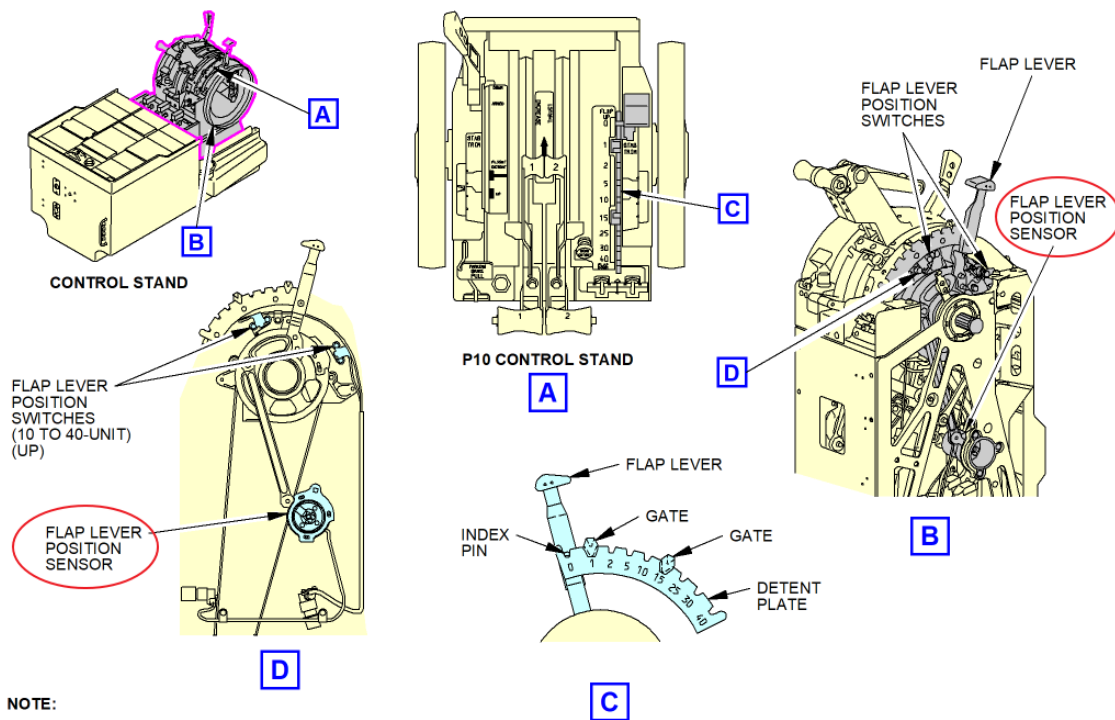
该案例一个典型的特点就是异响只出现在空中巡航阶段，起飞、爬升、下降阶段均无异响，地面也无法再现故障。SR咨询波音后，答复其它航司也出现过类似的故障，均是由于襟翼手柄位置传感器T538校装不正确导致的。

传感器角度的输出值不正确，错误的信号给到FSEU将会使巡航释压活门异常作动。如下电路

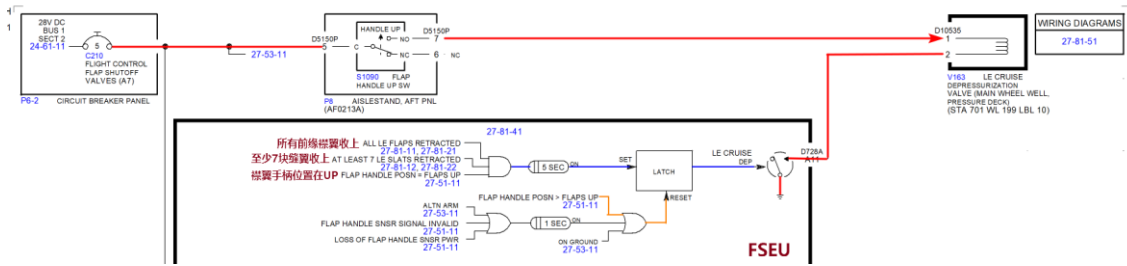
图和油路图所示，当襟翼手柄在 UP 位，FSEU 根据襟缝翼实际位置信号、空地信号、备用襟翼电门位置和襟翼手柄位置信号，给前缘巡航释压活门内的线圈提供地信号，激励巡航释压活门线圈。

电磁线圈激励后，活门滑阀向左滑动，使襟缝翼控制活门供压油路连通回油。从而切断前缘襟缝翼的液压，防止在巡航期间襟缝翼意外放出。不难看出，只有襟翼手柄位置信号即可以 LATCH，也可以 RESET 地信号。FSEU 内触发地信号的 LATCH 模块可以理解为一个 RS 触发器，若襟翼手柄位置传感器信号输出异常，就会导致巡航释压活门线圈一会通电、一会断电，进而导致内部的滑阀来回作动。我们在客舱听到的异响其实就是线圈断电后，滑阀被弹簧复位的声音。

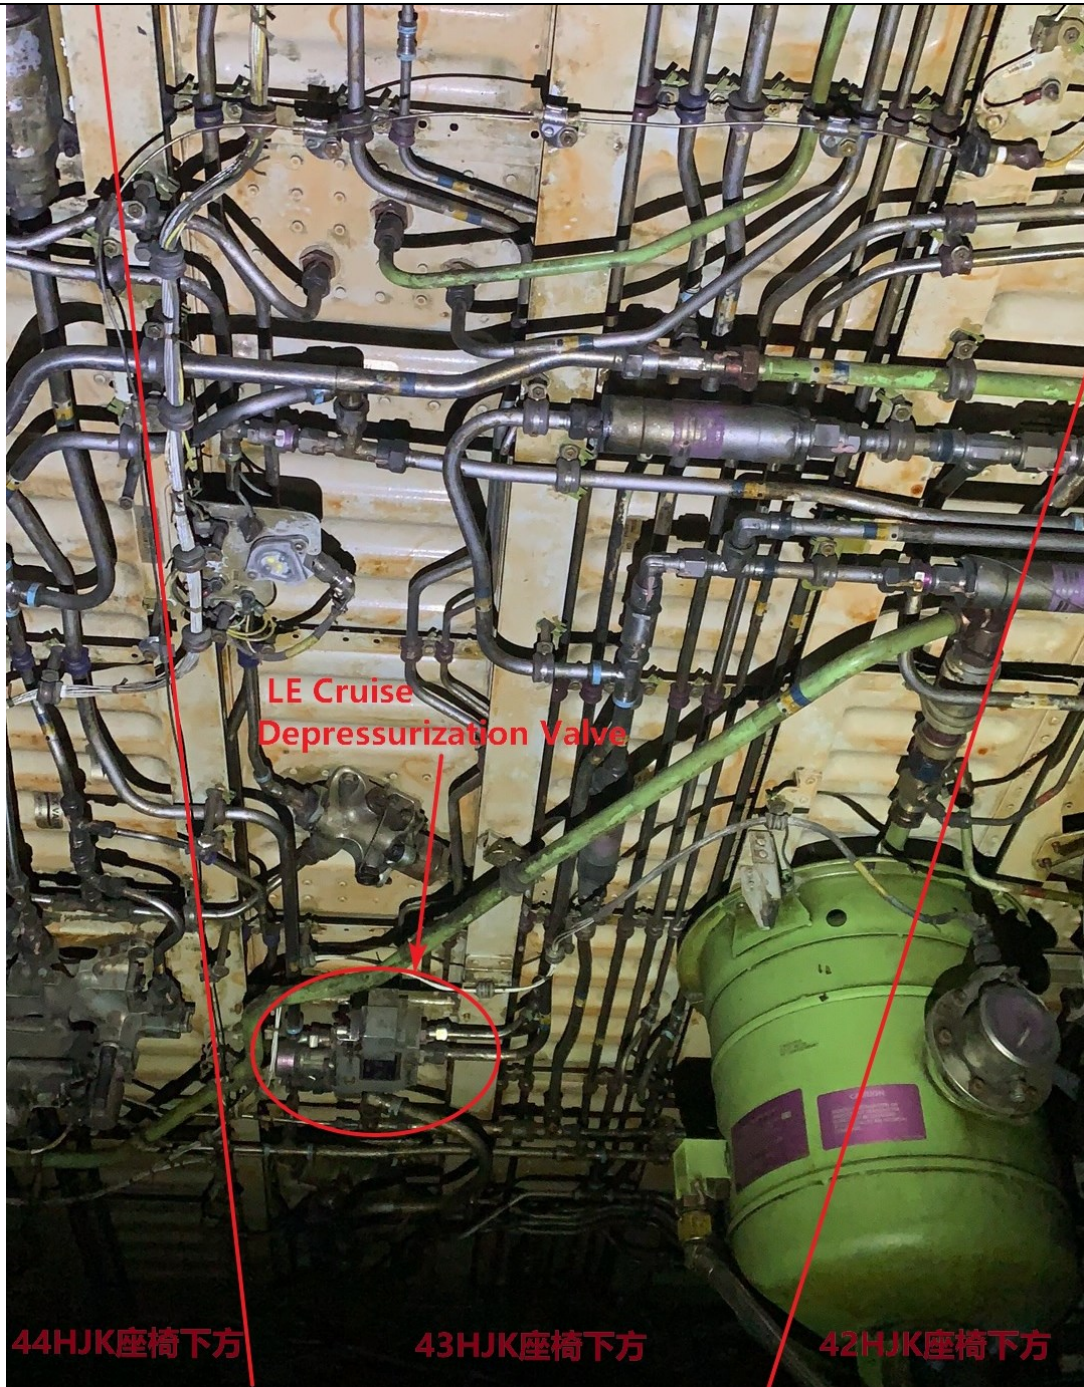
在地面接近巡航释压活门，发现该部件刚好位于 43-44HJK 座椅的正下方：

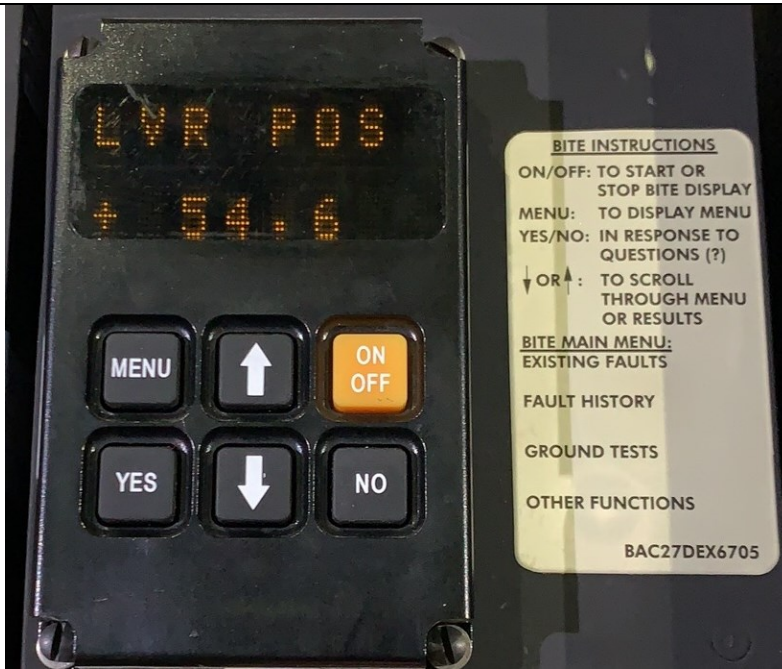
1、参考 AMM27-51-06-820-802，襟翼手柄 10 个单位时，在 FSEU 内读取传感器的角度值（正常范围为： 52.3° - 52.9° ）。而本机读取的角度值为 54.6° ，略大于标准范围的上限。

最终，通过对传感器的调节，确认后续航段 LE_CRSE_DEP 参数恢复正常，异响也不再出现。
