HNAT 737 技术问题说明

提示单编号	撰写	校定	批准/日期
TIP737-2020-27-014R1	符方洲	张桃	曾晶/2021.12.28

标题 后缘襟翼蜗杆万向轴衬套掉落

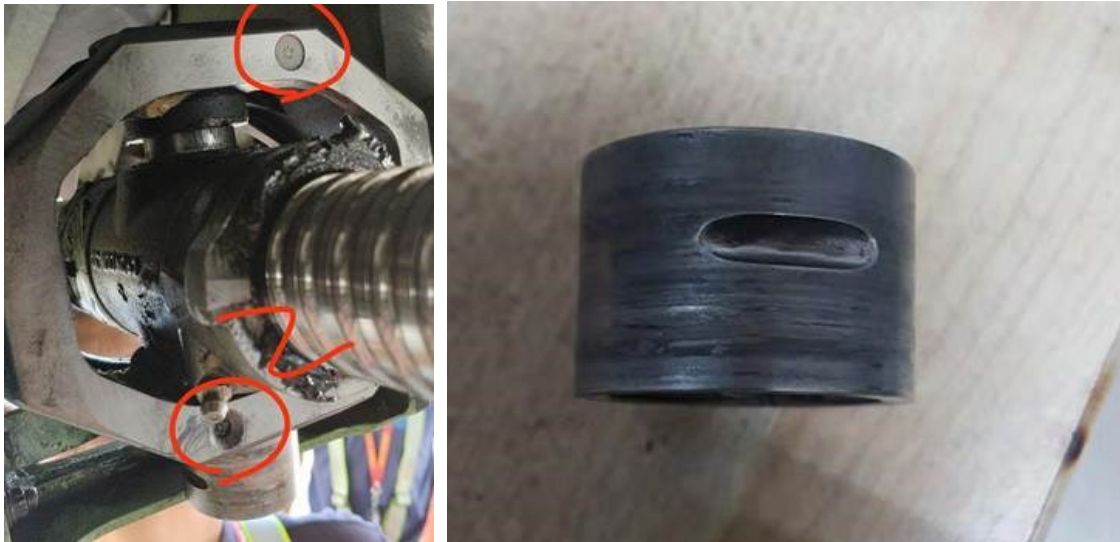
1, 掉落的万象轴衬套是这样的

2, 此类缺陷在机队中有过类似的案例，统计机队运行中的情况，相关事件清单如下所示。因为这个衬套是使用螺栓穿过其本体析出来的凹槽固定，从故障表象上看均是安装螺栓丢失导致的衬套跌落，分析可能性成因是由于高振动导致的磨损断裂。这个问题在机队也是广泛存在，运行中反映基本上 1 年 1-2 起。而更多的磨损通过 C 检检查发现。在检查工卡中加入了间隙的检查要求，当磨损超标时更换。年均 30 起以上。我们的分析认为设计问题，这个螺栓是带镀层的普通合金钢，长期振动磨损情况下被剪切，导致脱落。

厂家也建议在未明确原因前, 客户可以采取一些目视检查工作。对应的除日常的区域检外, 此前在工卡改版中也在 C 检中也加入了对于衬套间隙的检查工作。可以通过测量磨损活动量的方式来进行检测, 并按需更换衬套。

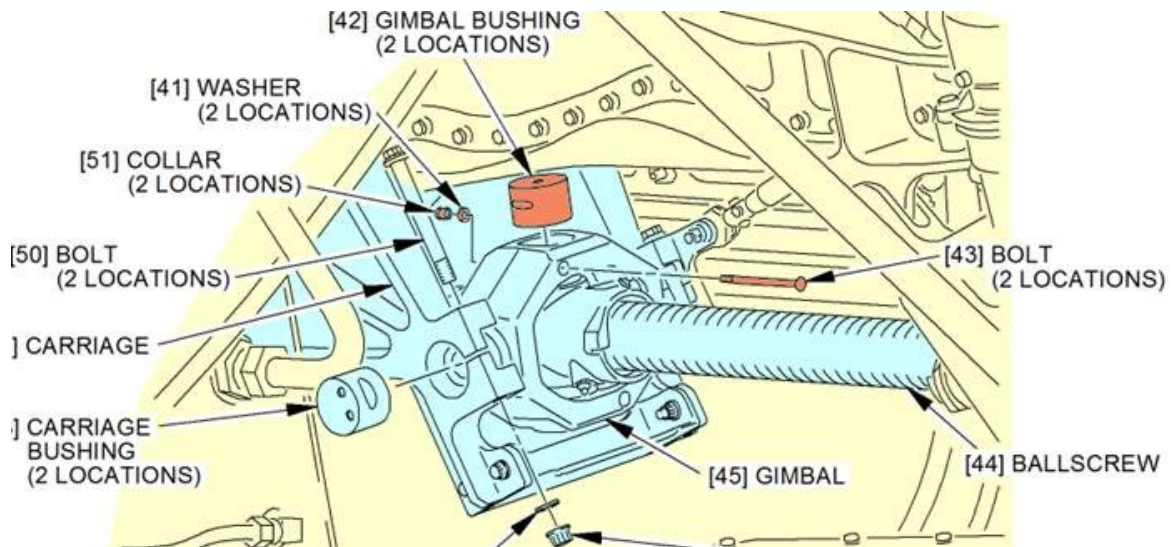
2009 年	2013 年	2015 年	2016 年	2017 年
263*飞机 3 号蜗杆万向轴衬套掉落	508*飞机 8 号蜗杆万向轴衬套掉落	568*飞机 8 号万向轴衬套掉落	178*飞机 5 号蜗杆万向轴衬套掉落	571*飞机 3 号蜗杆万向轴衬套掉落

2019 年 15*1 飞机 3 号蜗杆 万向轴衬套掉落	2020 年 17*7 飞机 3 号 蜗杆万向轴衬套 掉落	2021 年 9 月 17*8 飞机 8 号 蜗杆万向轴衬套 掉落	2021 年 12 月 15*2 飞机 6 号蜗杆 万向轴衬套掉落	
------------------------------------	--	--	---	--
