# HNAT 737 技术问题说明

提示单编号	撰写	校对	批准/日期
TIP737-2022-38-001	王康业	赵斌	曾晶/2022.2.7

## 标题 737 飞机加纯净水后导致水箱指示异常

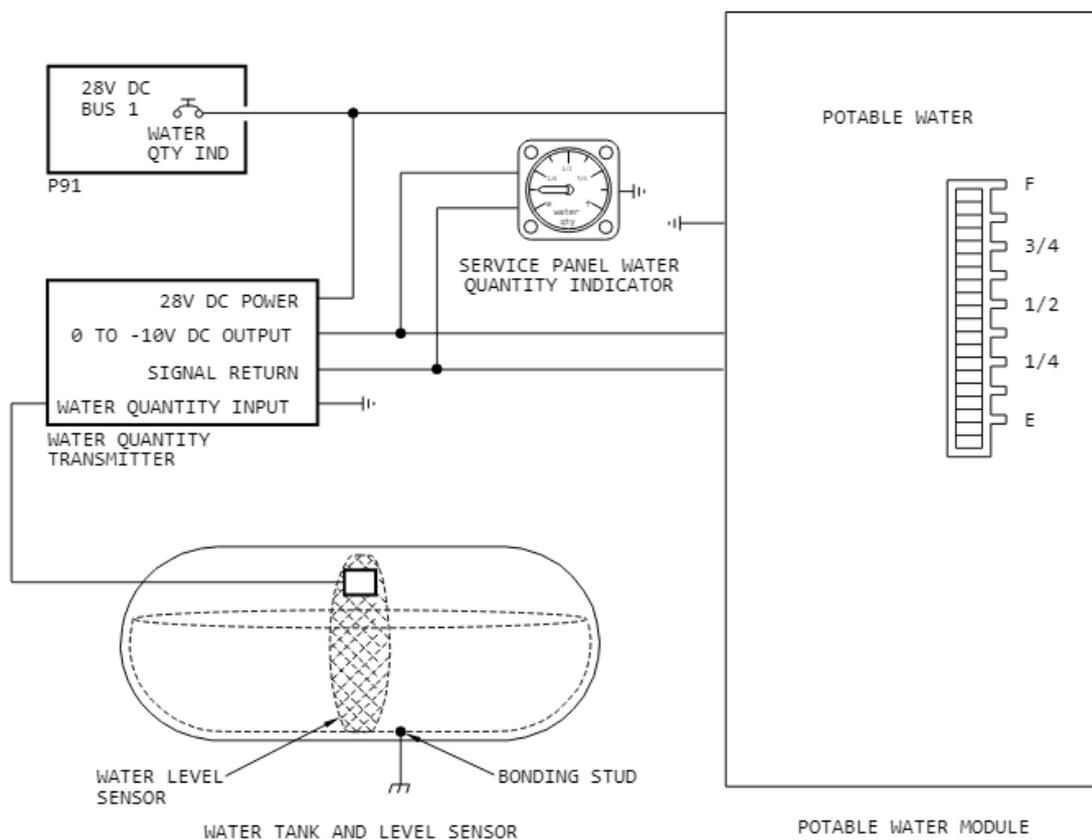
水箱本身可看成是一个整体电容式的传感器，不同材料的水箱，其满位电容也不相同。其测量水位的原理是：随着水箱内水量的变化，水箱输出的电容值也跟着变化。该电容值经过转换器，将电容信号转换成电压信号后，点亮后 ACP 面板对应数量的指示灯，用于指示水量的变化。由于涉及到不同的材料 (现在使用的水箱一般都是玻璃纤维的)，因此在更换水箱时需注意要使用匹配的转换器。

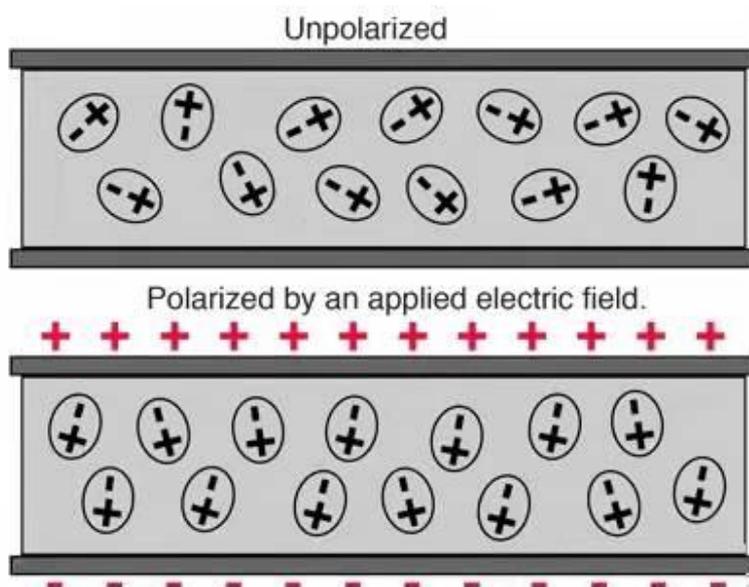
根据物理知识，电容的本质就是电介质的极化。而水车加入水箱的水，我们就可以理解为电容极板之间的电介质。正常情况下，电介质内部有一定数量的正负电荷，但因没有外加电场时，整体上分布没有规律，故而显电中性。当电容极板上连接电源后，外电场使得电介质的电荷发生移动或转向，这种电介质在电场的作用下改变空间电场分布的现象，就叫极化。
