HNAT 737 技术问题说明

提示单编号	撰写	校对	批准/日期
TIP737-2022-52-004	张桃	符方洲	曾晶/2022.3.30

标题 货舱门内部手柄回位弹簧断裂导致舱门警告

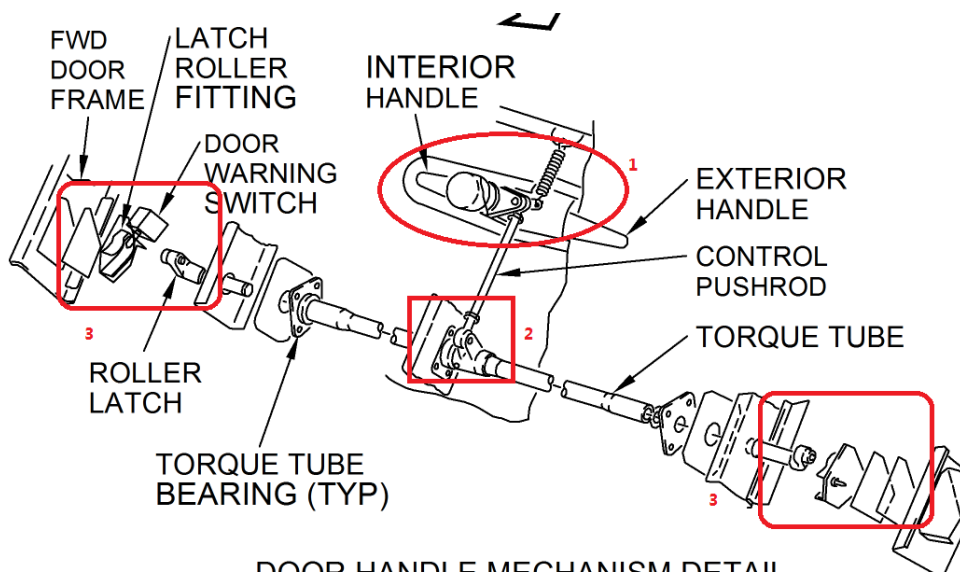
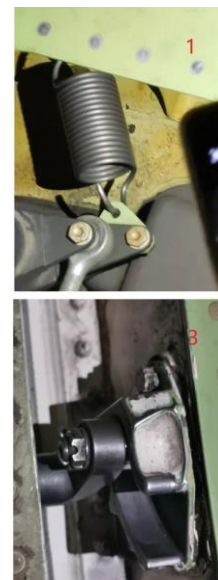
货舱门分内外两个操作手柄，其中内部手柄和手柄转轴连接在一起，当转动手柄操作舱门时，手柄转轴通过控制杆将运动传递到锁紧扭力杆，扭力杆将滚轮转动到门框的滚轮槽中进行锁定，同时手柄的回位弹簧起到辅助内部手柄复位和滚轮入槽后拉紧的作用，整套机构为刚性连接，任何机构的部件的运动传递到其他部件。而货舱门外部手柄，通过另外一个收回弹簧加载在舱门外部的凹槽中，当外部手柄拉出时与上述转动机构啮合，从而作动舱门。当内部手柄机构不在打开位或关闭位时，由于无法啮合，外部手柄是无法转动的。

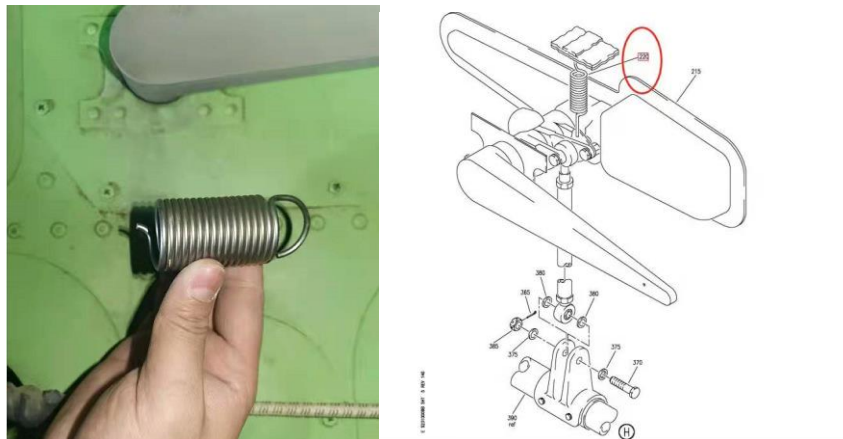
1) 前货舱门内部手柄处的回位弹簧断裂；

从弹簧断裂位置看，有疑似疲劳裂纹扩展的贝壳纹，分析为存在初始疲劳源后，缓慢扩展导致疲劳断裂的发生。

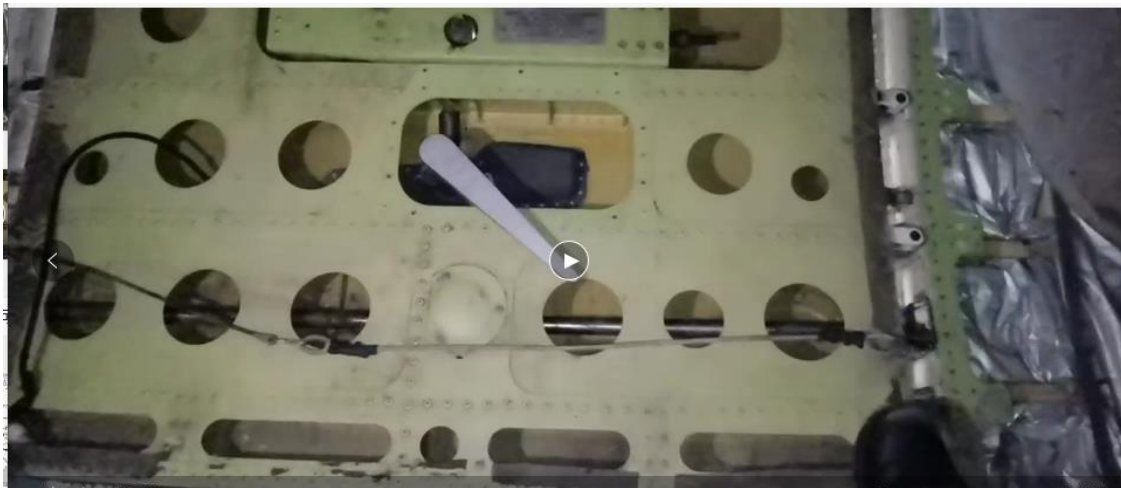
2) 地面模拟在货舱门关闭情况下，从内部踩压货舱门边缘，在力的变化作用下，滚轮会出现轻微的移动，从而带动手柄转动。

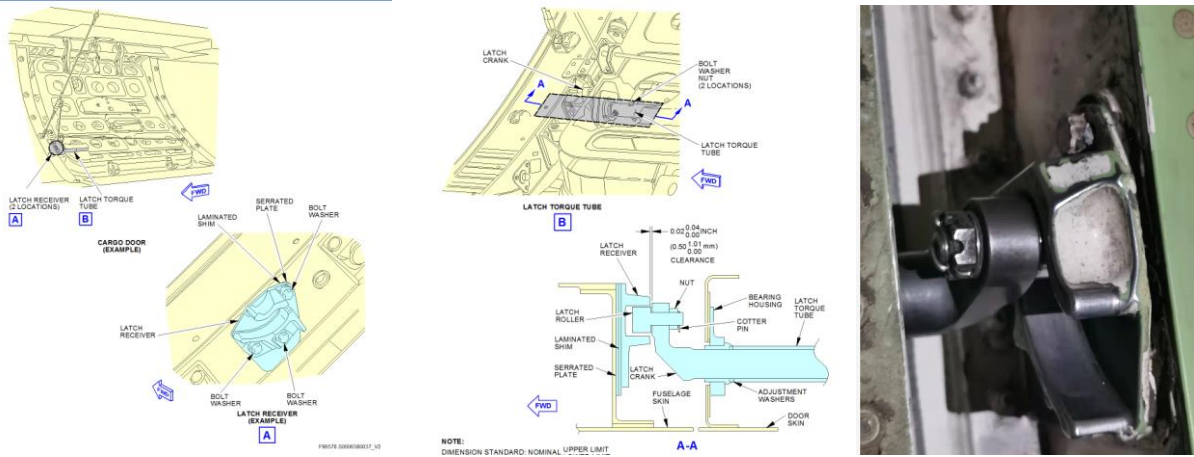
2) 当回位弹簧失效后，由于机构不受弹簧力，滚轮的锁定力相对减少，主要受内外压差、滚轮摩擦力和过槽阻力保持。在飞机滑跑的过程中，由于振动等原因会使机构出现小幅变动，从而导致舱门警告灯亮，严重的引起滚轮脱出卡槽。

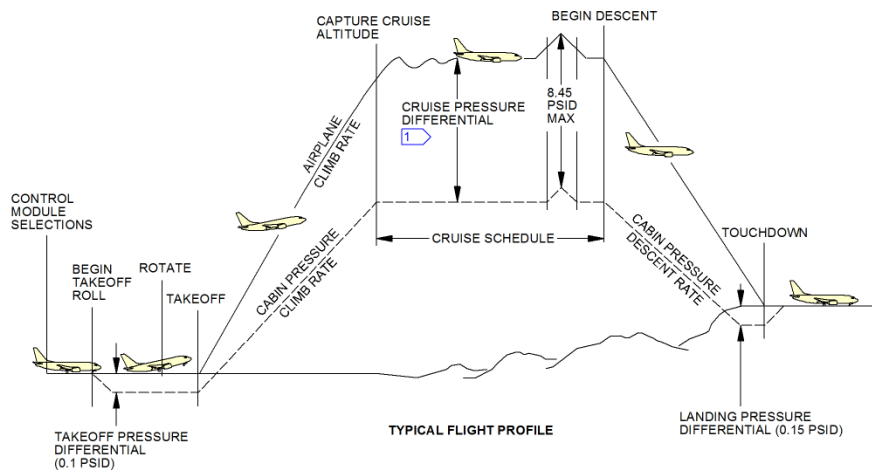
当飞机处于起飞阶段的时候，增压系统会给客舱增加 0.1PSI 的压差，减小飞机起飞时的压力变化，相当于给门一个压紧力，而到空中，由于 7 个多 PSI 差压的作用，这个货舱门将一直处于压紧关闭的状态，而在落地阶段也会同时会施加 0.15PSI 的压力，直到落地滑行时，才逐渐释压。

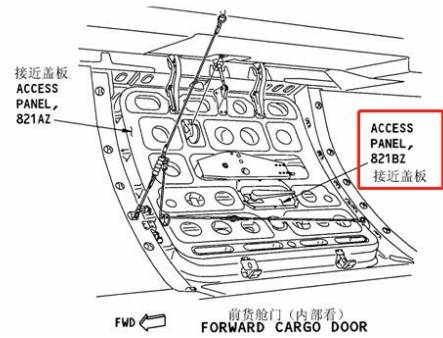
当前工程措施中，按每 6600FC 执行相关区域检查工作，其中通过 821BZ 接近盖板可以接近检查到弹簧。
