HNAT 737 技术问题说明

| 提示单编号 | 撰写 | 校对 | 批准/日期 |
|---|---|---|---|
| TIP737-2022-34-016 | 吴坤恒 | 余泳兵 | 曾晶/2022.11.18 |

标题 关于延迟更换风蚀损伤 TCAS 天线的技术问题说明

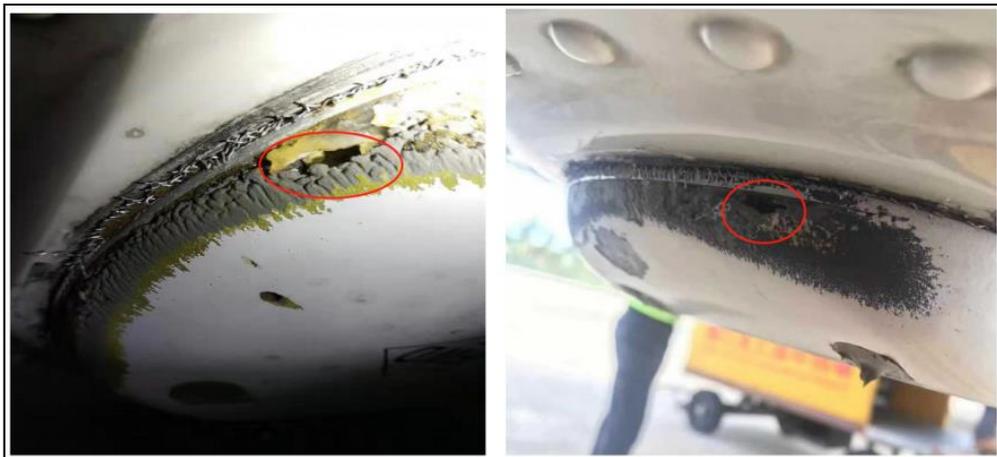
图 1.TCAS 天线

737 机队在运行中频繁反映 TCAS 天线风蚀损伤情况,前期 TSD 已发布 TA-MULT-00-2022-003R1 《737 机队部分天线的损伤标准说明》对 TCAS 天线风蚀或其他损伤进行说明。本文针对由于风蚀造成破损,但因航材保障或其他特殊原因无法第一时间更换 TCAS 天线进行说明。

1.接报 TCAS 天线风蚀损伤时,应根据 TA-MULT-00-2022-003R1 《737 机队部分天线的损伤标准说明》对风蚀损伤情况进行评估。评估结果需更换天线时,应安排更换天线。

2.若因航材保障或其他特殊原因无法第一时间更换天线,确保系统工作正常的情况可参考波音 SR 给出的 NTO,两天内完成更换天线。
