737 No.2 Window - Thermal Edge Break

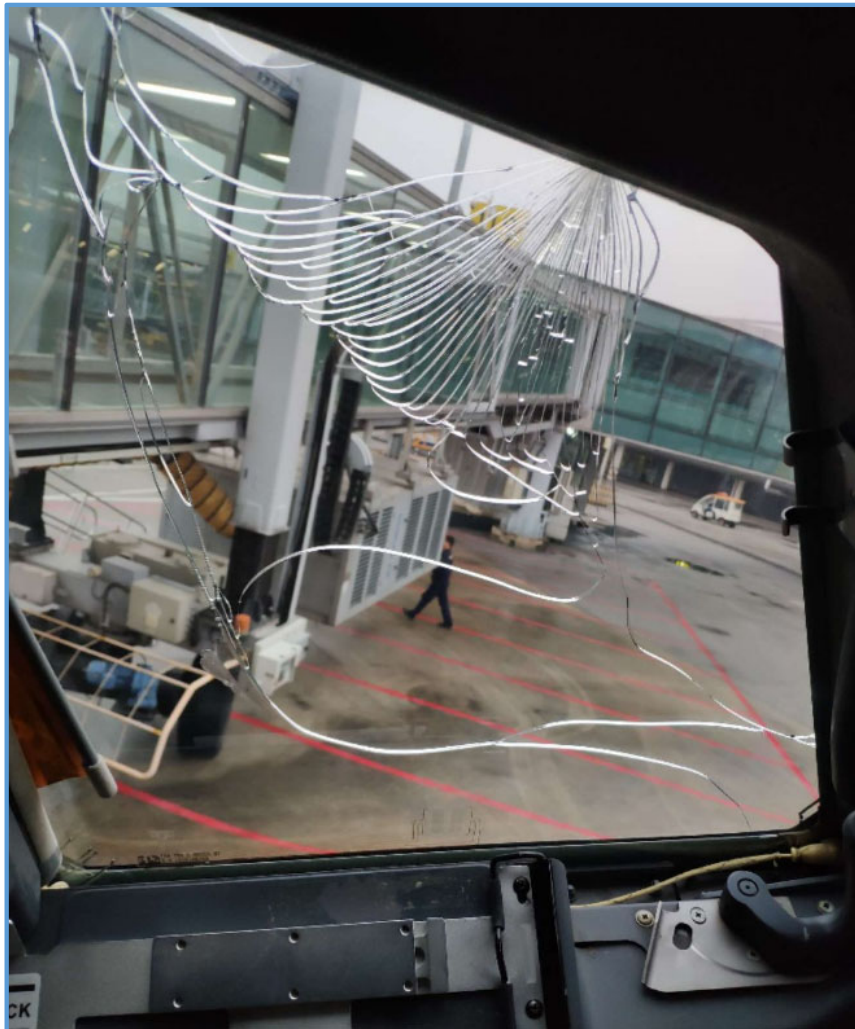
Wet area around the sensor terminals for the No.2 Window, i.e., moisture from condensation, rain when No.2 window open, etc., may cause loss of insulation resistance. This condition may cause the window heat control unit (WHCU) to sense a cold window, leading to a runaway heat condition, causing the window to overheat, and fracture in the pattern shown below.

Thermal edge break fracture pattern, typical.

- inspect and replace the No.2 windows per AMM TASK 56-12-11-200-801
- inspect and repair the fillet seal per AMM TASK 56-12-11-300-804 if found eroded, cracked, or missing

(May help reduce the risk of thermal edge break.)

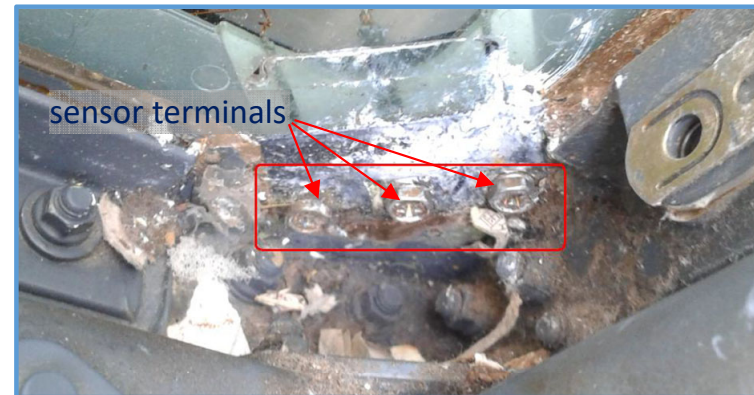
Evidence of moisture at the No.2 window sensor terminals.

- inspect the No.2 window assembly and sill per AMM TASK 56-12-11-200-802, removing any blockage on the aft drain hole on the No.2 window sill and the No.2 window assembly or removing any water accumulation
- apply a layer of Dow Corning 340 heat sink compound to the No.2 window temperature sensor terminal connections per AMM SUBTASK 30-41-00-900-001 step (e).

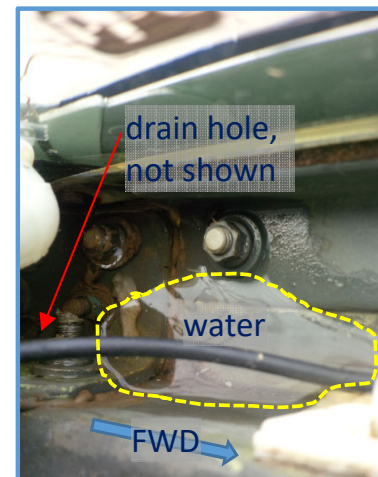
Water accumulation in window assembly due to plugged drain hole.

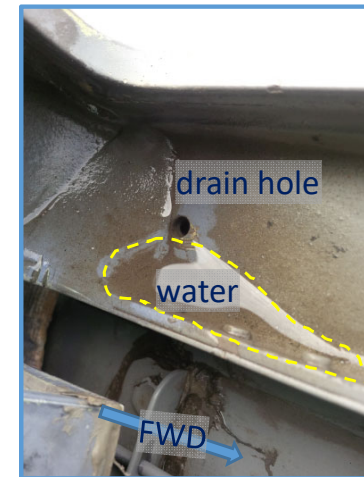
Water accumulation in window frame sill due to plugged drain hole.
