# B737 PTU Cracked Seal Retainer Investigation PN 56586

P/N:63169 – Rev. A (Mar-2026)

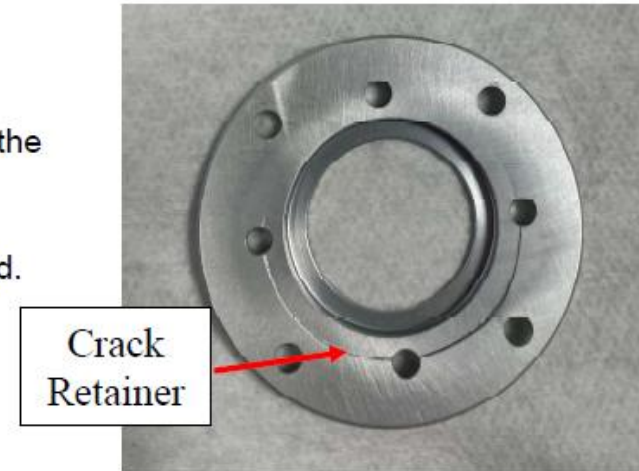
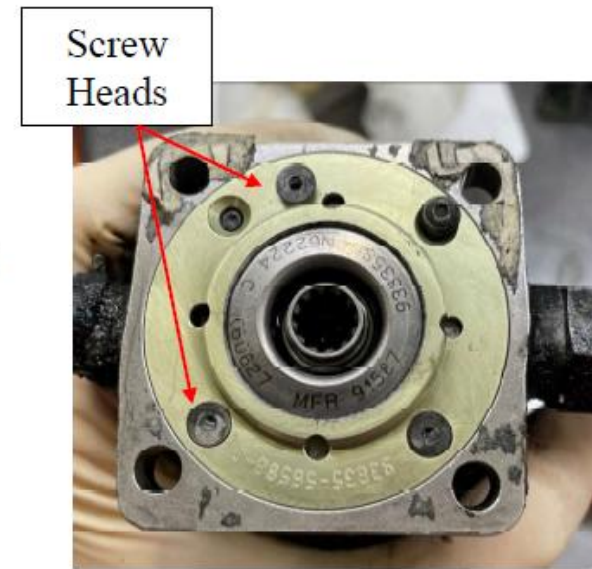
- Increase of PTU returns due to external leakage
- After teardown for investigation, units present cracked seal retainer on the motor side
- Oftentimes the screw heads are busted off and internal seal is damaged.

- Aircraft system exceeds existing system requirements, specifically case pressure.

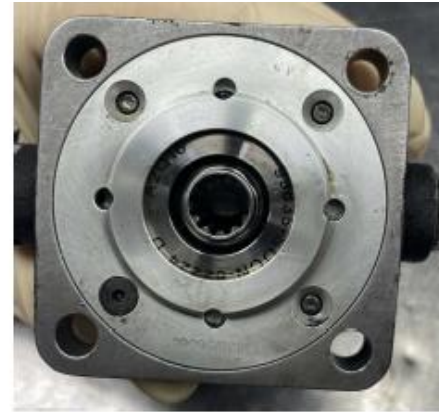
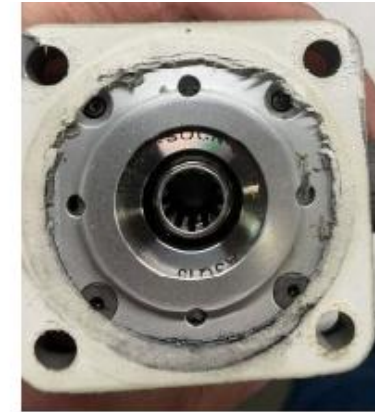
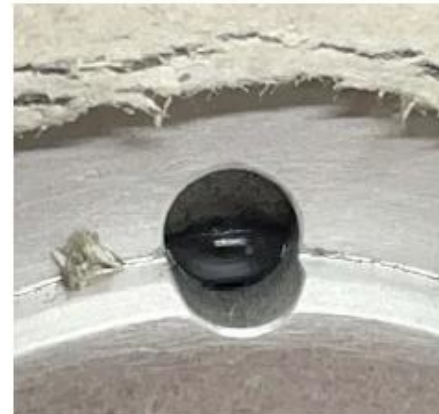
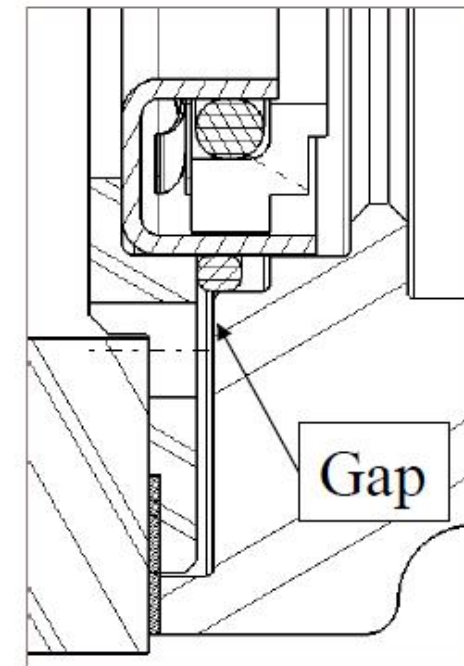
1. Screw Heads Break
2. Retainer moves toward bracket and destroys the gasket.
3. With the gasket damaged, the internal seal has a 0.023" gap.
  - Seal extrudes out un-used hole.
  - Even without un-used hole, seal is expected to extrude.
4. Retainer cracks
  - Supported by FEA
  - Different predicted life depending on location
  - 0-600-0 psi, 300,000 cycles
  - 13,302 cycles predicted in exterior radius of retainer.

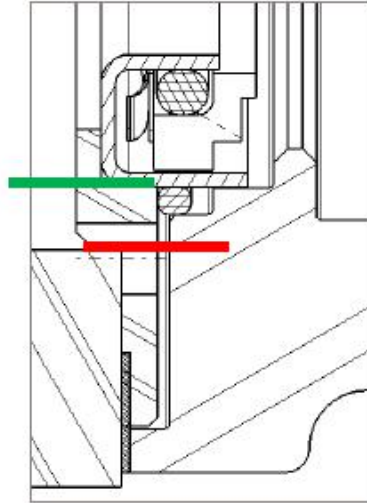
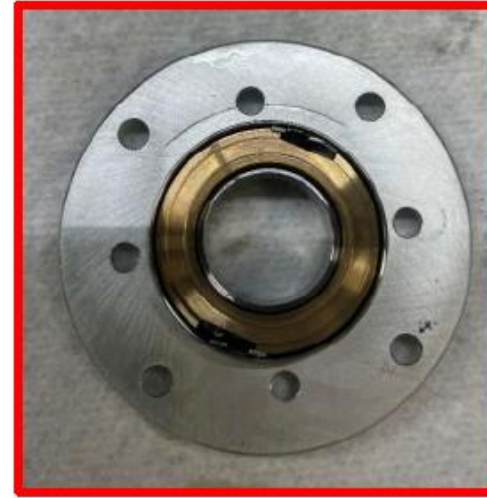
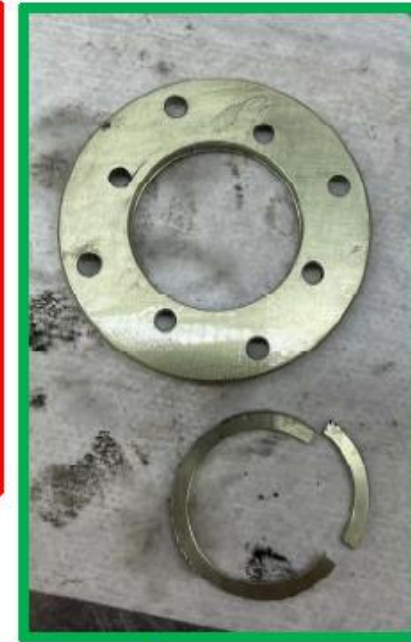
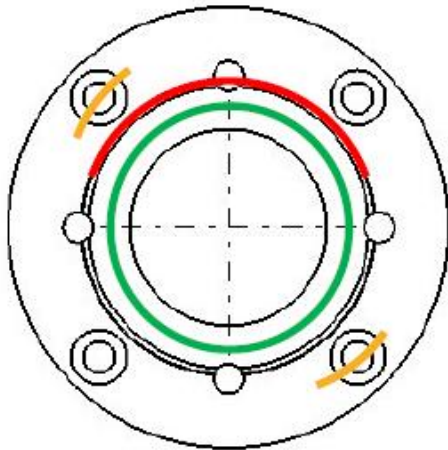
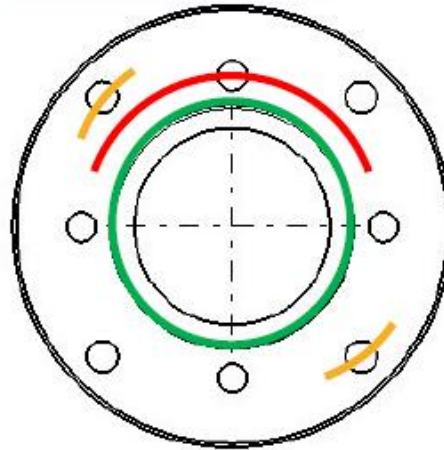
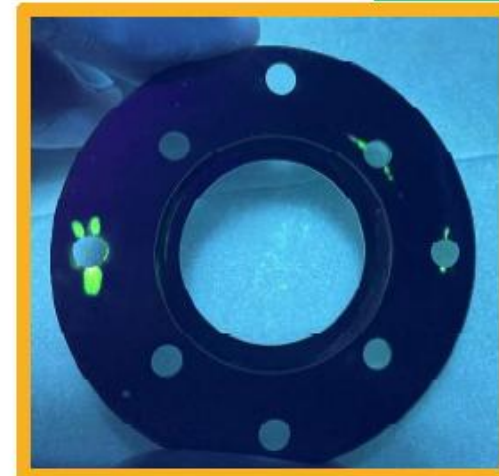
- Screw Location
- Exterior Radius
- Internal Shaft Seal Shelf
