737 MAX / LEAP-1B

# WTT Meeting

October 10<sup>th</sup> – 12<sup>th</sup>, 2023

## Tail Pipe Fire (TPF)

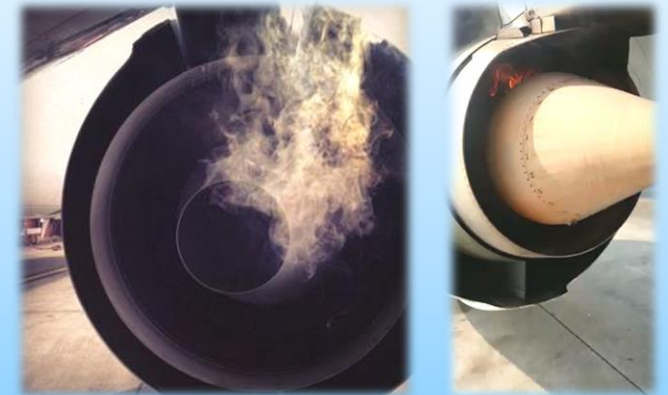
### Candle fire

Smoke with possible flames inside exhaust plug or exhaust nozzles

After shutdown only

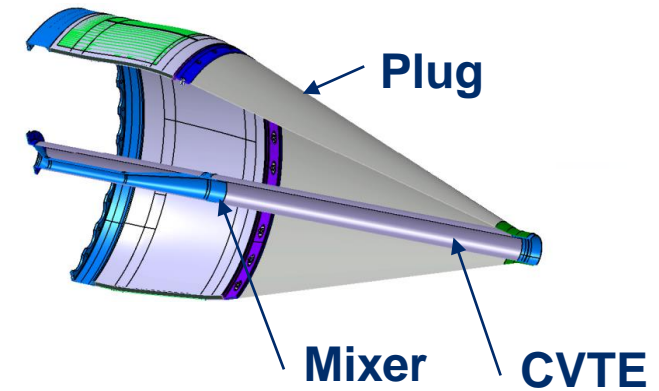
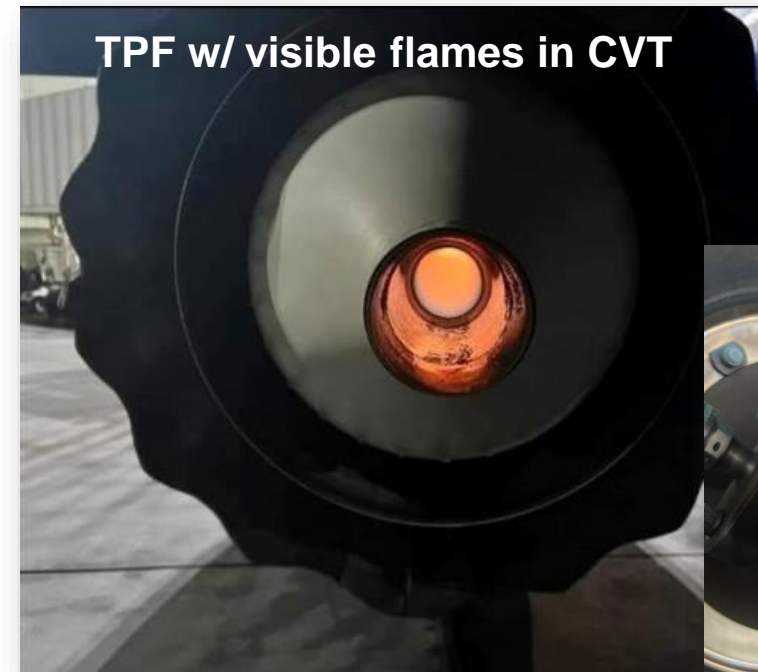
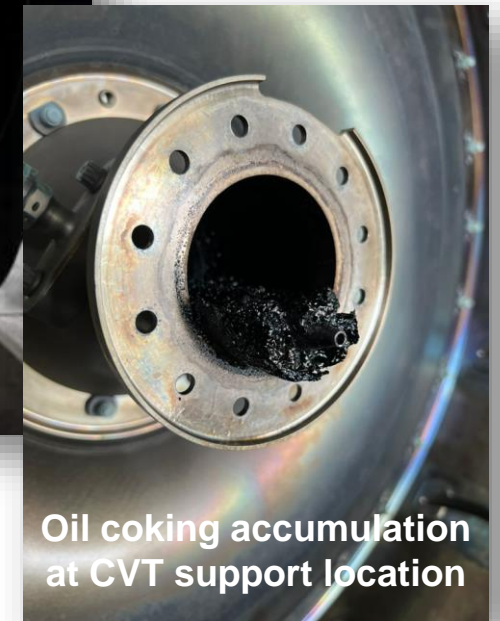
- CVT Extension (CVTE) between CVT support and rear of exhaust plug

- 5 cases reported of TPF in CVT since EIS
  - No correlation with engine oil type or ETSN/ECSN
    - 4,000 – 8,000 ETSN / 1,200 – 3,300 ECSN

- Suspected root cause (to be consolidated in 2024)
  - Oil in the CVT from the A-sump air/oil system travelling through CVT/CVTE
  - Under certain conditions, oil can degrade around CVT support location and self-ignite
  - Oil puddling and coking at CVT support location reported in some cases

- Monitor oil consumption is within AMM limits
  - AMM TASK 71-00-00-800-802-G00 - Engine Operation Limits
- Inspect CVTE/Mixer for oil coking criteria for coking, clean as required
  - TASK 78-11-03-210-801-G00

- Create a new section for TPF in AMM TASK 71-00-00-200-801-G00 *Engine Exposure to Fire and Extinguishing Agents Inspection*
- Target for 2024

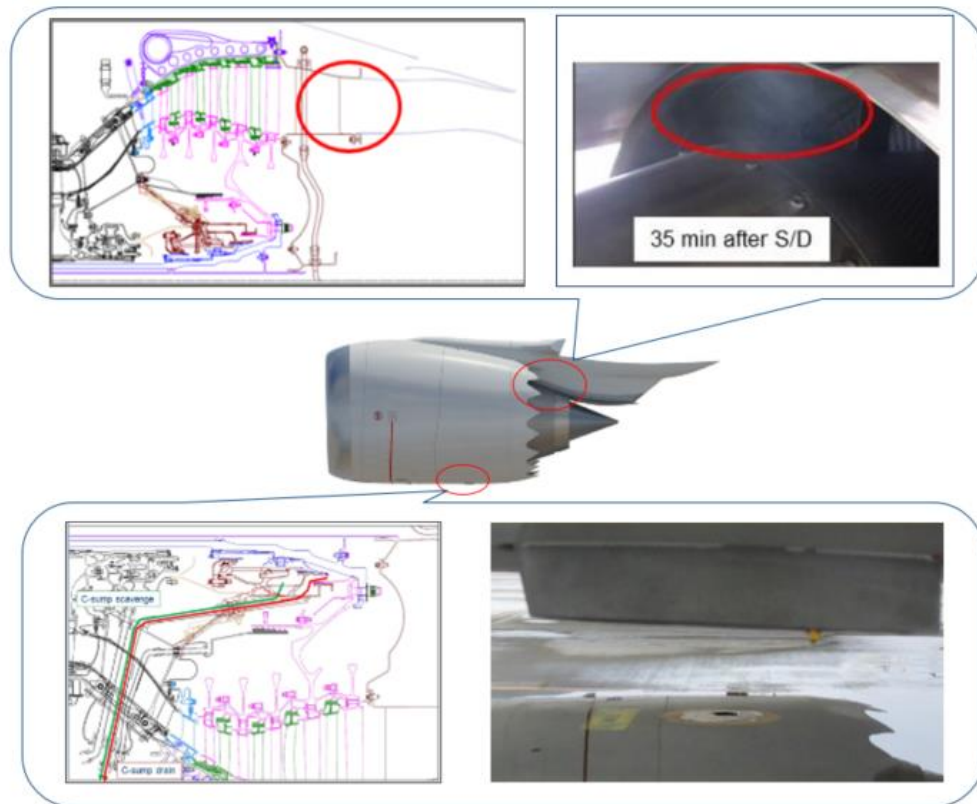
Fumes at LPT exhaust after engine shutdown (~30min) are not related to fire in exhaust plug

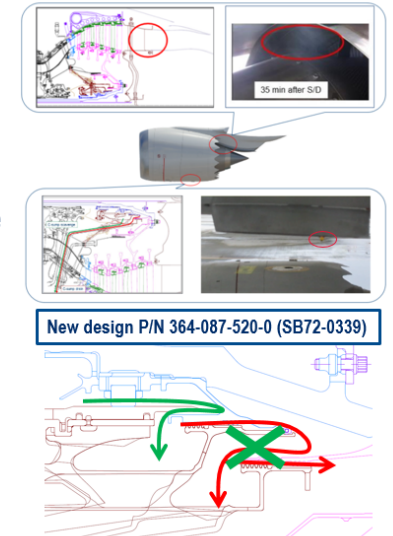
- Two recurring oil related findings for the C-sump :
  - oil drops from drain, 5 min post S/D
  - oil fumes at LPT exhaust, 30 min post S/D
- No impact on : Operational use & Oil consumption

- Happen randomly and linked to flight condition, ground flatness and engine installation (tilt/clocking)

New design P/N 364-087-520-0 (SB72-0339)

- New SB72-0339, cat 7E (August 2022) : new design of LPT rear rotating seal preventing leaks in C-sump drains & fumes
- Studies in progress for a CIS prior oil leak rate determination

**New design available & AMM update in study for a reduced inspection burden**
