# HNAT 737 技术问题说明

提示单编号	撰写	校对	批准/日期
TIP737-2024-32-027	张勇	张桃	曾晶/2024.05.11

## 标题 关于 737 轮速传感器线束磨损的故障分析

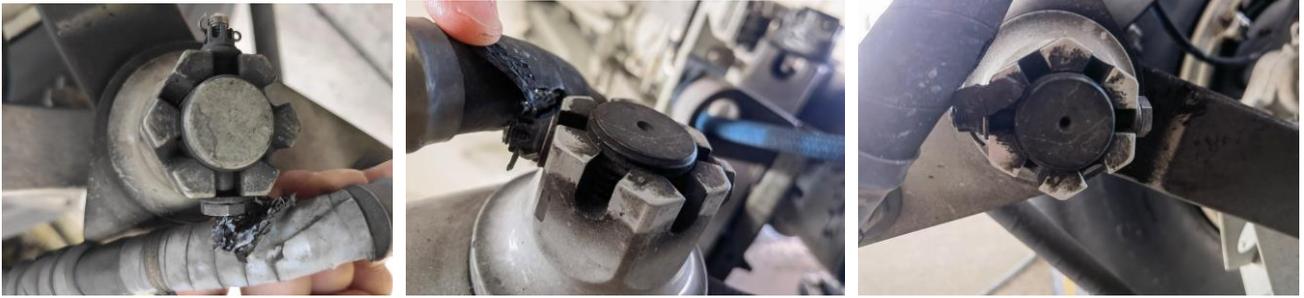
线束磨损的位置，都处在起落架减震支柱上下防扭臂扭力连杆连接的大螺帽处，如下图所示。

从以上图中可以清楚的看到磨损的位置及原因，就是在连接扭力连杆的大螺帽处，由于线管与大螺帽的固定螺栓及其保险销相磨，导致外层保护套出现明显磨损。即使已做过处理的线管，仍有被磨损到的情况（如下左侧图）。

1. 加强航后检查，在出现磨损后能第一时间发现并处理，不会产生后果；
2. 安装线束时，注意应符合手册/图纸要求的安装角度，同时线束调整余量尽量留到下方的大螺帽附近；
3. 固定螺栓初始安装方向注意远离线束，同时打开口销时，应使用TYPE B打法；
4. 联系波音，争取进行设计更改，或以NTO获取自行调整的可能性。
5. 为对航线工卡起一定的补充作用，修订 A 检 MPD 项目 32-804-01/32-808-02 对应的工卡，添加对该导管检查的相关提醒。

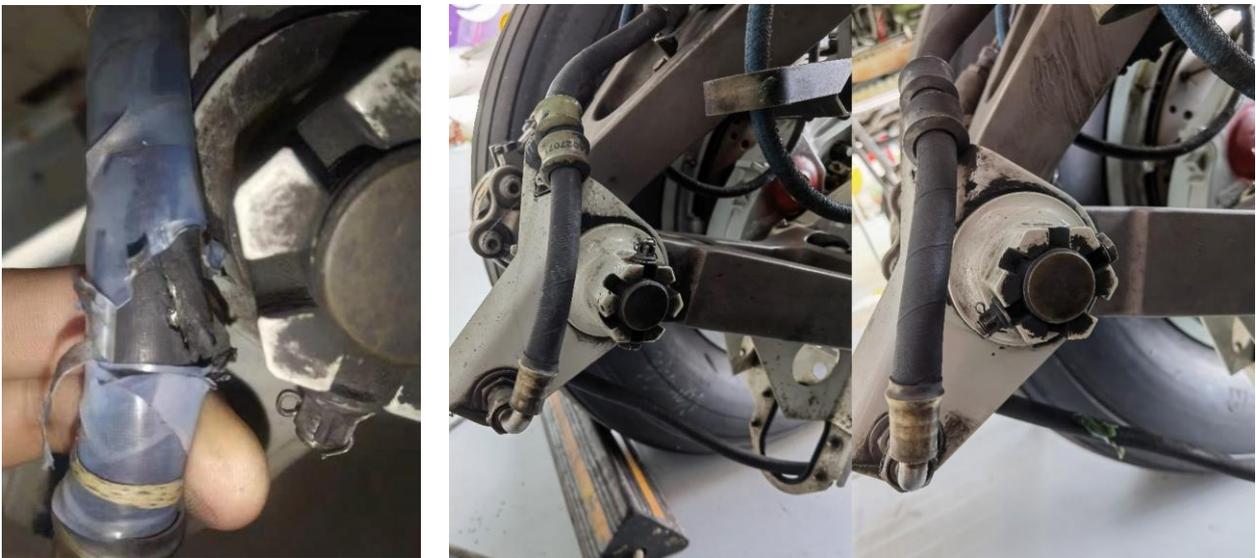
正常状况良好的线束如上右侧图所示。

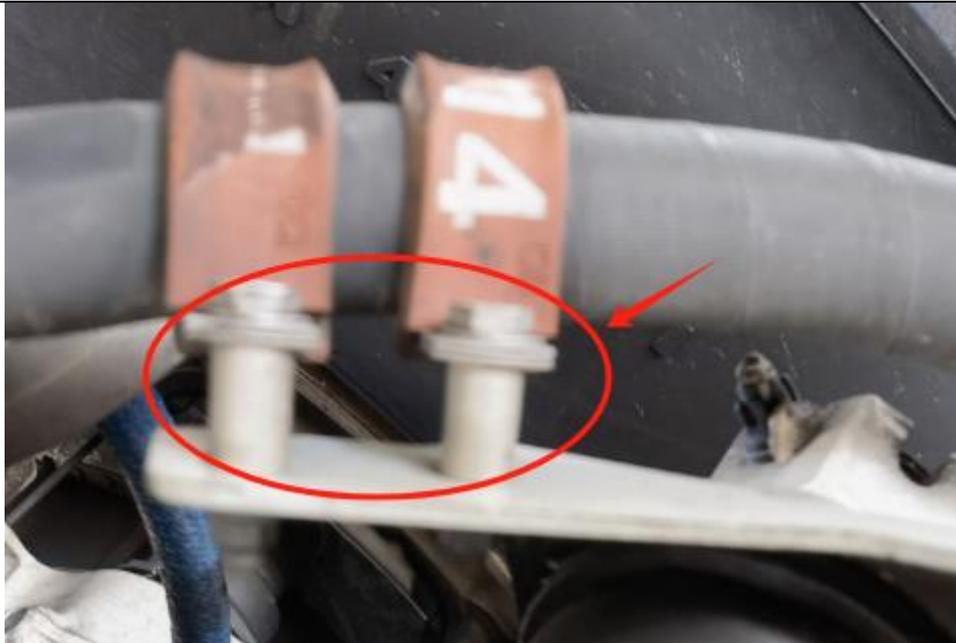
1. 线束调整不当，与大螺帽间距太近。由于长度限制，尽管一路上有7个线卡，但所有线卡角度都基本无法调节，线束基本走向也无法调节，只能将线束余量尽量留下下端，保证有足够间隙。此外，对于NG与MAX，虽然此处构型基本相同，但MAX在线卡处加装有SPACER，可以有效的解决线束与大螺帽之间的间隙问题，而NG线卡处却只有WASHER，无法有效调整线束间距。

下图展示的就是 MAX 上的设计，可以看到有 SPACER 垫高线卡，这些可以给线束留出充分的空间。

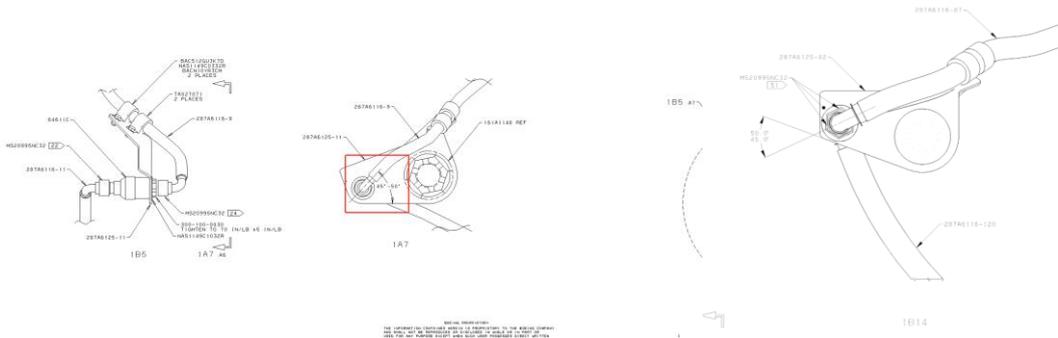
而NG上就只有WASHER，导致线束与大螺帽之间间隙无充分可调空间。后续已联系波音，看能否在NG上加装SPACER。另外对于线束安装角度，图纸和手册中均有明确要求，也是为了避免出现相磨情况，安装时应注意并遵守。

(i) Make sure that the electrical conduit and apex nut [24] do not contact one another.

1) Make sure that the electrical conduit is at an angle of 50 +0/-5 degrees from the bottom of the bracket [28].

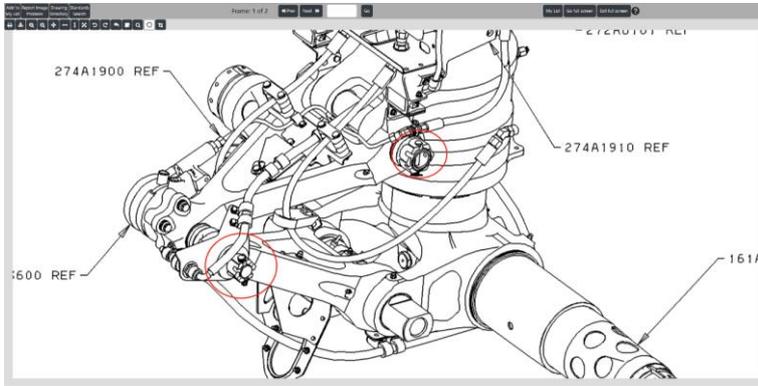
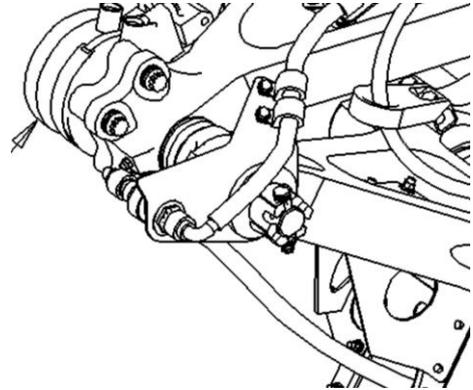
2、大螺帽固定螺栓安装方向问题。可以看出来，即使线束与大螺帽间隙比较近，但出现磨损的情况，

都是由于与螺栓及其保险销接触到了，螺栓的安装方向可以调整，使其朝向远离线束，但由于此处是运动部件，大螺帽会随着减震支柱的上下运动而发生旋转，因此即使调整螺栓安装方向，其也会随着时间发生变化，因此无法彻底解决问题，不过还是可以要求，在初始安装或调节后，应将螺栓安装方向保持在一个远离线束的方向，以最大限度减小相磨的可能性。图纸上也展示出了螺栓安装方向，不过没有特别标注出来：

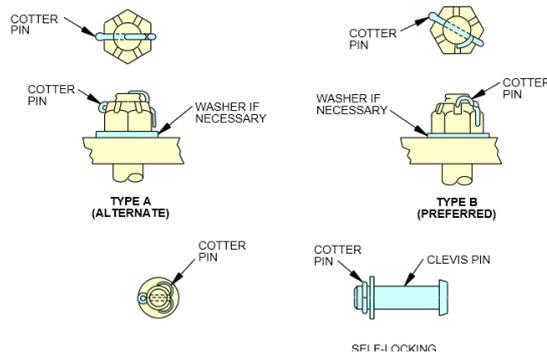
3、螺栓固定开口销。从图中可以看出，线束最先或者说最可能与螺栓相磨的部位，通常都是固定罗双的开口销，而对于开口销，手册中有两种打法：

目前查看几架磨损的飞机，开口销打法都是使用的TYPE A，这样的打法销子的一个边会冲外且容易翘起，更加加剧了磨损的可能性，而使用TYPE B打法，则可以完美避免这个题。同比起落架类似的另一个位置——地扰推拉钢索套管处，手册里就明确写明了推荐使用B打法，且有CAUTION注意相磨问题：
