Hainan Airlines

Chafer cord visible

Goodyear
28th July 2025

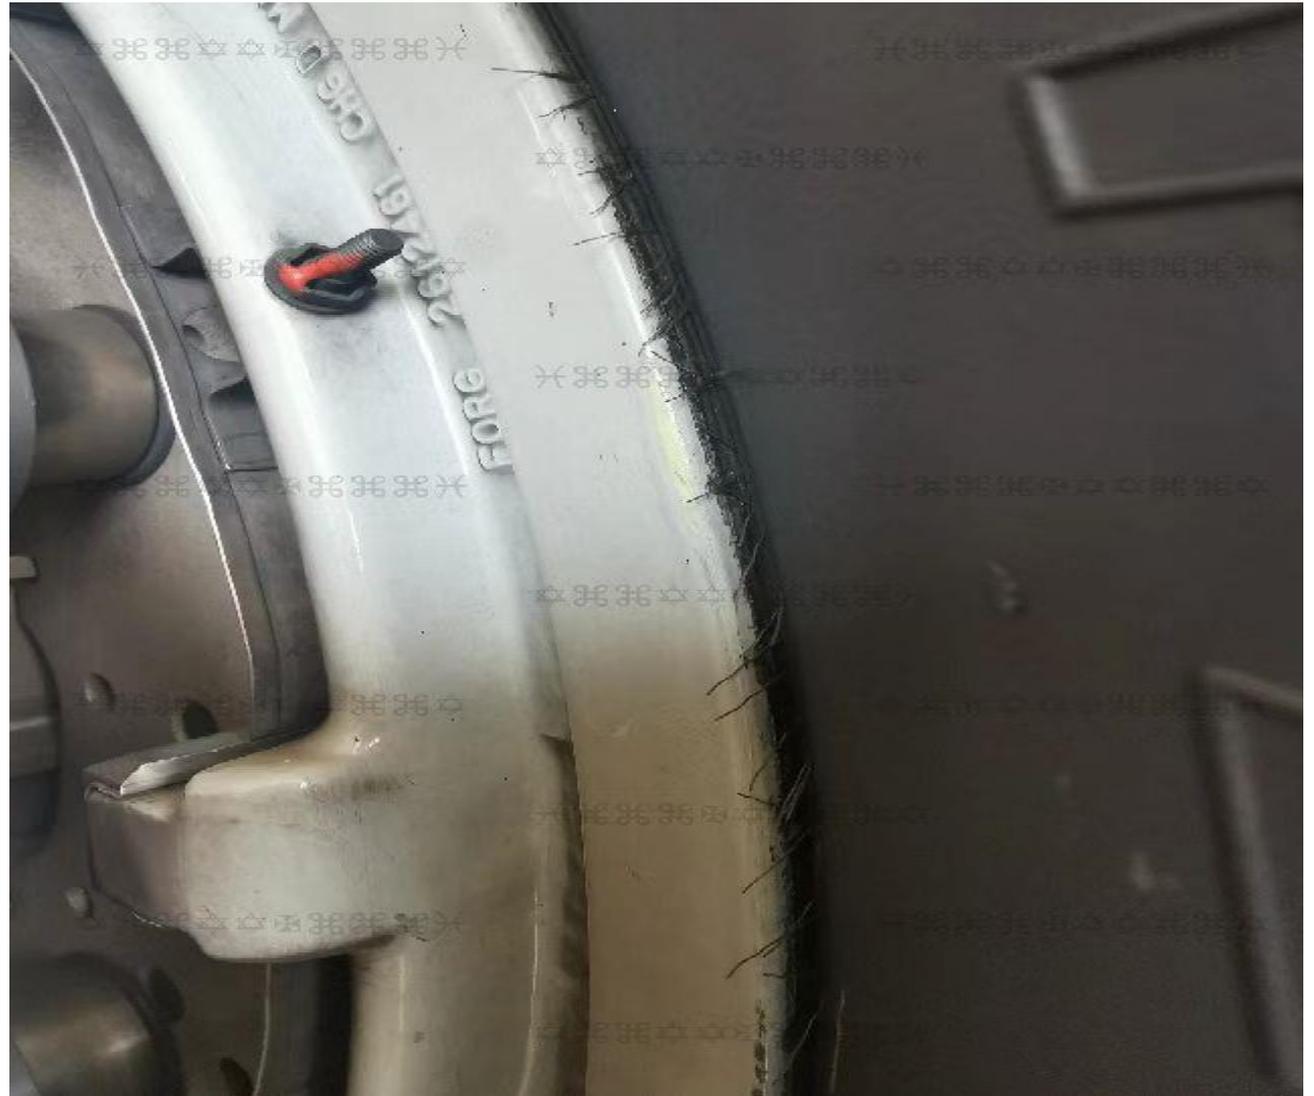
Hainan Airlines reported that there was one tire Chafer cord visible.

- Tire size : H44.5X16.5-21 28PR-225MPH
- Part number : 441K82T1

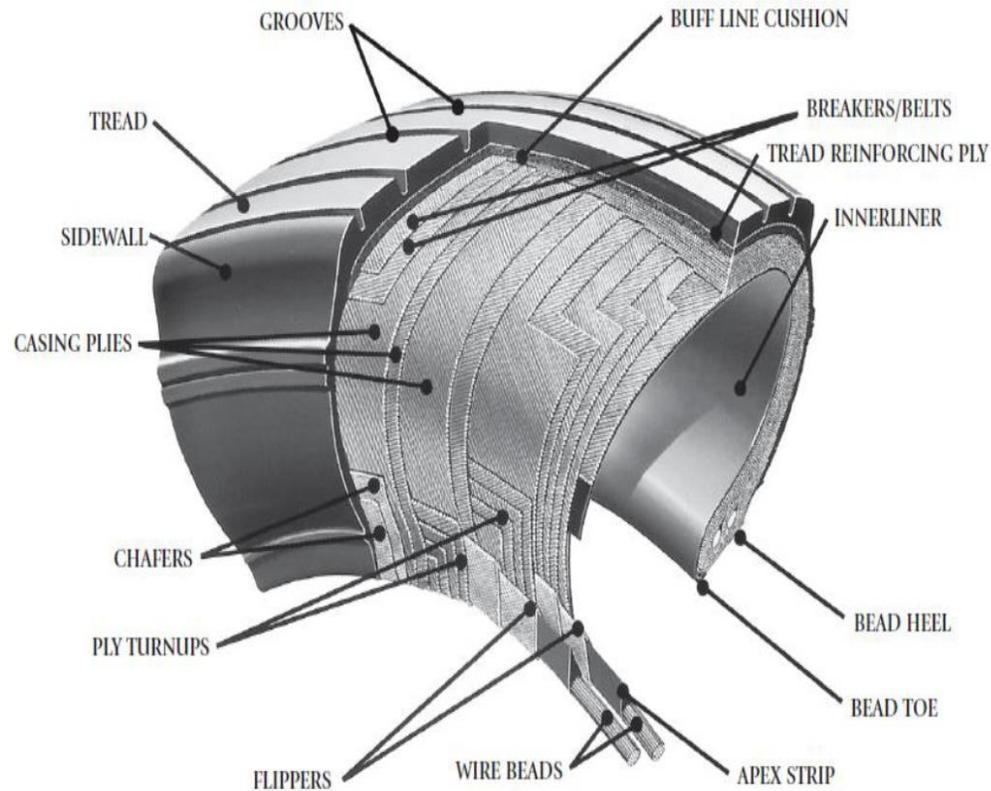
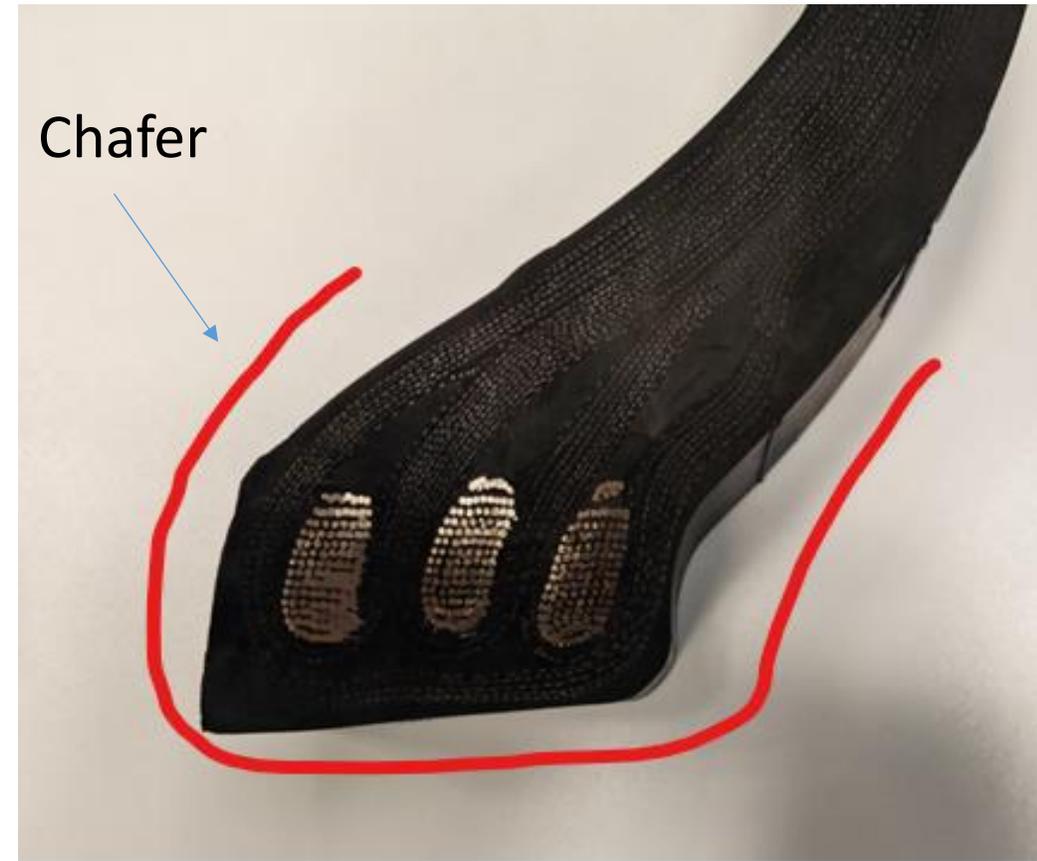
Sample of Chafer cord

chafer cord visible found on some tire. due to severe wear with wheel hub.

Chafer cord是摩擦片里面的成分，目的是为了增加摩擦片的强度。摩擦片非胎皮结构，它是在胎体和轮毂之间的一层橡胶，其目的是为了减少轮毂对胎体的磨损。

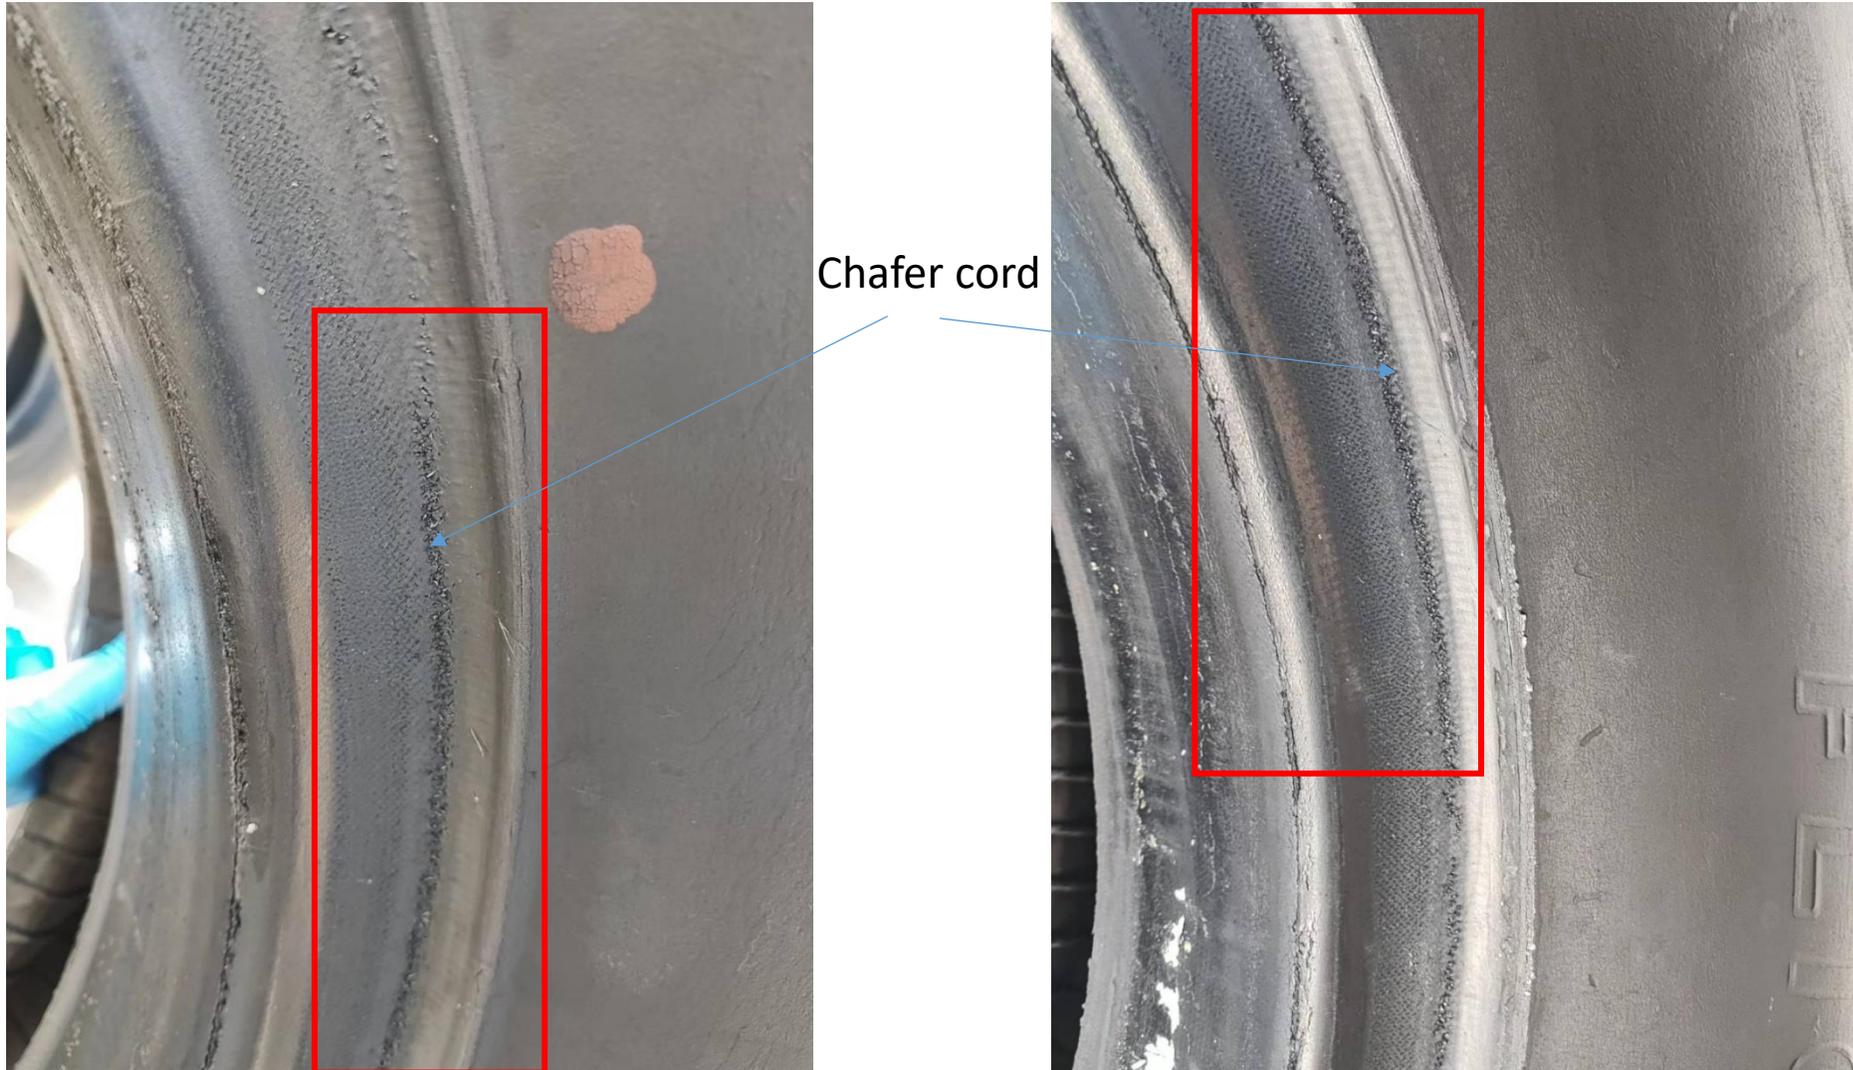
- Chafer cord是摩擦片里面的成分，目的是为了增加摩擦片的强度。
- Chafer摩擦片非胎皮结构，它是在胎体和轮毂之间的一层橡胶，其目的是为了减少轮毂对胎体的磨损。
- Chafer cord 在一些磨损比较严重的胎皮的胎圈位置偶有看到，通常会在R-level比较高的胎皮上。
- 观察这条发现Chafer cord的胎皮，在胎圈附近Chafer摩擦片位置发生了比较明显的磨损。
- 夏天橡胶偏软，也是磨损明显的原因之一。

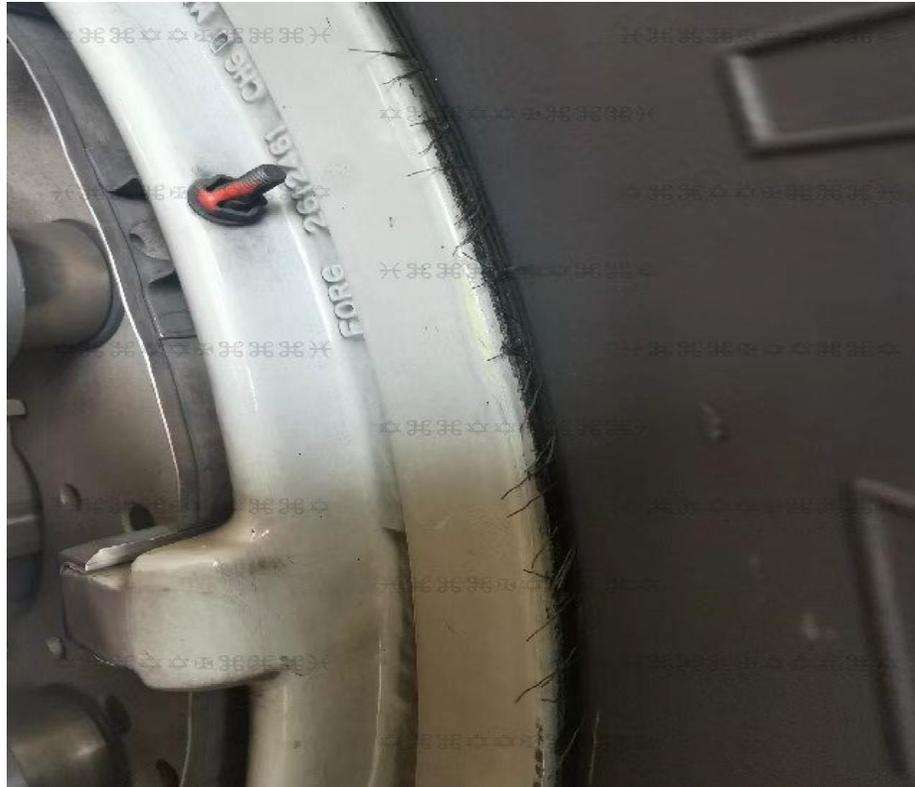
Sidewall Damage

Remove tire from service if weatherchecking, cracking, cuts and snags extend down to the casing ply in the sidewall and bead areas.

- 参考我司CMM手册P26页，胎侧损伤见Casing ply(胎体帘布层)不能使用。
- Chafer cord 不是胎体帘布层，此胎皮可以继续使用。
