Abnormal rust inside of PITOT 0851HT-2

1、Background

JJC encountered two early failure of 0851HT-2, and one cause a delay. We inspect the two pitot probes, found abnormal rust inside of PITOT(0851HT-2). During following inspection on the available pitot probes in store and installing parts on-wing, we found similar rust.

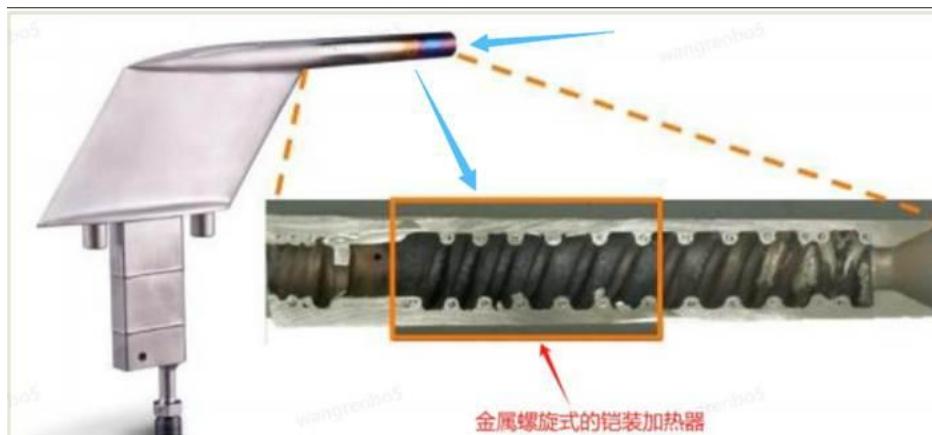
2.2.1: We borescope pitot probe from the airinlet hole as figure below(blue arrow) for detecting rust on protective surface of heater line, because the rust will cause heater line broken. **We name it “position1”**

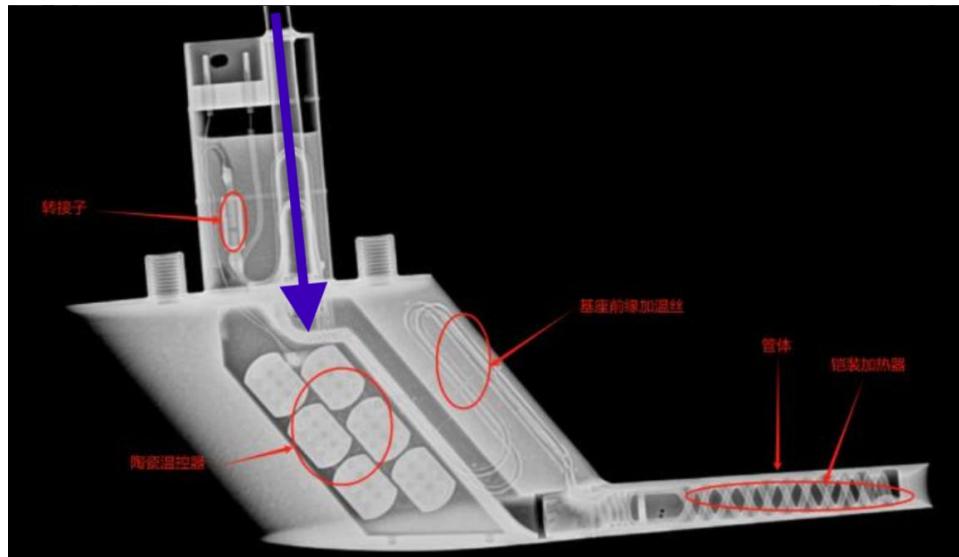
2.2.4 We began to explore borescoping pitot probes from airoutlet hole, and found the rust in the new position as figure below (Blue arrow point) : **We name it “position2”**

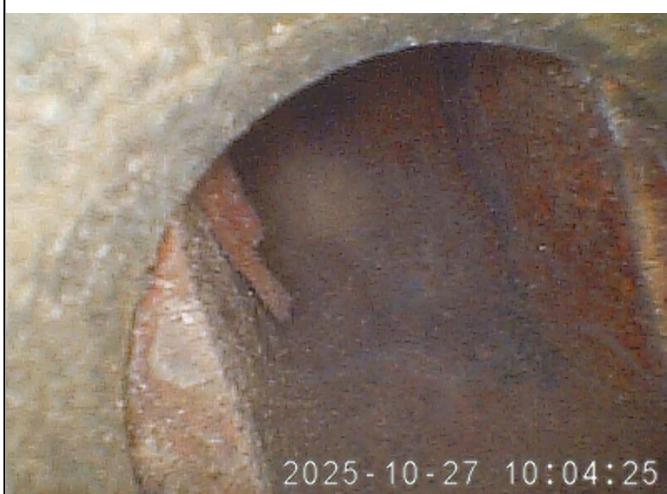
PN	SN	Installed Date	Removal Date	status	Inspection Result	TSN	CSN
0851HT-2	457478	2024/9/2	2025/9/22	Unscheduled Removal	<p>During the 2C inspection, the execution of EOJC-APL-73N-20-002 revealed that the base of the co-pilot's pitot probe was ablated. Other measurement results are as follows:</p> <p>(1) Conductance resistance (required 45-65 ohms): 47.2 ohms</p> <p>(2) Working current (required 0.15A - 0.85A): minimum 0.391A, maximum 0.658A</p> <p>(3) Insulation resistance (required greater than 1M): >550 megohms</p> <p>The reason for disassembly this time was that an abnormality was visually detected. However, no abnormality was found during a visual inspection in the warehouse. The coating condition of the intake port was within the acceptable range upon endoscopic inspection, but there was obvious rust and foreign matter in the corner area of the pitot tube airway when the endoscope was inserted into the exhaust port.</p>

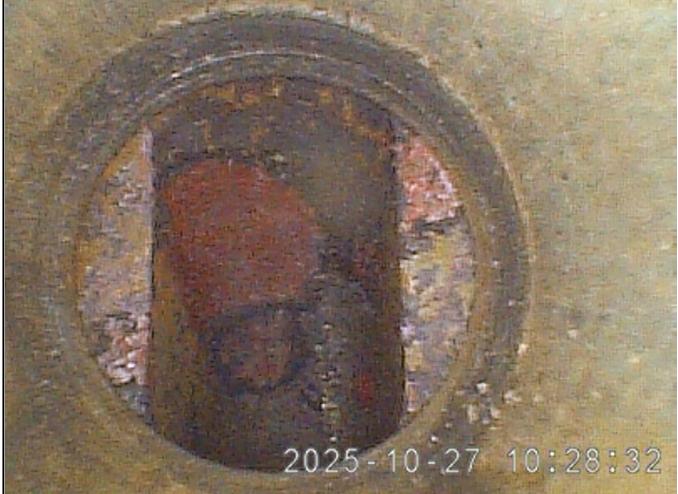
0851HT-2	462606	2025/9/22	2025/10/16	Unscheduled Removal	<p>Troubleshooting and replacement of the co-pilot pitot tube heating failure during operation. Measurement found that the conductance resistance of the pitot tube was 40K ohms, exceeding the standard value (45-65 ohms). This inspection of the pitot tube found that the conductance resistance was far beyond the standard value, indicating an open circuit. The coating condition inside the air intake was within the acceptable range, but the endoscope inspection of the exhaust port found obvious rust in the corner area of the pitot tube airway. This pitot tube showed such a state of rust after only 148 flight hours of use, which was</p>	148	88

abnormal.

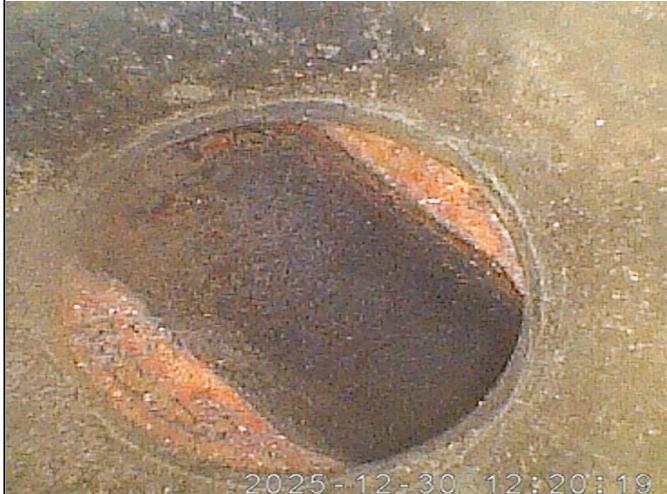
0851HT-2	452233	2024-06-10	On-wing	Capt probe

2025-12-30 12:20:19 Obvious rust in position2	3253	1587
0851HT-2	458687	2025-01-26	On-wing	Standby probe

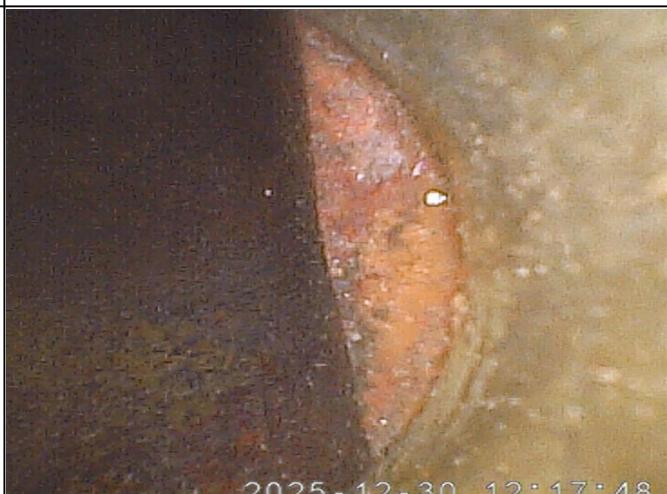
2025-12-30 12:17:48 Obvious rust in position2	1776	821
