标题:	关于 CFM56-7B 发动机 76 片构型 (件号 2403M91P02/P03/P04/P05) 高压涡轮叶片叶根断裂故障的分析报告 R5			
一. 问题概述				
CFM56-7B 发动机 76 片构型 (件号 2403M91P02/P03/P04/P05) 高压涡轮叶片存在叶根榫头断裂的风险。				
二. 已发生事件汇总

2026 年 6 月 5 日 编写: MTU 任炎炎 修订: 厦航 周颖

审核: 民航发动机专项工作组

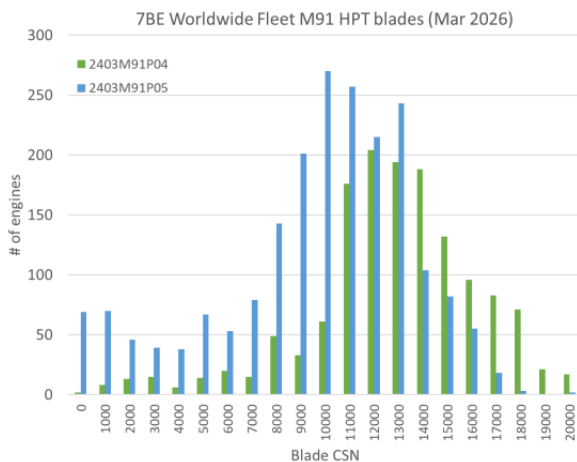
Worldwide 7B M91P04/05 Cycles Distribution and Significant Events

- Five significant events observed in P04 fleet, Four events are at highly affected sub-fleet customers
- No event in P05 fleet

CFM recommends to follow published RRTs for HPT blade management

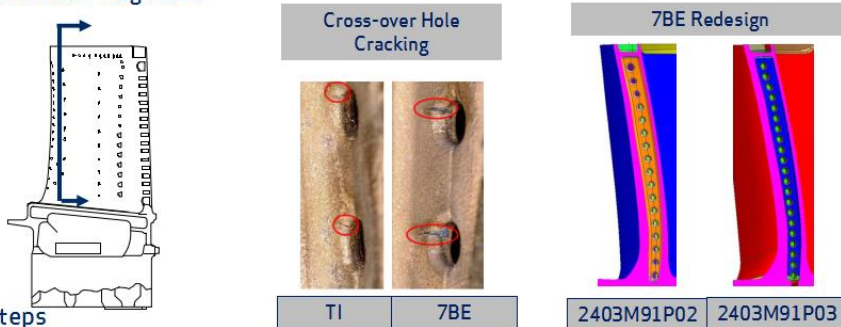
Lead edge internal rib - cross-over hole modification – 2403M91P03

2013 年 3 月 CFM 发布了 SB72-0935, 引入了 2403M91P03 构型的 HPT 叶片。根据 SB 介绍, 由于在工厂的测试阶段时发现 2403M91P02 构型的 HPT 叶片在第一排的冷却孔存在裂纹 (详见下图), 2403M91P03 构型叶片改进了这些冷却孔的设计, 减少应力集中, 避免产生裂纹, 其它部分均无改变。

- Re-shaped cross-over holes and increased number – stress reduction
- Introduction - Aug-2013

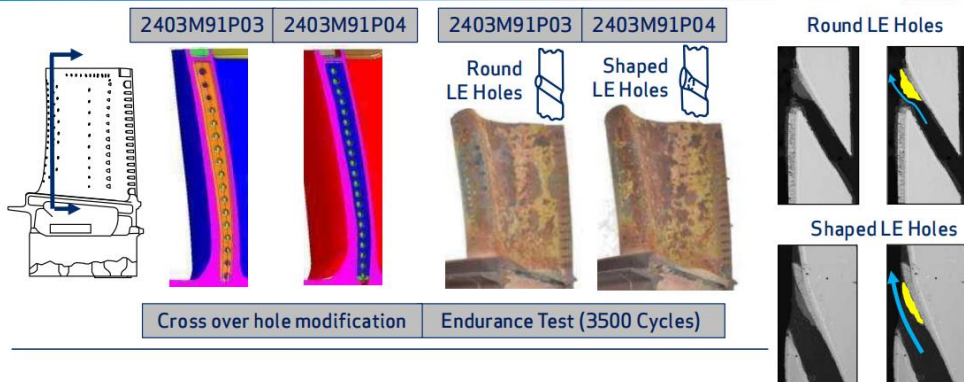
76 Blade Rotor (-5B PIP / -7BE) – Lead Edge Improvement

2403M91P03 → P04 Sept-2015 introduction
Service Bulletins -5B 72-0916, -7B SB 72-0983

Internal and External lead edge cooling modifications - fully tested: 3500 cycle endurance engine test with dust ingestion

Significantly reduces L. E. temperature & distress in severe environments

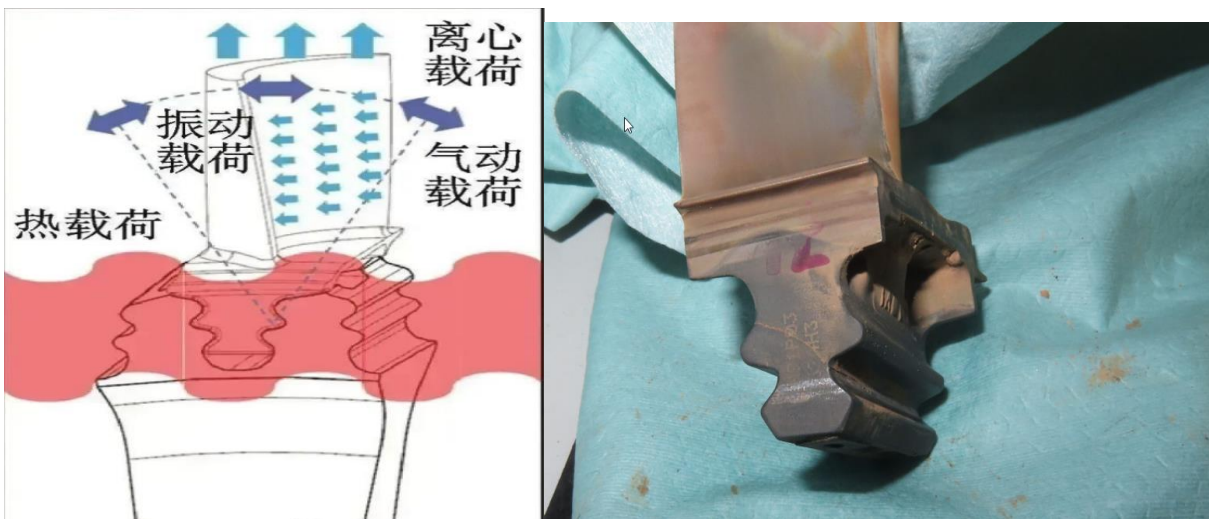
- 2、根据 CFM 的调查，76 片构型的高压涡轮叶片低周疲劳寿命对应力的变化非常敏感，叶片自身的偏差和发动机运行差异会影响叶片实际受力状态，造成小颈裂纹的萌生和扩展时间上存在差异。
- 3、根据已经出现的案例分析，件号 2403M91P02/P03/P04 高压涡轮叶片榫头小颈裂纹萌生于叶片背面，属于低周疲劳裂纹，高温与高负载是低周裂纹的萌生的主要促成因素。少数情况下小颈裂纹向上扩展导致叶片快速断裂飞出。大部分情况下小颈裂纹向下扩展不会直接导致事件，但进一步加剧上压力面应力集中产生裂纹失效。

典型的榫头小颈裂纹向上扩展

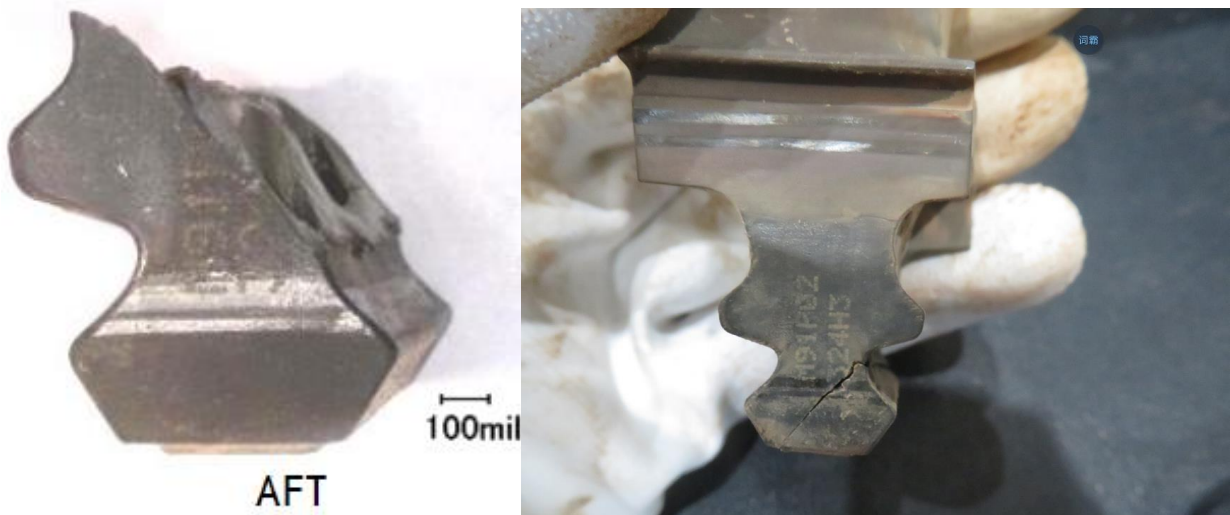
左图榫头小颈裂纹向上扩展导致叶片断裂，右图榫头小颈裂纹向下

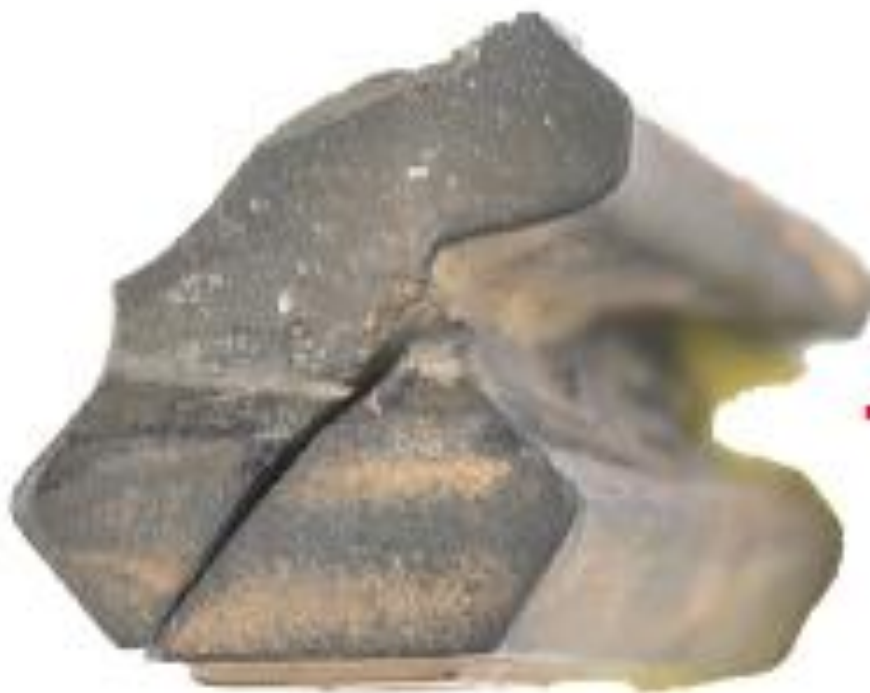
榫头小颈裂纹向下扩展引起上压力面应力集中导致叶片断裂

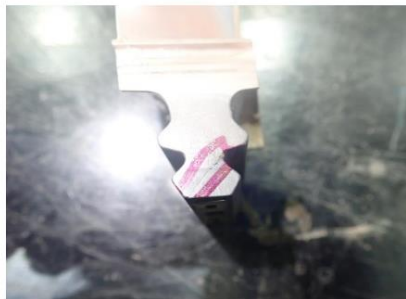
HPT Blades
PN: 2403M91P04 SN:FELEYU99

- 4、2024 年至 2025 年，国内多个航司在 CFM56-7B 发动机送修时发现了大量 2403M91P03 高压涡轮叶片叶根榫头小颈裂纹的现象。
- 5、2026 年初某航一台装有 2403M91P04 高压涡轮叶片的 CFM56-7B 发动机（发动机序号：862767，TSN：26744 小时，GSN：14173 循环）因第 4 级 LPT 叶片断裂送厂大修。发动机分解后，发现 7 片 2403M91P04 高压涡轮叶片叶根榫头小颈存在裂纹，其中 6 片裂纹贯穿

到一个端面，1片裂纹贯穿了前后两个端面。经了解，国内多个航司在 CFM56-7B 发动机送修时也发现了 2403M91P04 高压涡轮叶片叶根榫头小颈裂纹的现象。

Dovetail area found with crack

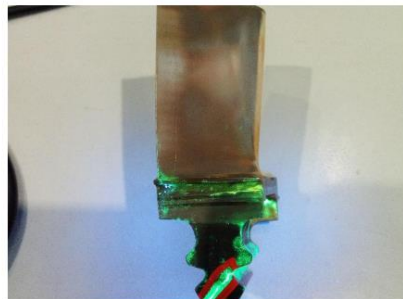
Dovetail area found with crack

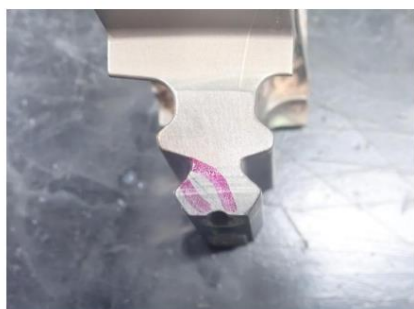
HPT Blades
PN: 2403M91P04 SN:FELEYU99

Dovetail area found with crack

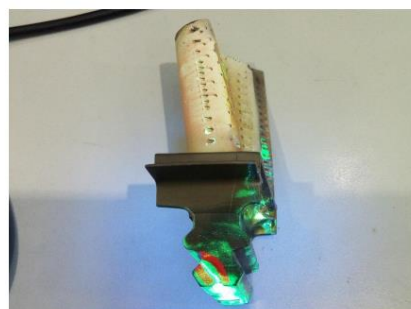
Dovetail area found with crack
