**H44.5X16.5R21 30PR 235MPH**

**P/N : 441009-1**

**Chafer Crack**

**Hainan Airlines**

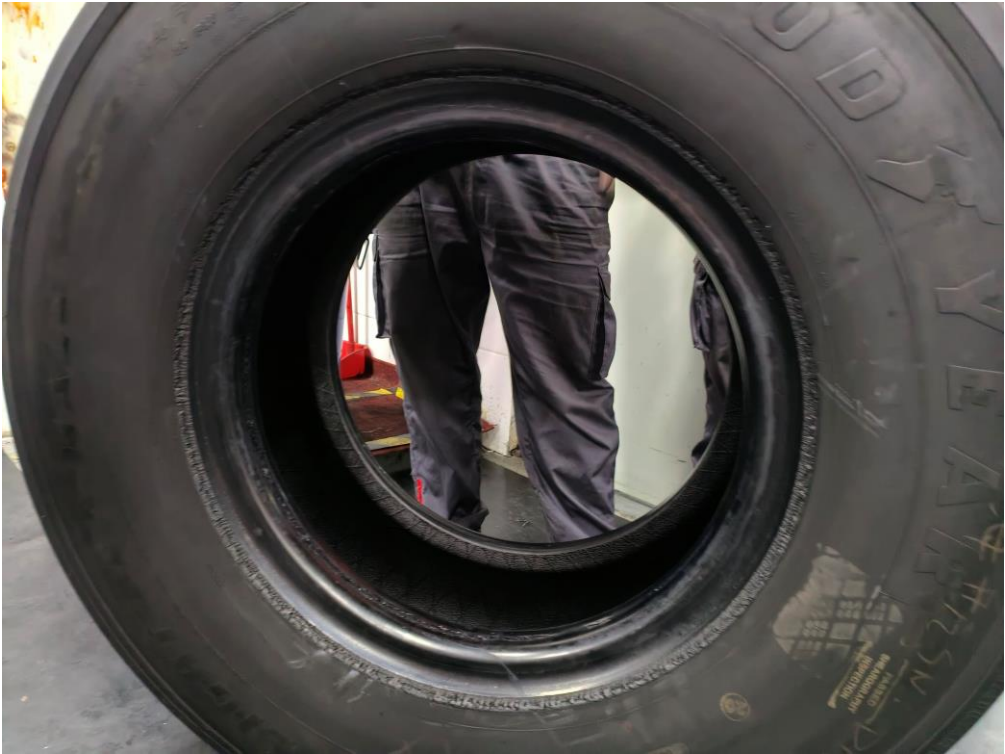
- Hainan Airlines found chafer crack on one tire.

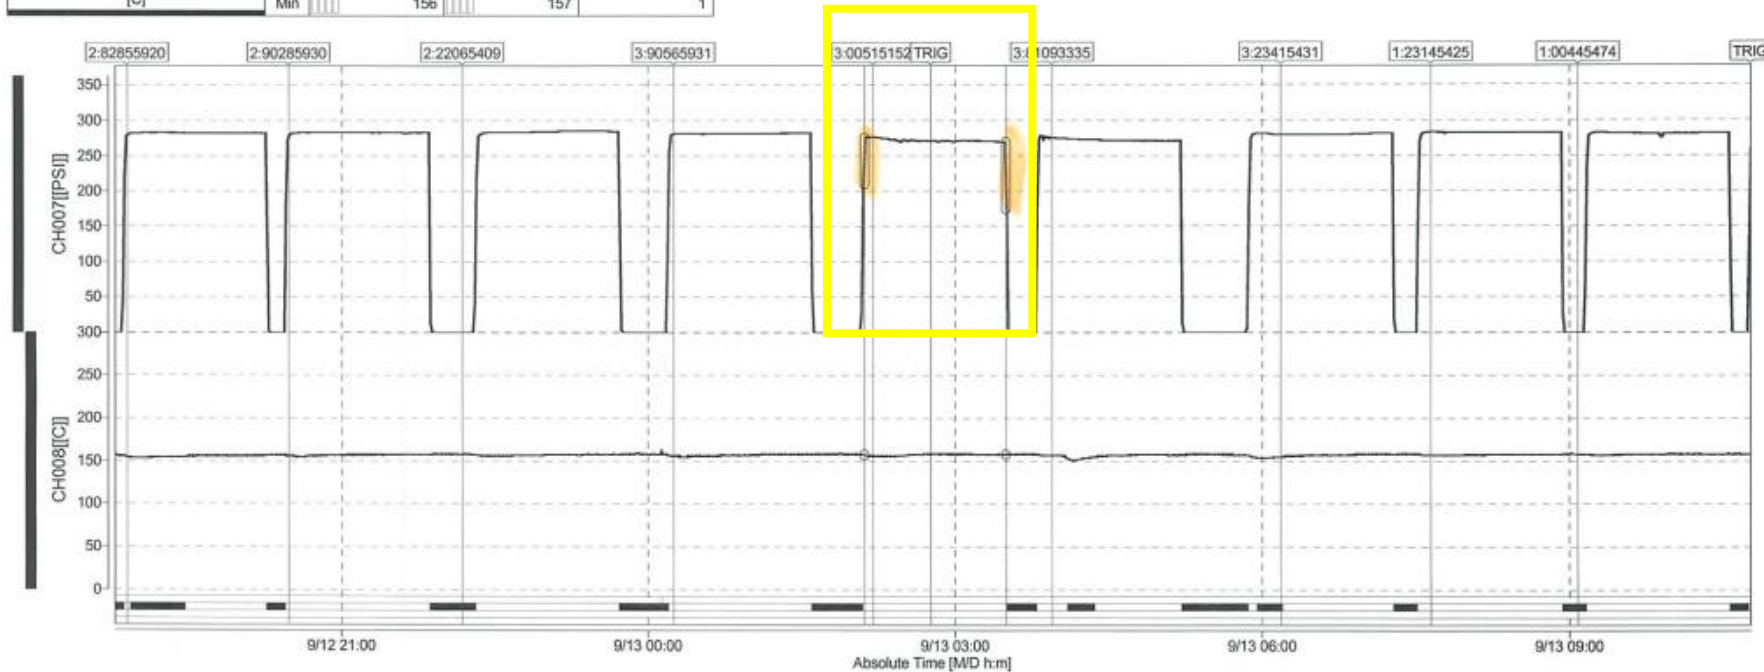
## Cure Chart

- Curing OK, No abnormalities

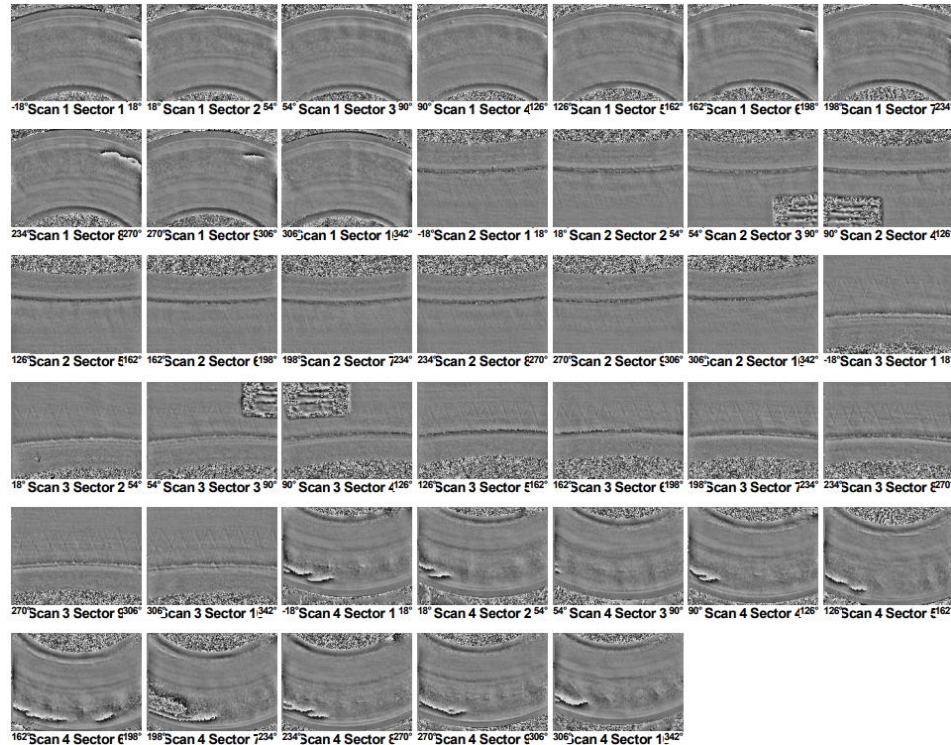
## Shearography Test Result (Pre)

- Shearography Ok, No abnormalities

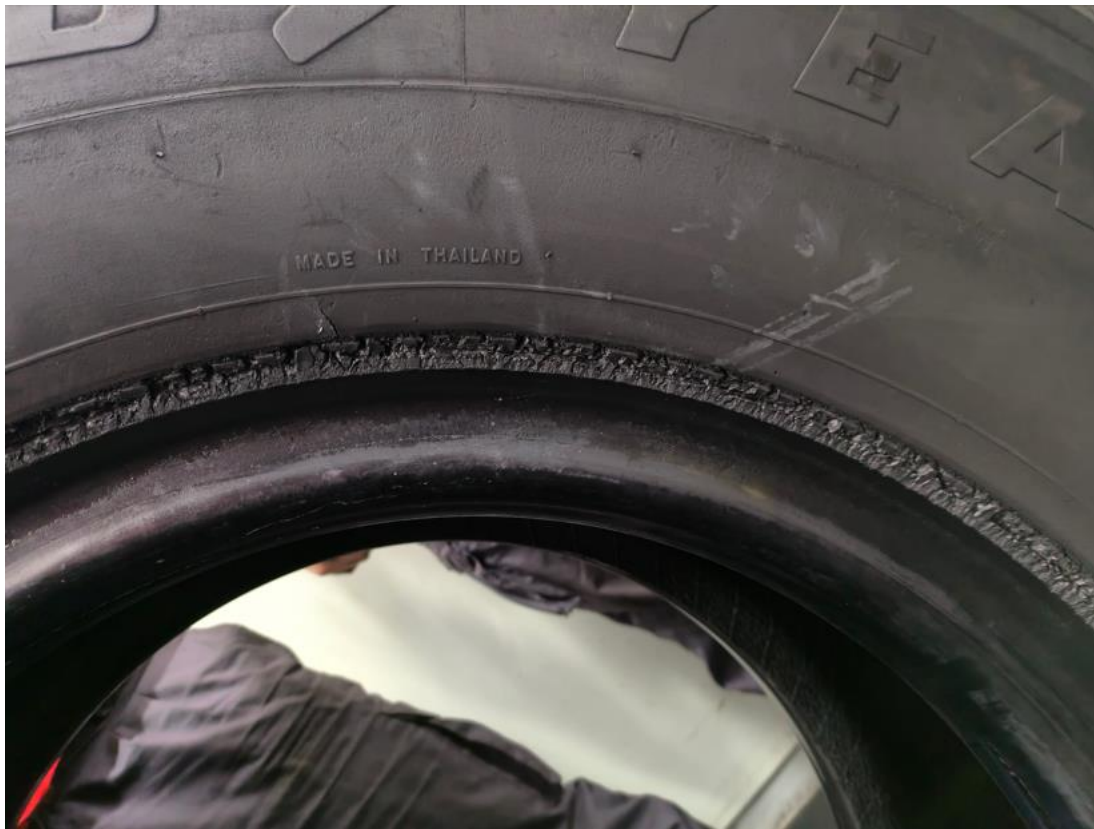
- 回顾胎皮翻修过程工卡等，没有发现有异常的地方。
- 这不是“鼓包”，是胎圈附近“摩擦片”（chafer）的橡胶裂纹。这个裂纹是受外力摩擦造成的。
- 使用中如果有一些比较极端的受力情况发生，可能会偶尔在一些此件号的胎皮的这个位置观察到类似的裂纹。
- 此裂纹不会带来安全问题。
- 此胎皮为R2,使用中累积的疲劳和老化是可能的原因之一。

- 此胎皮不存在批次，制造，安全问题。
- 我司会在翻修中加强品控，做好相关区域检查，避免给航司带来类似问题。
- 航司运行中可以参考我司CMM手册关于胎圈附近的裂纹，不见线可以继续使用。CMM的P26页，截屏如下。

Remove tire from service if weatherchecking, cracking, cuts and snags extend down to the casing ply in the sidewall and bead areas.
