# B737-800

## MAIN LANDING GEAR FORWARD TRUNNION PIN SEAL / TRUNNION PIN DAMAGE.

### Installation Post SB 737-32-1448

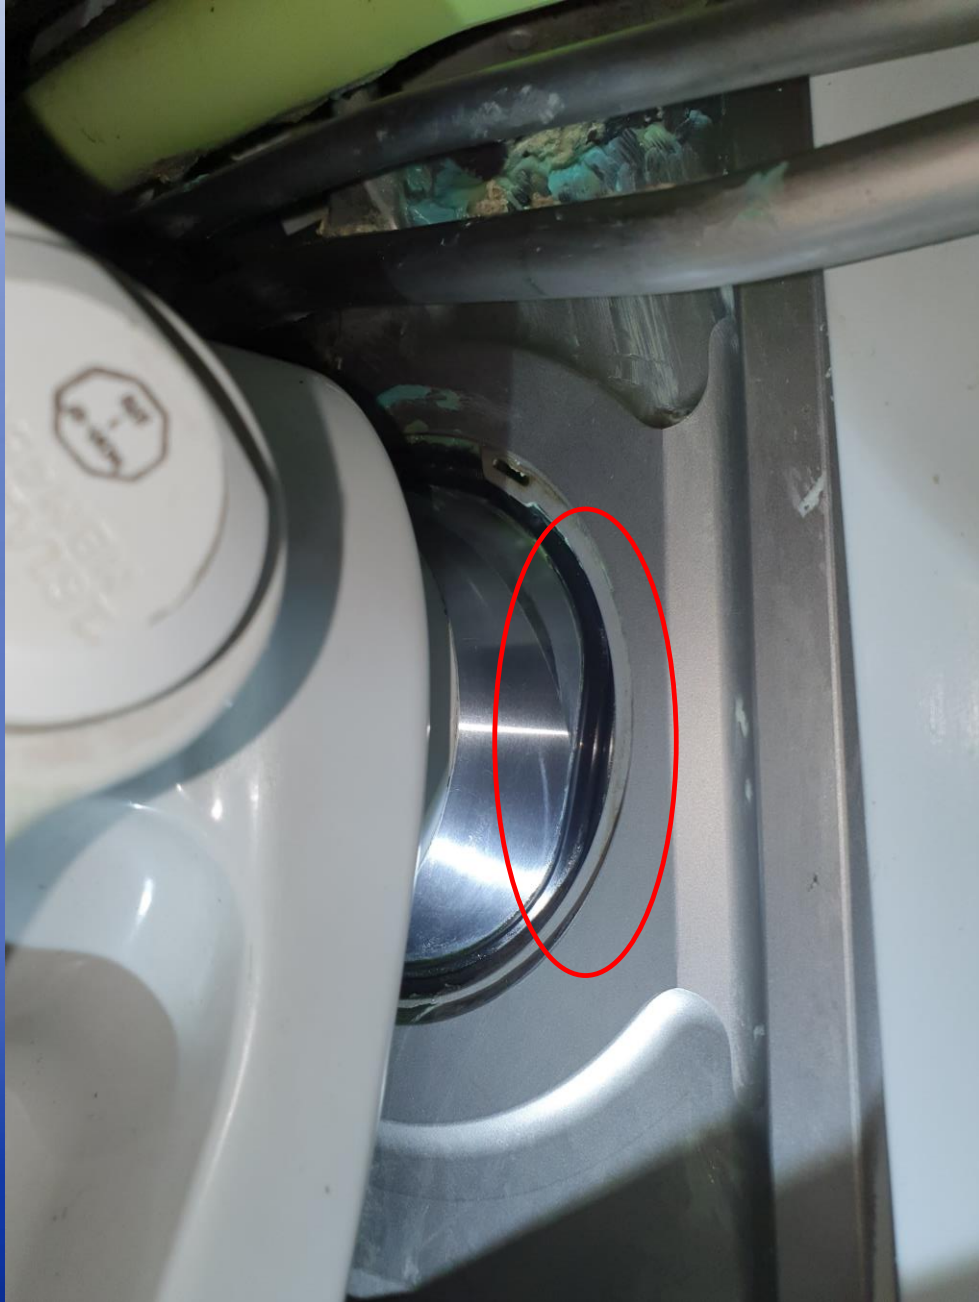
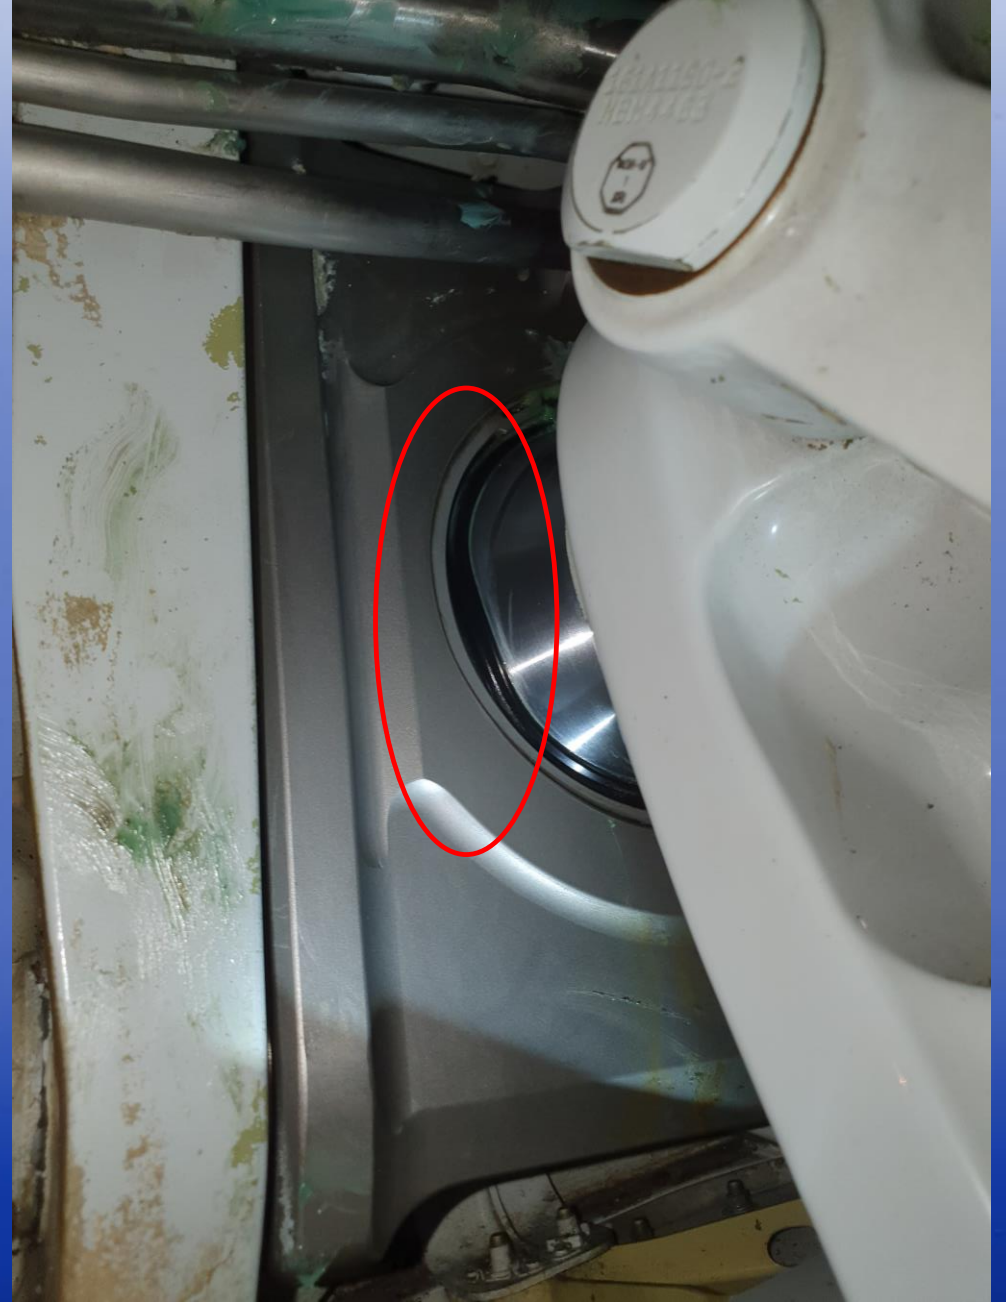
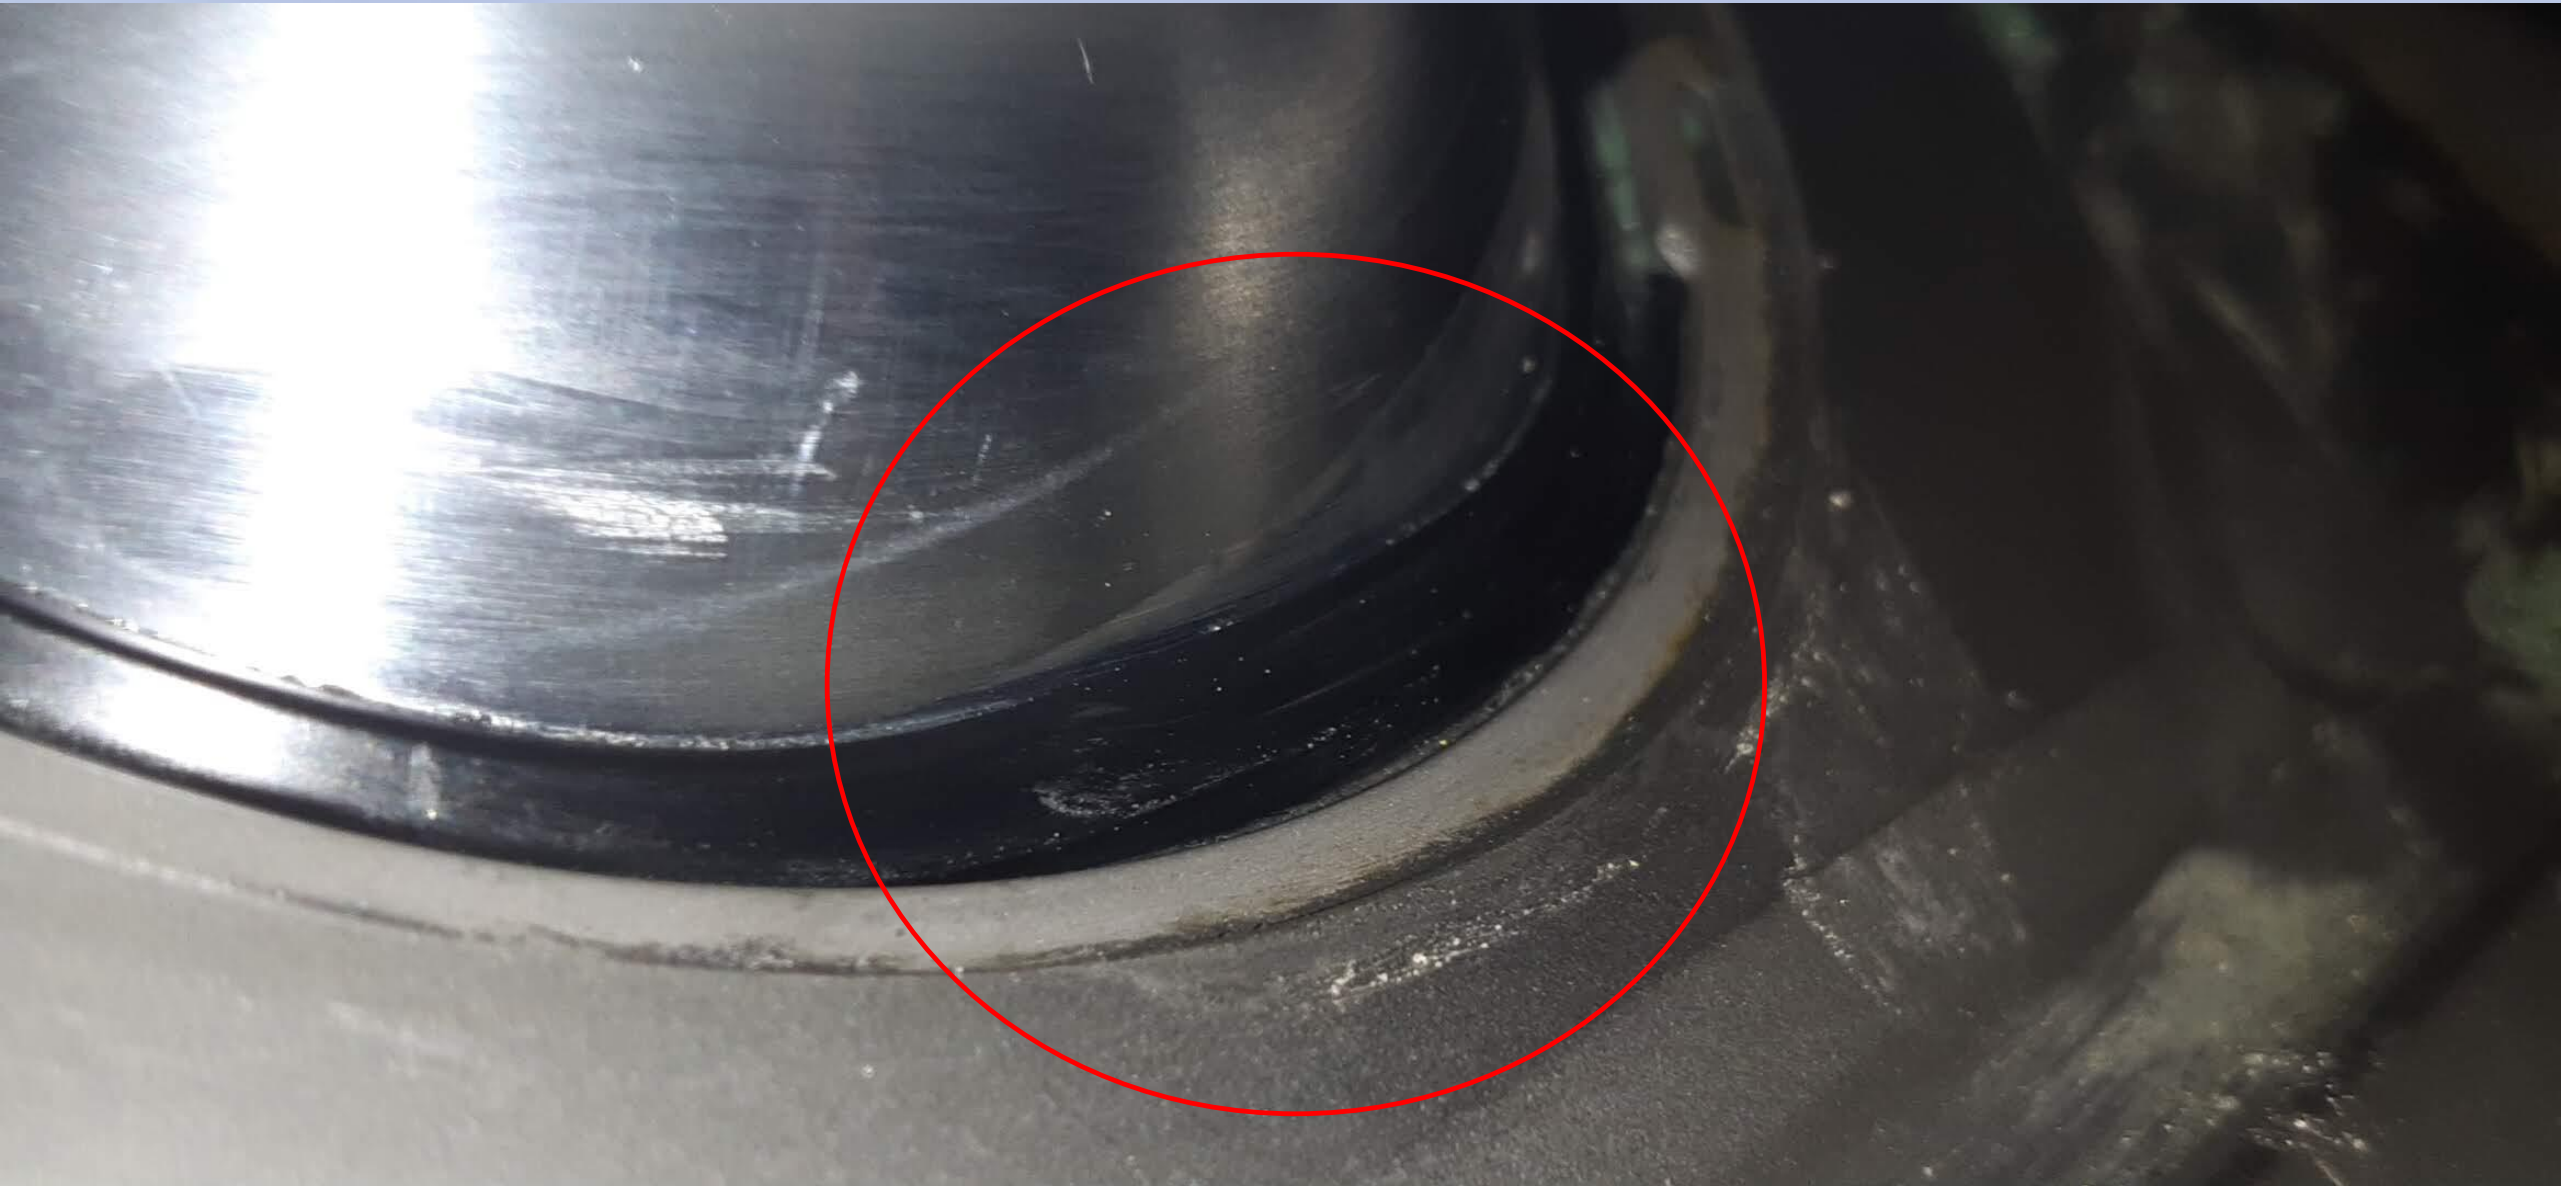
- Scandinavian Airline System do have cases reported showing the main landing gear forward trunnion pin seal migrated and clearly out of position looking directly to the trunnion pin with the landing gear installed.
- The problem is observed while doing the mandated inspections per SB 737-32-1448 R02 and FAA AD 2019-01-03.
- Both cases resulted in disassembly of the main landing gears mainly to replace the affected seals P/N 5649-0615-369. At removal we observe further damage to the trunnion pin backside with wear marks.
- The cases reported ended with trunnion pin P/N 161A1188-9 and seal P/N 5649-0615-369 replacement.

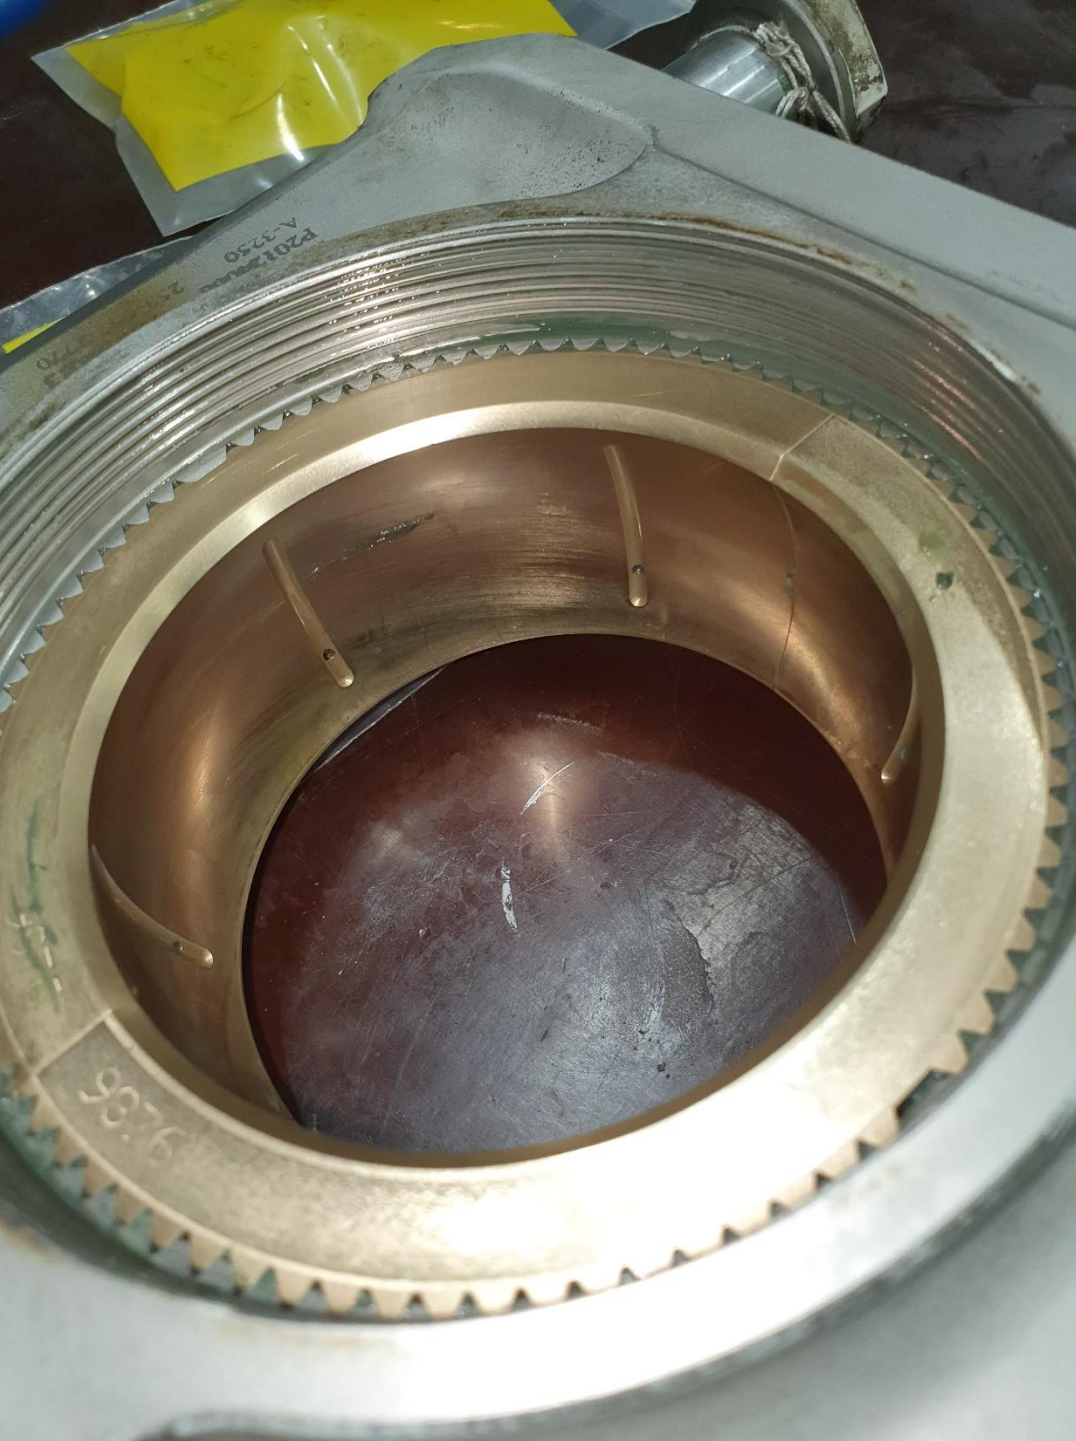
The inspection per AMM Task 57-16-01-200-801 checking for wear is performed without any remarks.

Ball joint checked for chrome wear and/or surface roughness without any remarks.

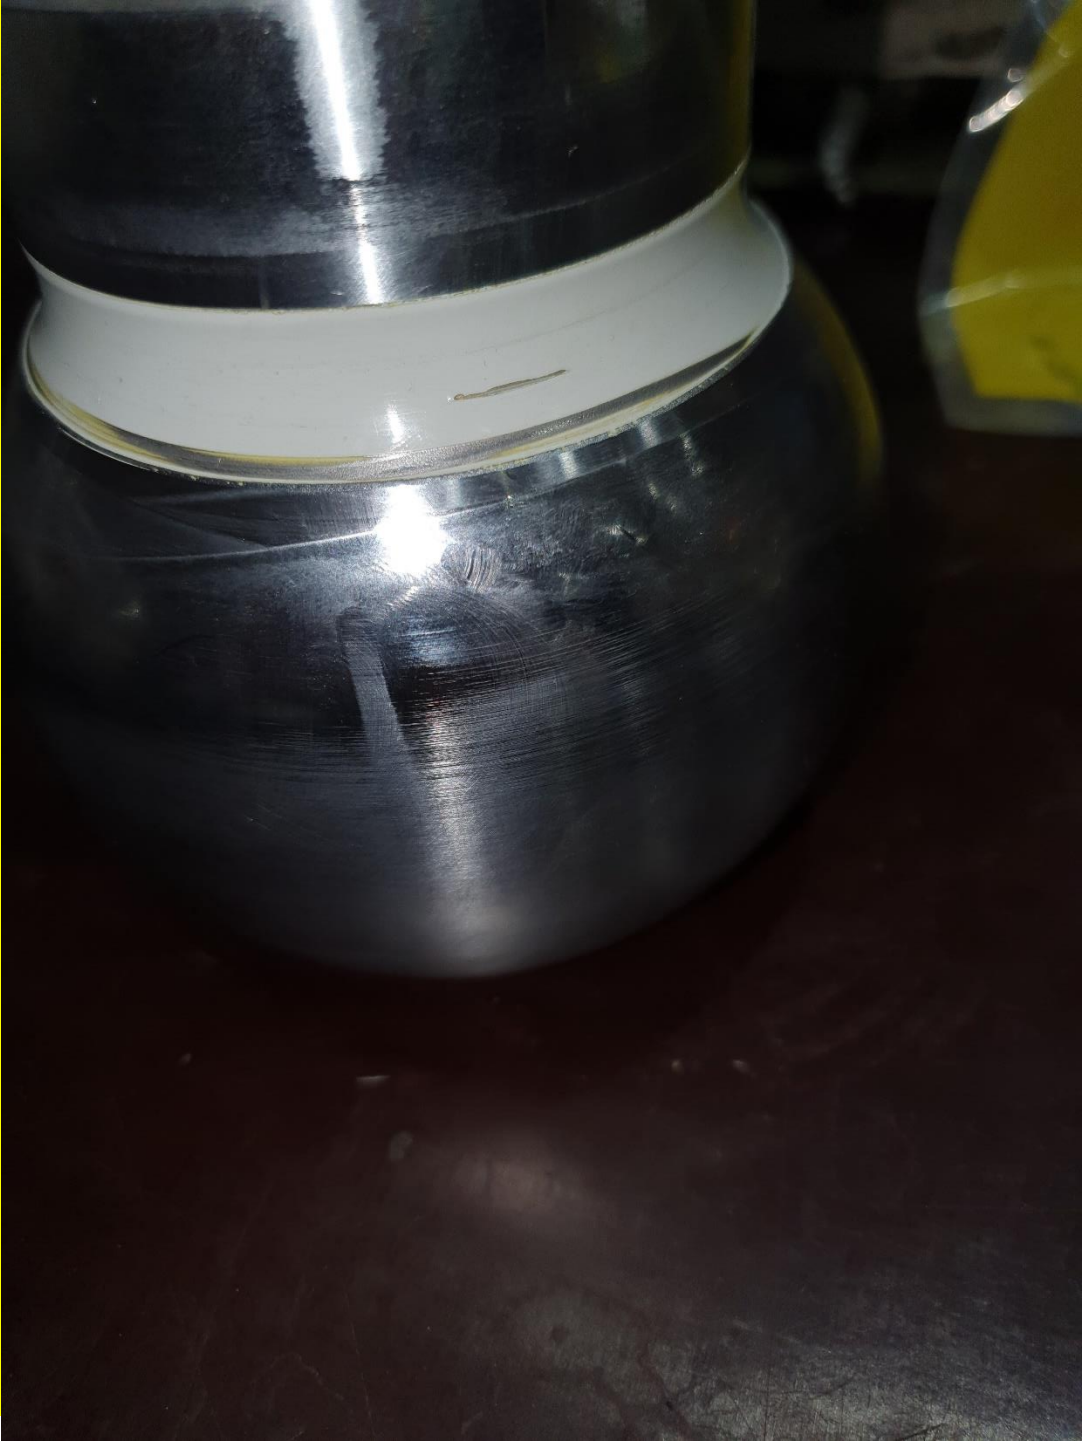
Damage observed to the seal back side at the area not clearly visible with the main landing gear installed using standard inspection methods set for detailed inspections.
