## **Harness MW0311(FADEC harness) Chafing**

RJ Boeing Group(JSV/S)  
System Engineering Office  
JAL Engineering Co., Ltd.

2024-Oct

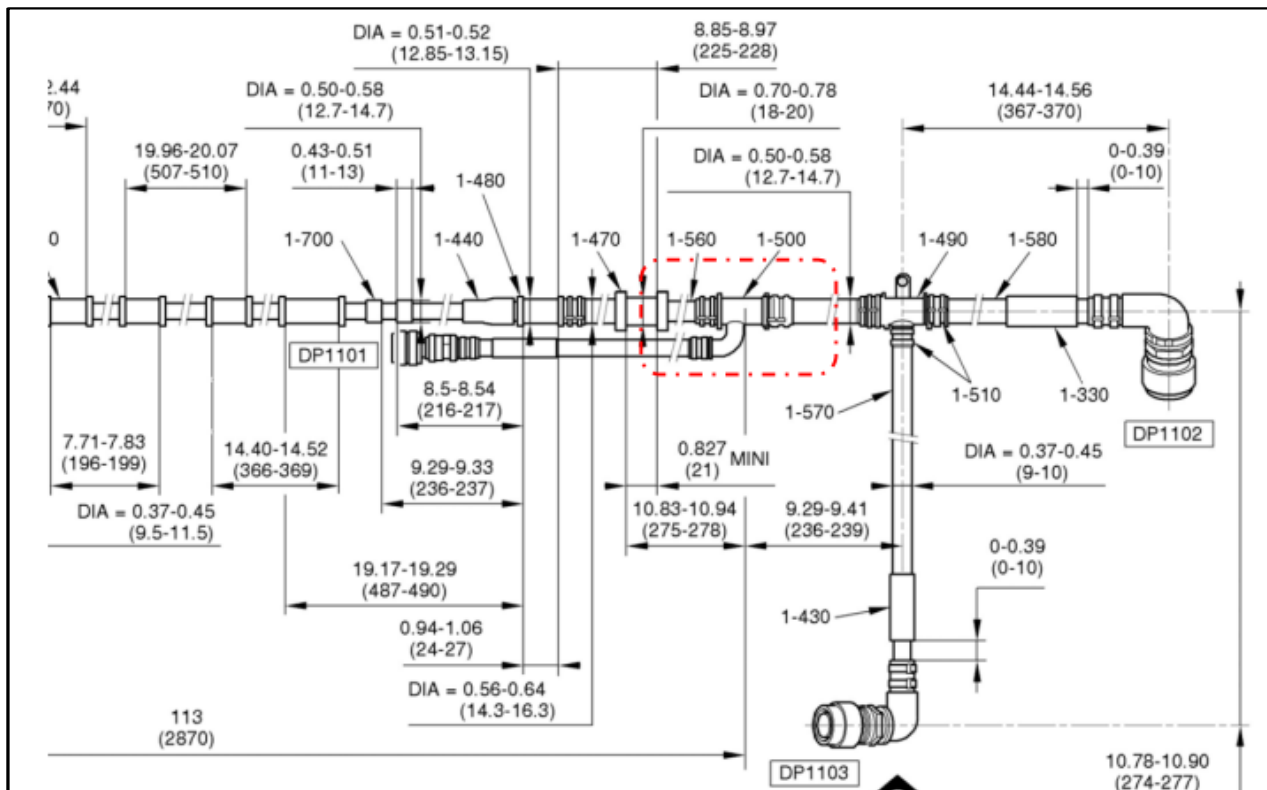
Figure 3 : Overview of MW0311

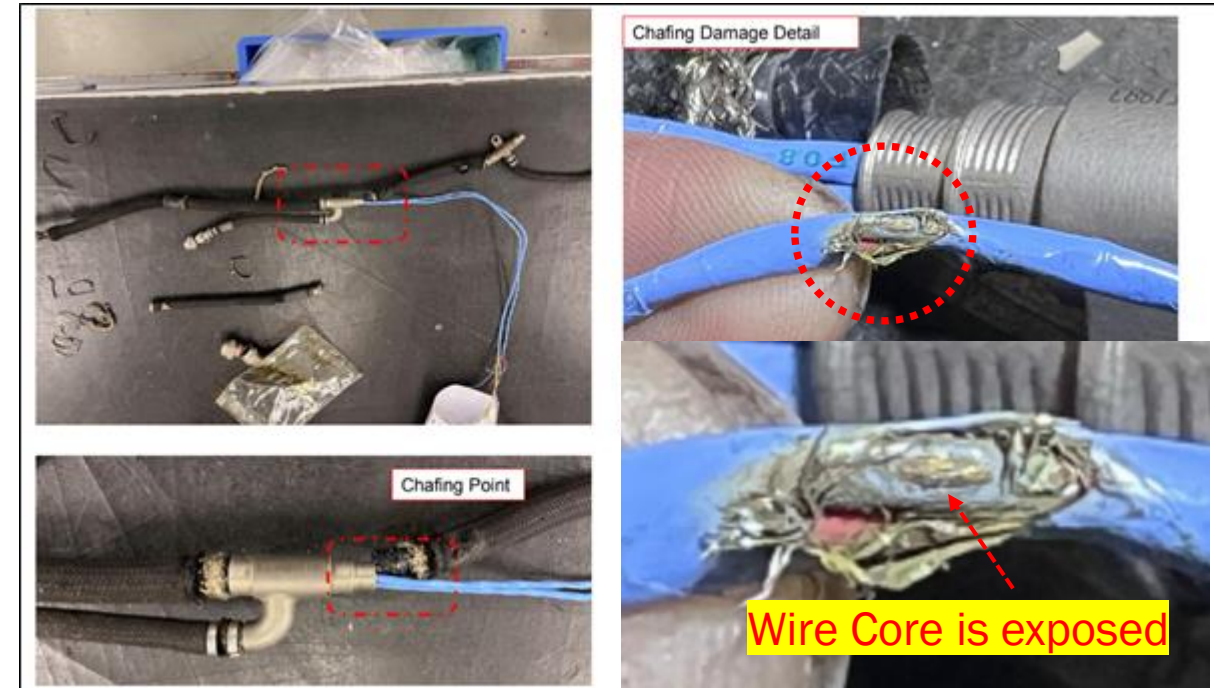
Figure 1 : Chafed point of MW0311  
(Mid Portion of the harness)

The chafing was at the mid portion(branching point) of the harness. And this was the first removal.

- TSI 34,926 hours
- CSI 28,294 cycles.

The chafed wire is routed into the overpressure detection switch in the BAR(Bleed Air Regulator). Resulted, the short circuit made at the chafed point was caused the incorrect overpressure detection.

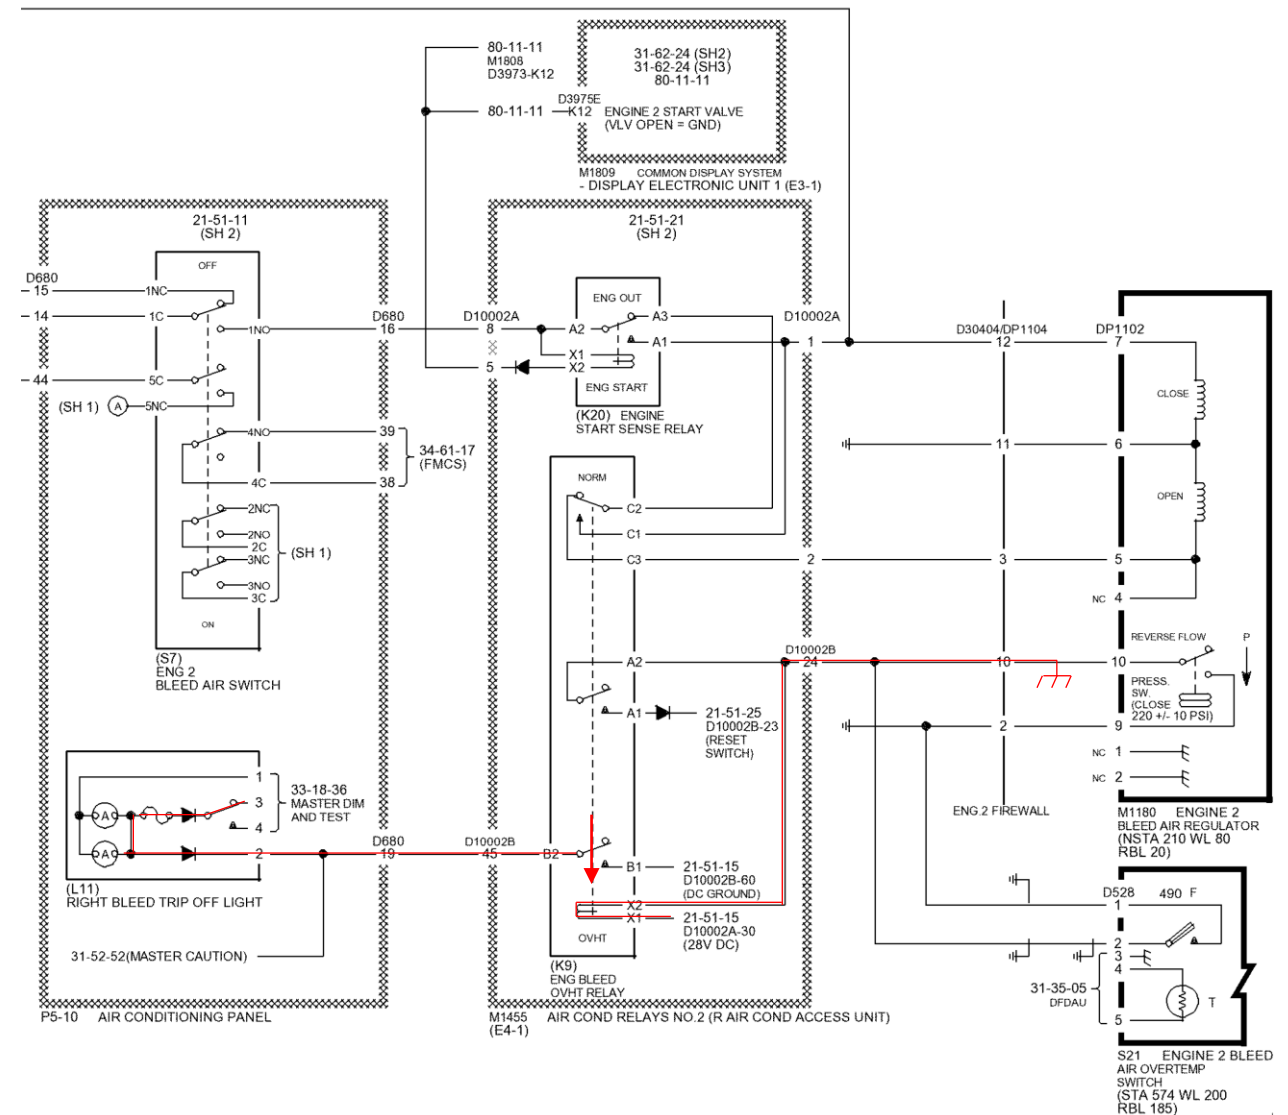
Figure 3 : Schematic of Overpressure detection and trip OFF light

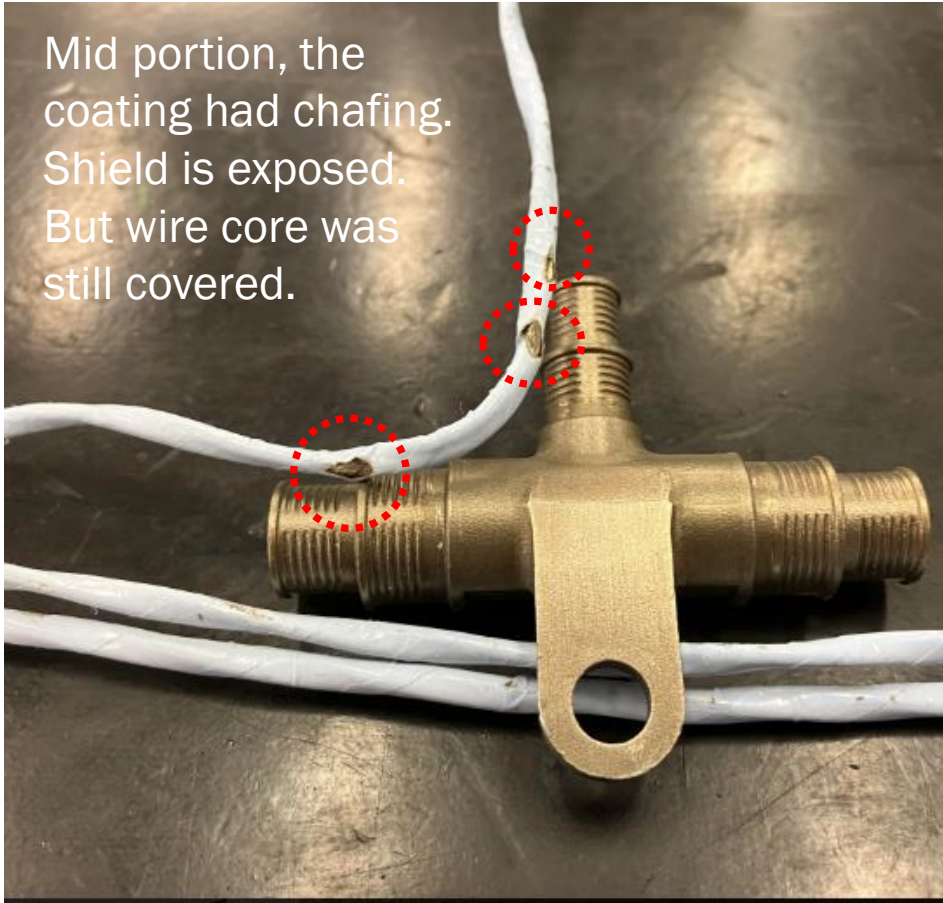
JA328J R/H Harness , 38,946 hours, 21,792 cycles , The highest TSI of “internal wire” (It had a shop-in history but internal wire was not replaced).

Mid portion, the coating had chafing. Shield is exposed. But wire core was still covered.

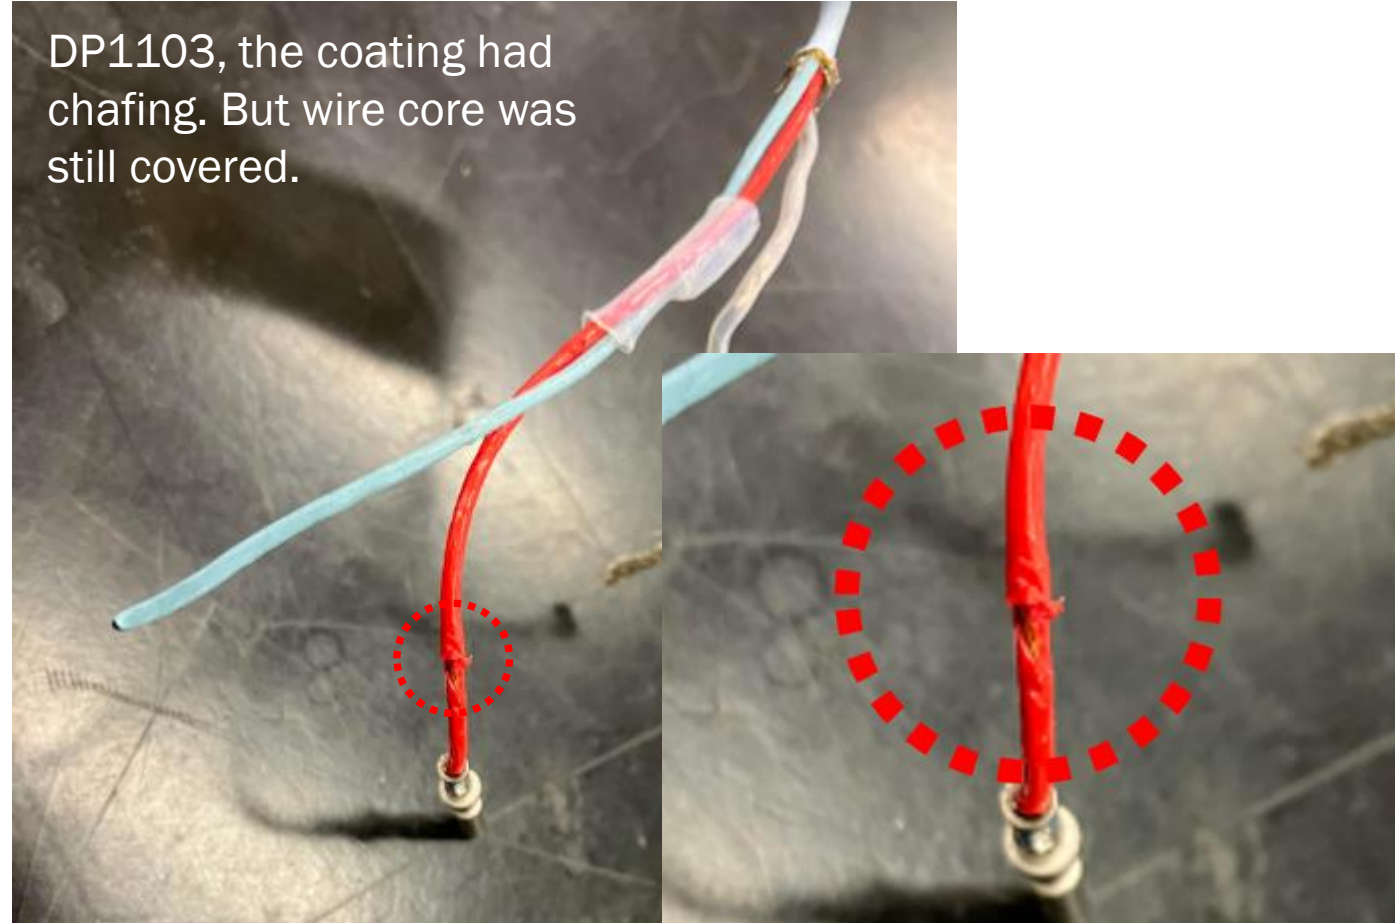
DP1103, the coating had chafing. But wire core was still covered.

- Damage on Mid portion : Isolated Case
- Damage on DP1102 : Solved by SB72-0779
- Damage on DP1103 : Still in high risk

- To operators, please comments your experiences about chafing of the harness MW0311.
- To Boeing/GE, please consider issuing an SB for DP1103 similar to the one issued for DP1102.

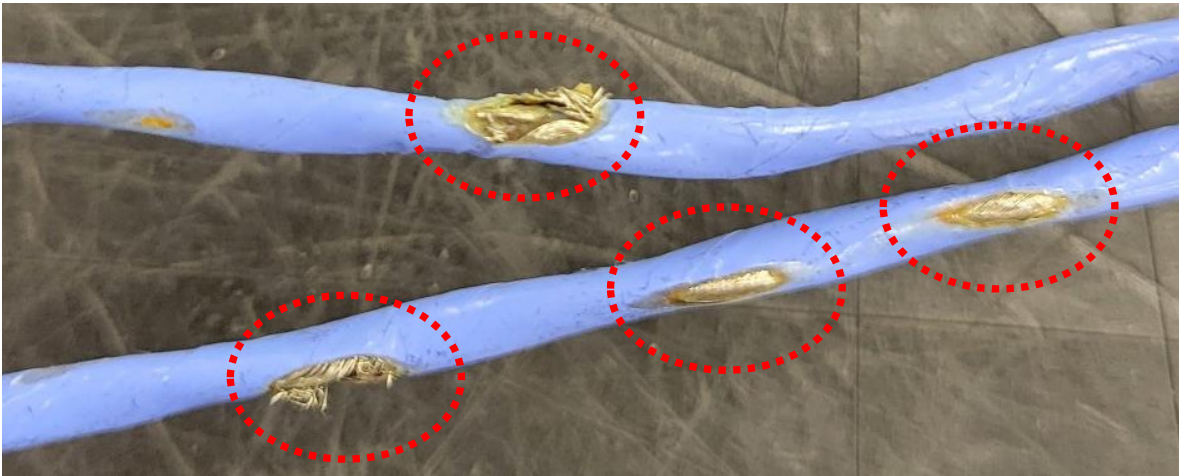
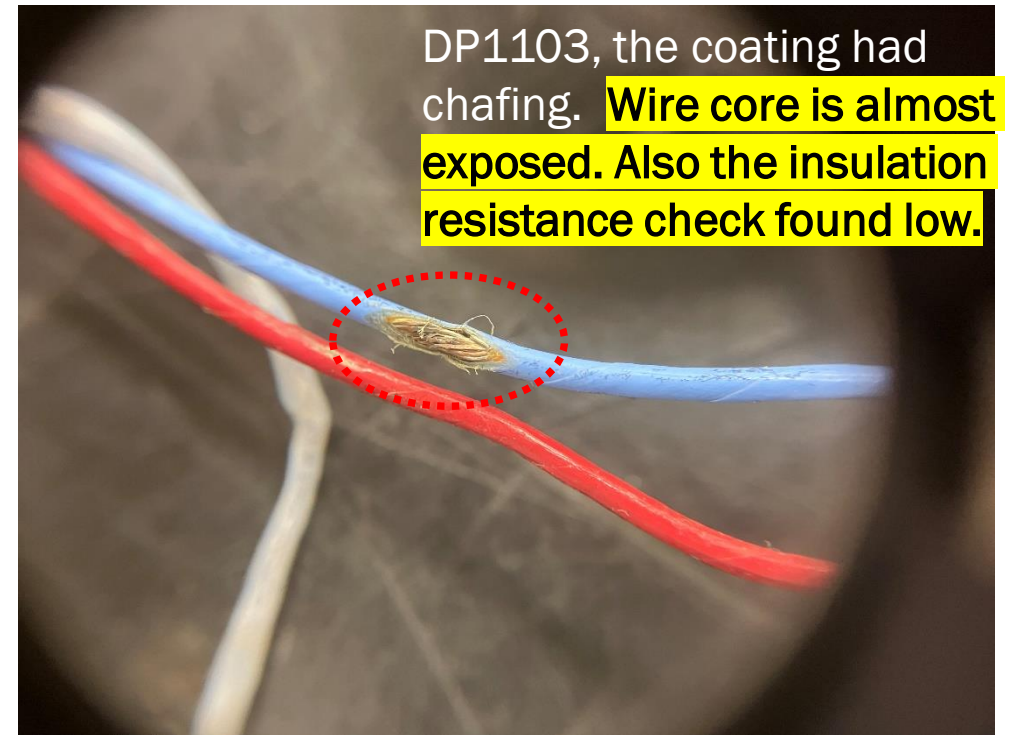
JA334J L/H Harness, TSI 33679 hours, CSI 19705 cycles, 2nd highest TSI

Mid portion, the coating had chafing. Shield is exposed.  
But wire core was still covered.

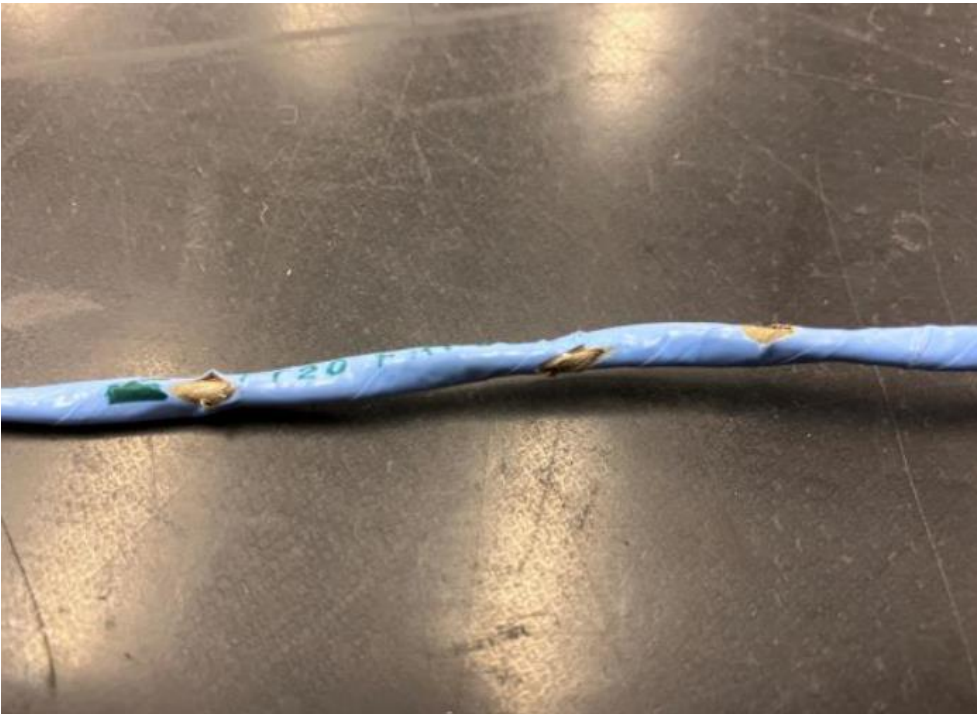
JA333J R/H Harness, ~~TSI 35060 hours, CSI 18372 cycles~~ TSI about 2600 hours since new

Mid portion, the coating had chafing. Shield is exposed.  
But wire core was still covered.

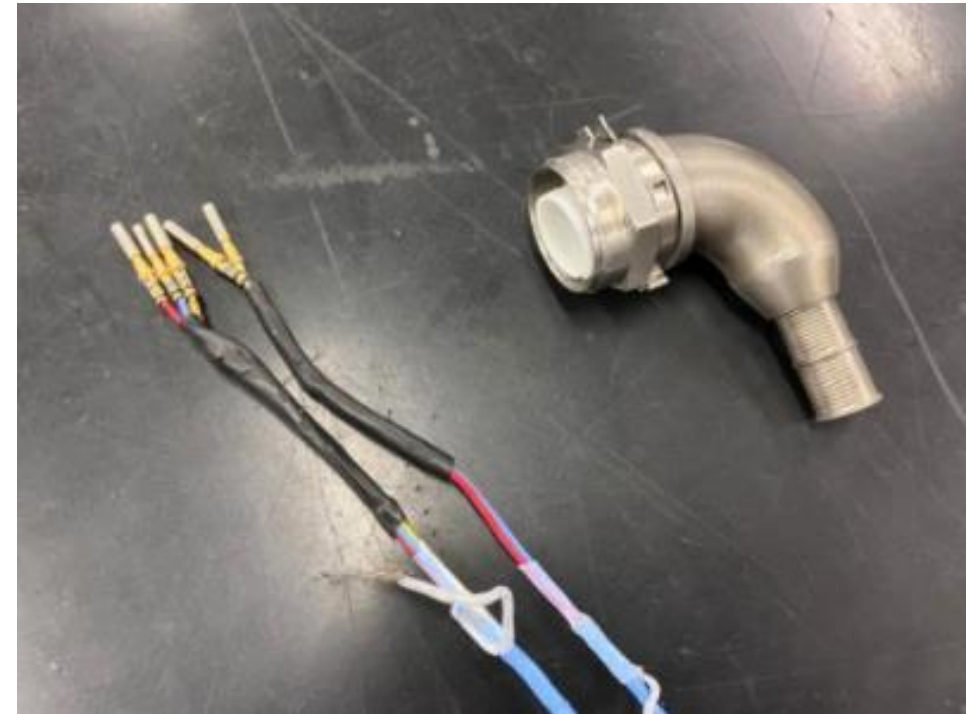
No damage on DP1102 and 1103
