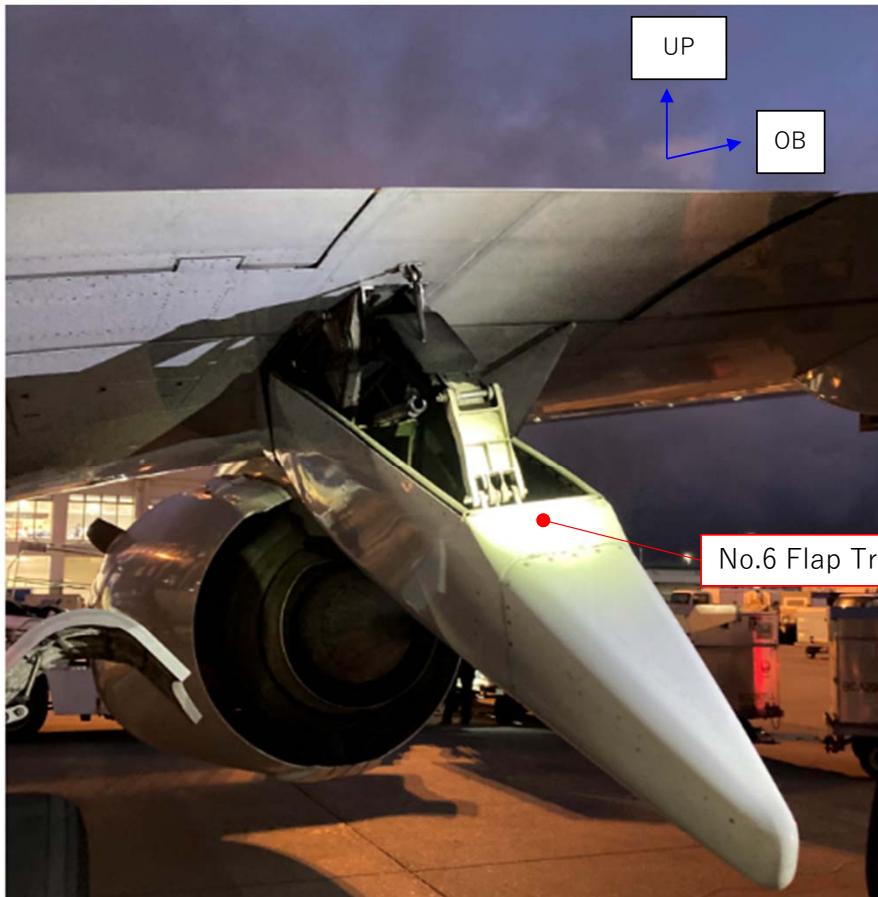
We found hanging down condition of No.6 flap track fairing with the Flap in the Up position.

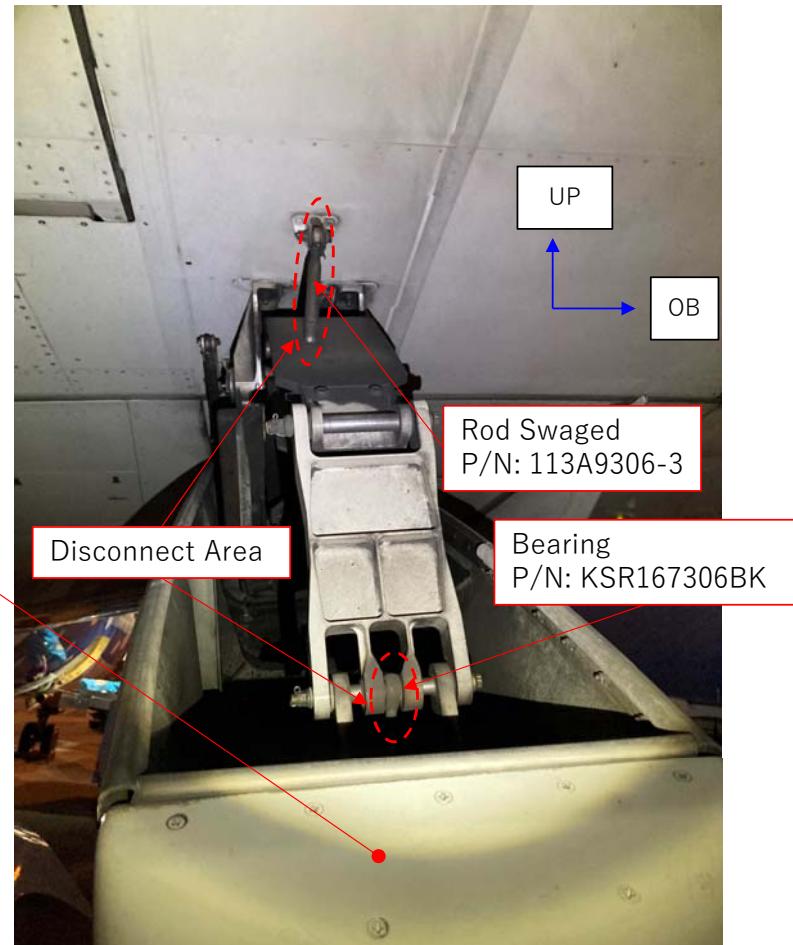
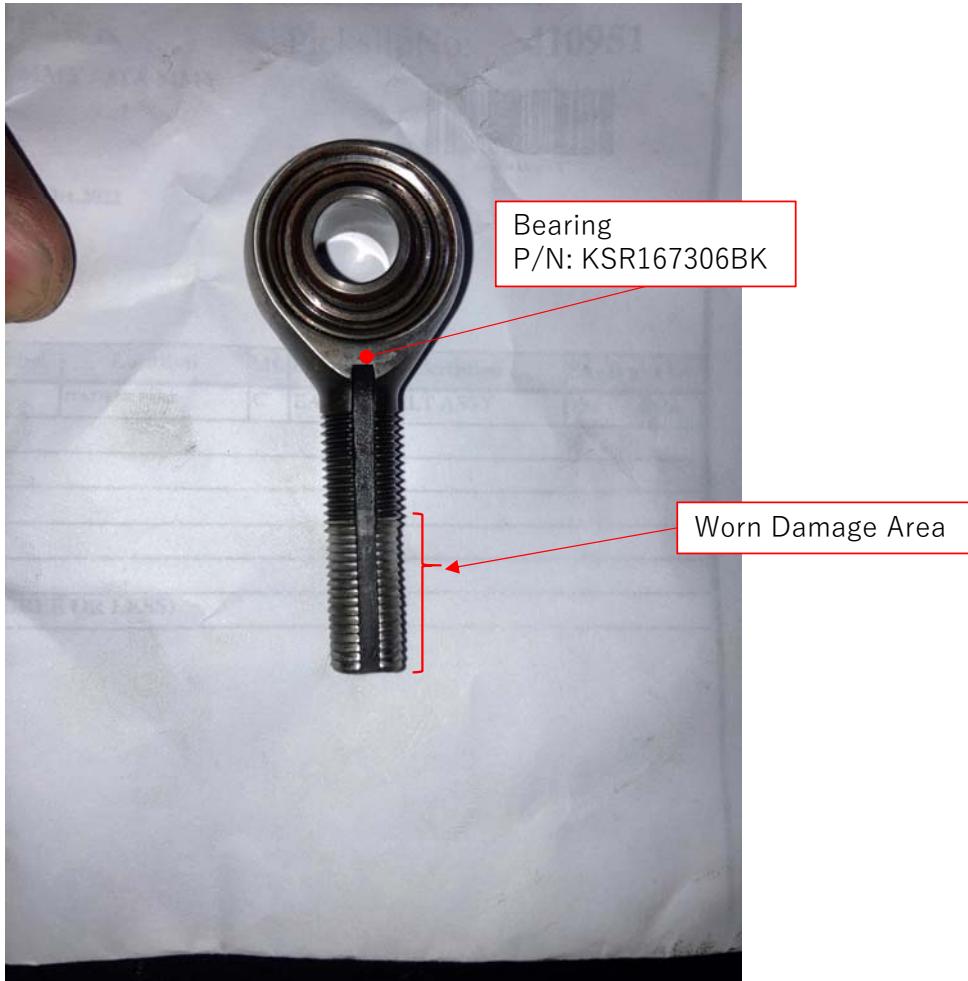
Figure 1 - JA05RK\_Worn Damage – Lower Bearing Thread of No.6 Flap Track Fairing Drive Rod

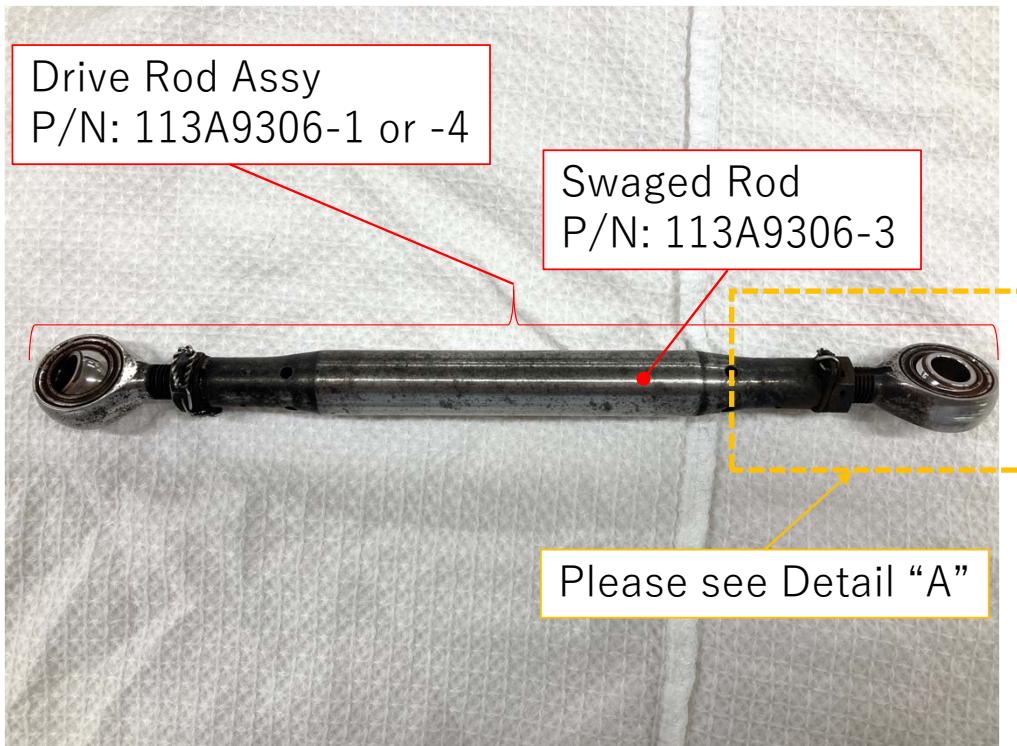
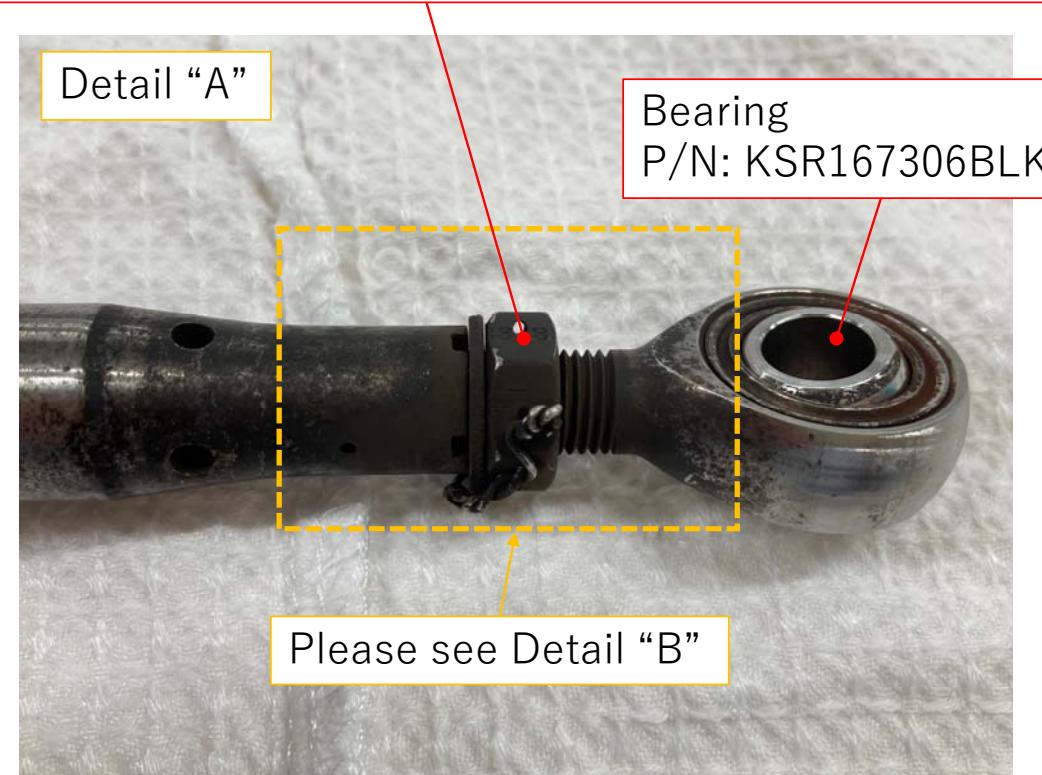
During our 737-800 fleet inspection of JA03RK, the locknut(P/N: NAS509L6C or BACN11U6CM1L) loose condition of drive rod assy was found in No. 6 flap track fairing.

Figure 2 - Locknut Loose Condition of No.6 Flap Track Fairing on JA03RK

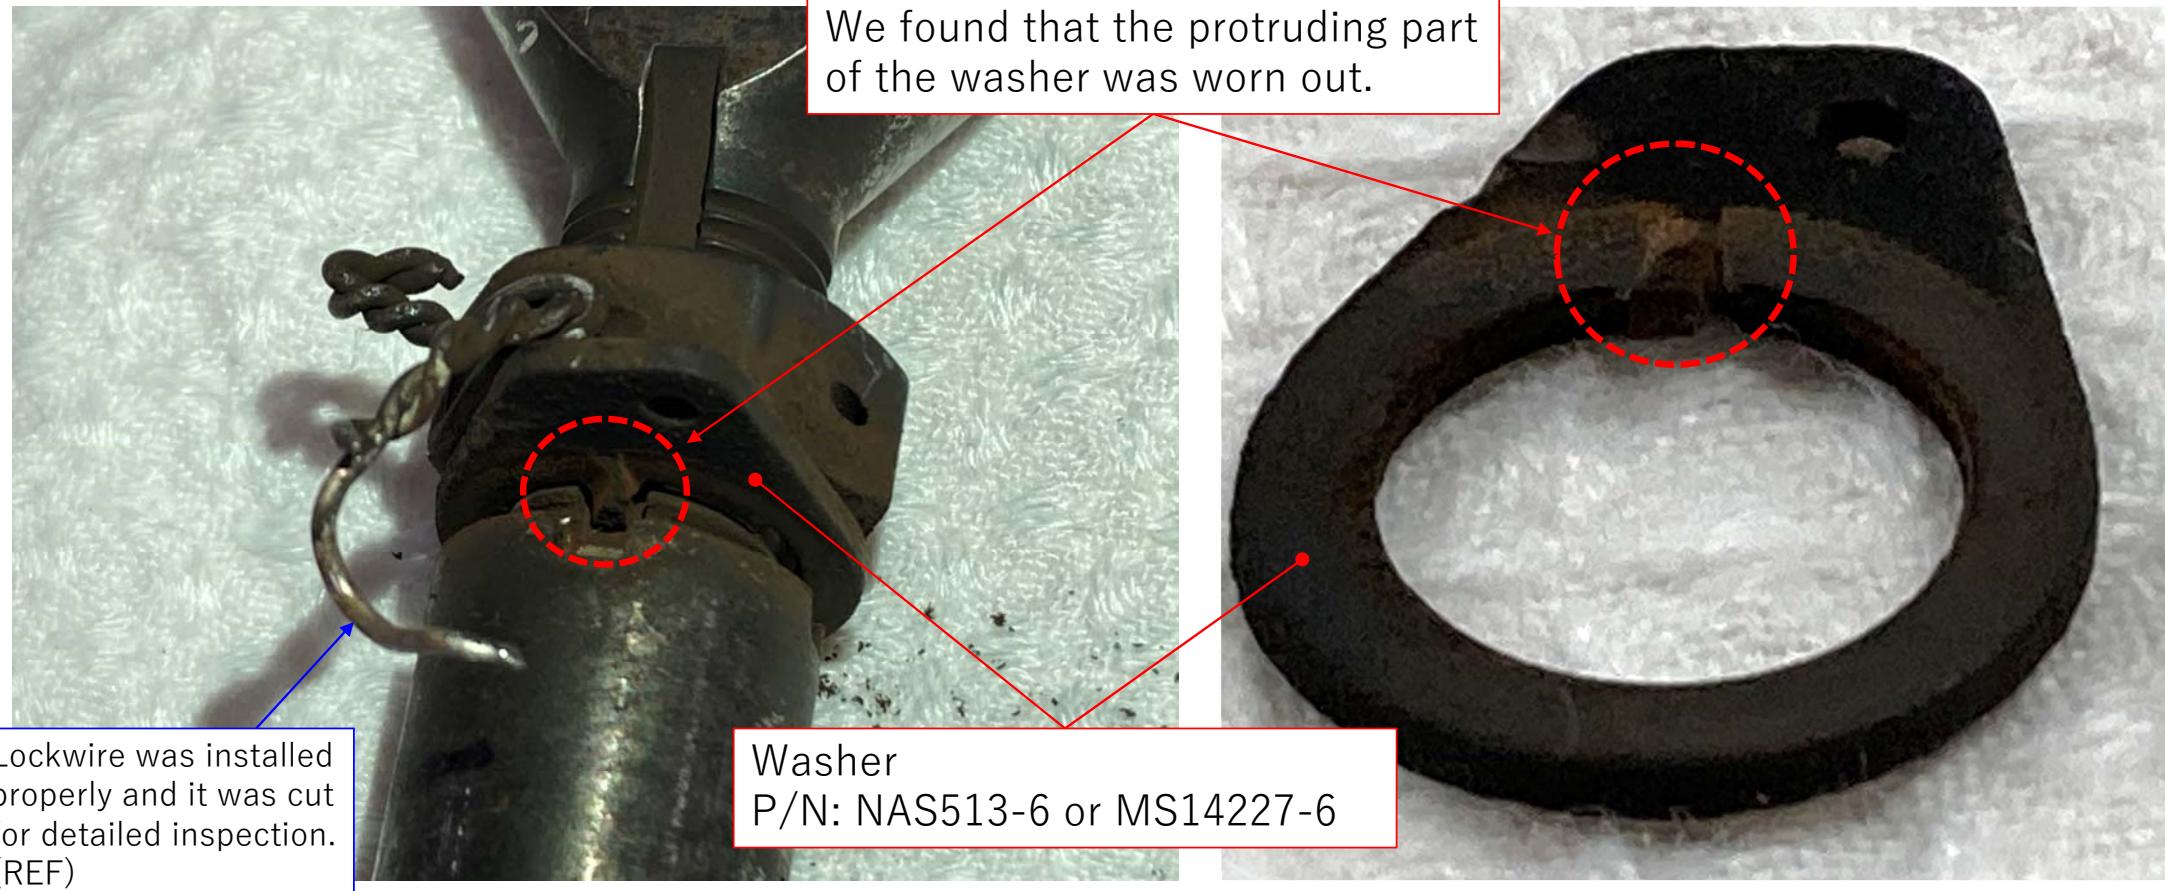
Detail "B"

Figure 2 - Locknut Loose Condition of No.6 Flap Track Fairing on JA03RK
