737MAX-SRP-21-0296

737 MAX – ATA 21 Erroneous Electrical Ground Signal Resulting in Hot Cabin and Flight Deck

Out of Sequence Call
January 27, 2026

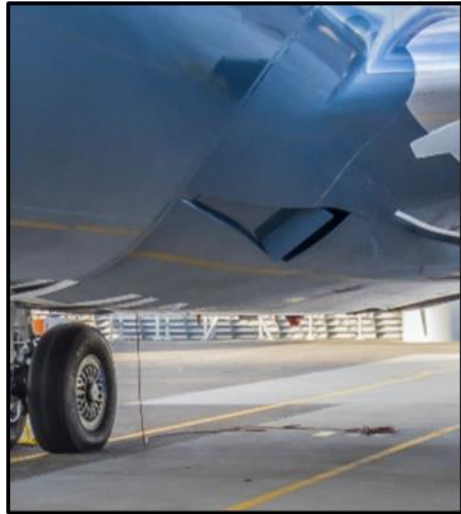
Ram Air Inlet Deflector Door Deployed

- During the power loss condition, both Left and Right Smart Ram Air Door Actuators (SRADA) move to the on-ground mode configuration due to an erroneous electrical ground signal on the SRADA.
- In this ground mode configuration, the following occur in air:
 - Both ram air deflector doors deploy which reduces ambient cooling air flow into the pack ram air inlets
 - This restricts the heat exchangers from adequately cooling the bleed air supply
 - The air conditioning packs will supply excessively hot air to both the flight deck and passenger cabin

- *A more comprehensive list of flight crew actions will be included in the revised STANDBY POWER OFF NNC*
- **Final Solution Identified:** wiring change (production and retrofit) to isolate SRADAs and ACAUs to prevent erroneous ground signal during C/B C3062 tripped condition
