[Details of the window]

P/N: 141A4800-2 S/N: 10260H1443

*NOTE: Installed on L/N 3501 from its delivery.

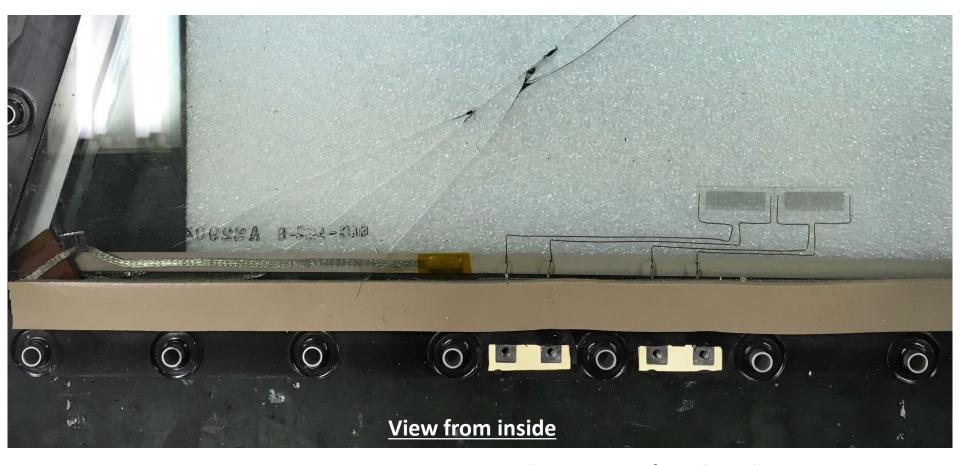
Typical Window Crack (Page 3 of 3)

No damage was found on the Braid wire, Solder joint and Sensors line on lower side Bas bar.

Detail B
