# 737 No.2 Window - Assembly and Window Frame Opening

## Ideal Condition vs Non-Ideal Condition

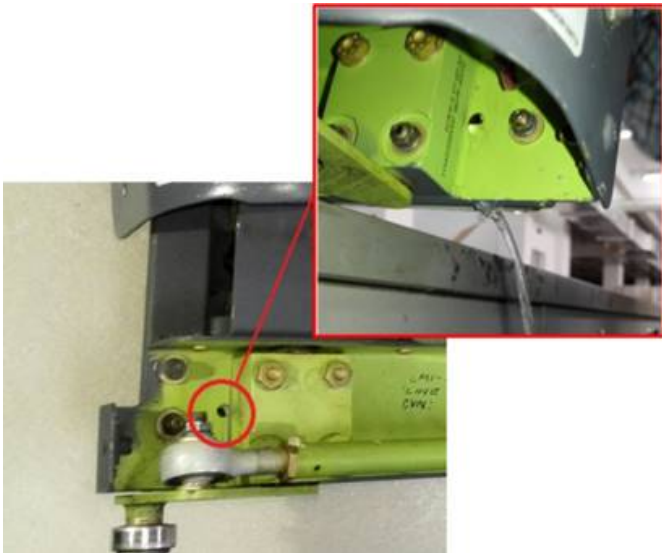
Clean Drain Holes in Window Frame Assembly:

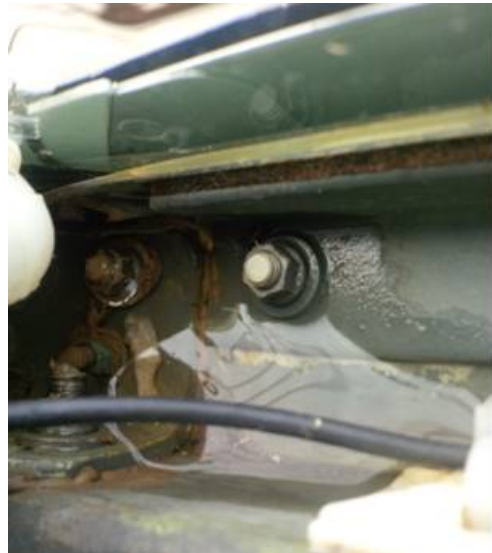
Clogged Drain Hole In Window Frame Assembly:

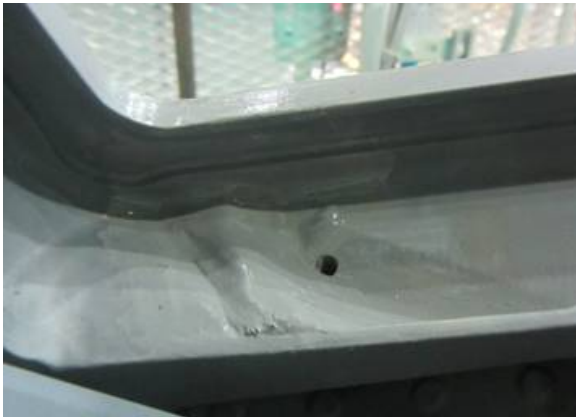
Clean Drain Holes in Window Sill (Structure):

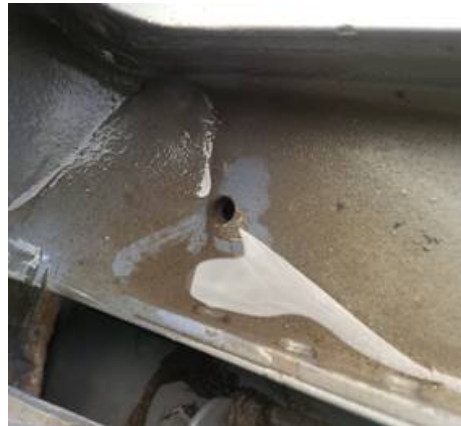
Clogged Drain Holes in Window Sill (Structure):

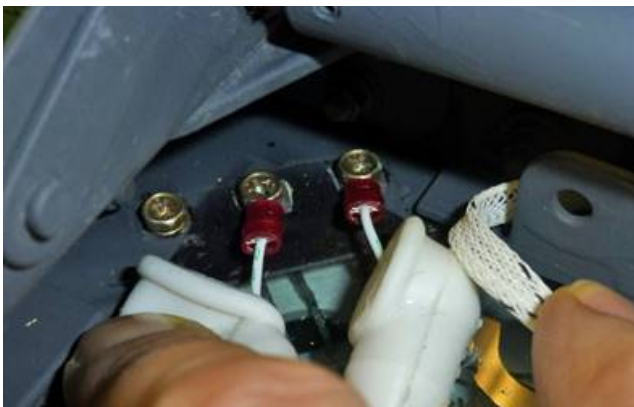
Clean Terminals, Ruber Boots Installed and Not Damaged:

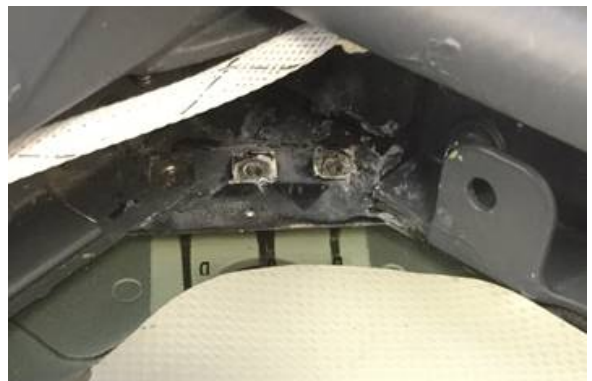
Dirty Terminals:
