737NG/MAX – ATA 28
Defuel Tube Cracks

737 NG/MAX Defuel Tube Cracks

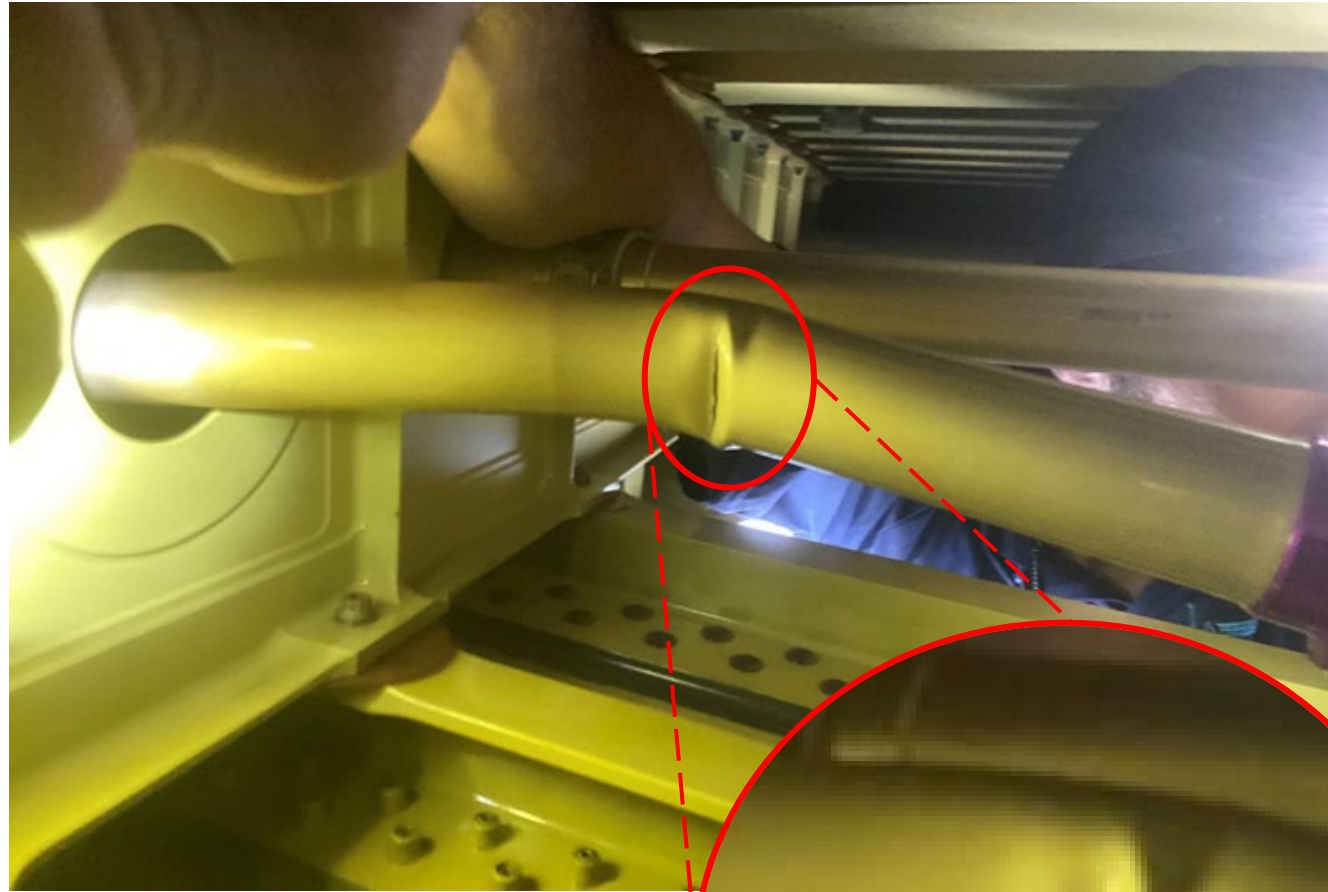
System Description

- Fuel is consumed from the center tank first as the center tank pumps override the main tank pumps due to the center tank pumps having higher pressure
- A crack in the defuel tube allows fuel, from the center tank, to leak into the right main tank
- When the engine gets fuel from the center tank, any fuel that leaks through the crack begins to overfill the right main tank
