Pitot Probe

Reliability overview May 2020

Pitot probe defects 1.1.2013 to 3.6.2020

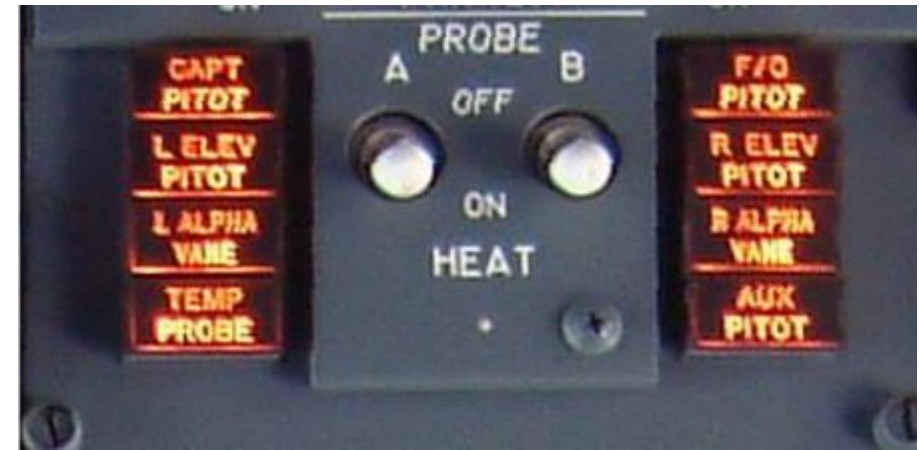
B. Possible Causes

- (1) Lower Right Pitot Probe, A25
- (2) Window and Pitot Heat Panel, P5-9
- (3) Circuit Breaker
- (4) Wiring

303 010 00	AUX PITOT light: light on.	30-31	TASK 801
303 020 00	CAPT PITOT light: light on.	30-31	TASK 802
303 030 00	F/O PITOT light: light on.	30-31	TASK 803
303 040 00	L ALPHA VANE light: light on.	30-31	TASK 804
303 050 00	L ELV PITOT light: light on.	30-31	TASK 805
303 060 00	Pitot probe: Does not get hot.	30-31	TASK 806
303 070 00	Probe heater indicator lights: do not come on when PITOT STATIC HEAT switches are OFF.	30-31	TASK 807
303 080 00	R ALPHA VANE light: light on.	30-31	TASK 808
303 090 00	R ELV PITOT light: light on.	30-31	TASK 809
303 100 00	TEMP PROBE light: light on.	30-31	TASK 810
304 010 41	WINDOW HEAT OVERHEAT light: light on - L FWD.	30-41	TASK 801
