6355C0001-01 Stabilizer Trim Motor

S/N 4580 Investigation

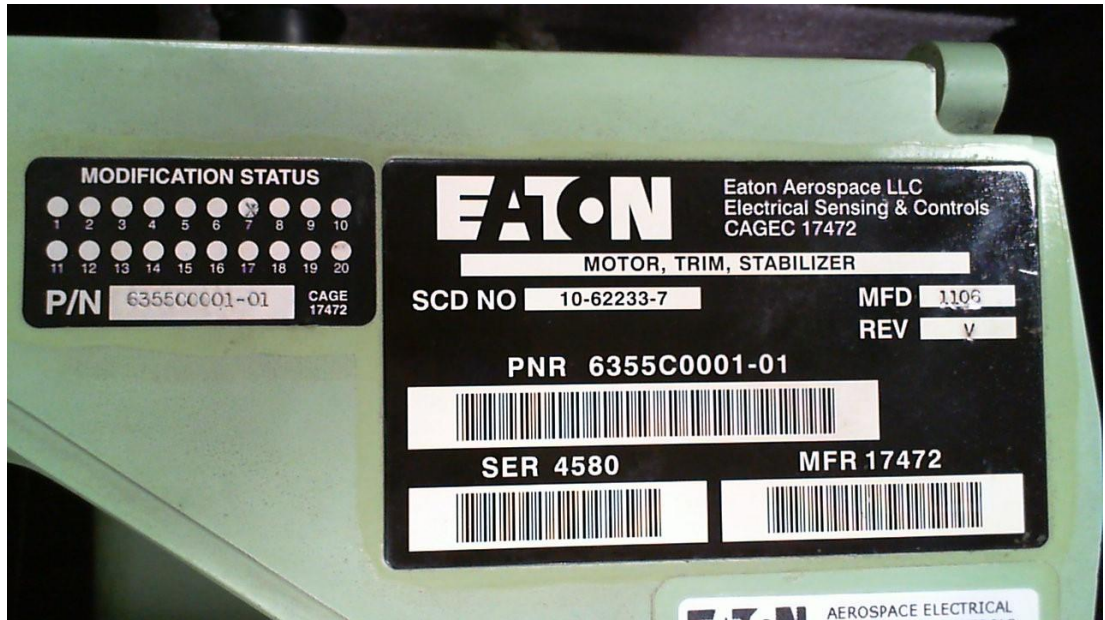
Figure 1: Identification Plate 6355C0001-01 S/N 4580

The removal/ return of 6355C0001-01 S/N 4580, modification level 7 was documented in C302097. The Stabilizer Trim Motor (STM) had minor scratches and dings, the paint was discolored and one of the connector caps was missing. None of these observations is believed to have caused the noted reason for removal.
