737 MAX / LEAP-1B

# WTT Meeting

October 10<sup>th</sup> – 12<sup>th</sup>, 2023

## Tail Pipe Fire (TPF)

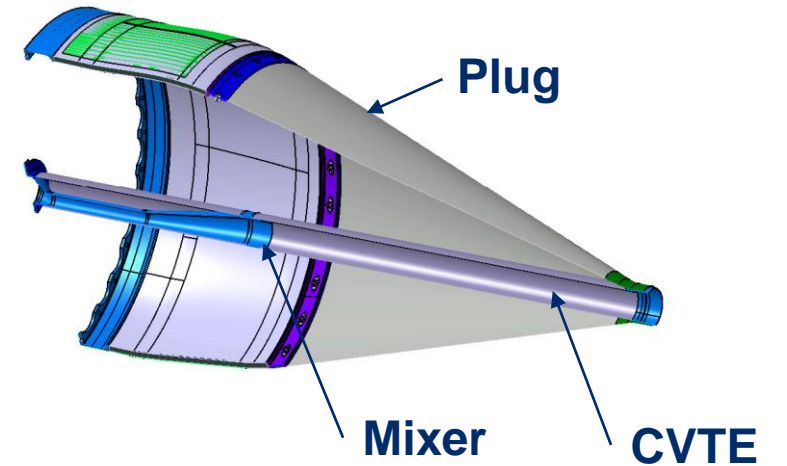
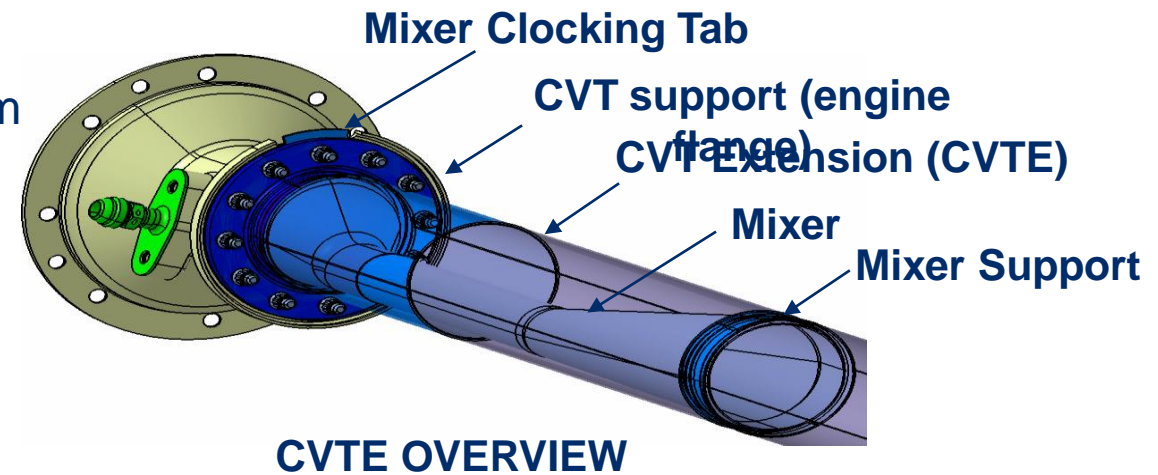
## Data collection for TPF in exhaust plug

- Collect and report to CFM the following information (contact your Field Service Engineer or open CSC/Salesforce case)
  - Pictures/videos of the flames/smoke
  - Findings at inspections per AMM TASK 71-00-00-200-801-G00 Engine Exposure to Fire and Extinguishing Agents Inspection, if performed
  - If exhaust plug/CVTE/mixer/CVT support removed from engine after TPF for troubleshooting:
    - Evidence of oil puddling (fluid)?
    - Evidence of oil coking (solid)?
    - Document with pictures/videos
  - Additional information may be requested by CFM

Field data is useful for Tail Pipe Fire root cause analysis
