# HNAT 737 技术问题说明

提示单编号	撰写	校对	批准/日期
TIP737-2024-32-027	张勇	张桃	曾晶/2024.05.11

## 标题 关于 737 轮速传感器线束磨损的故障分析

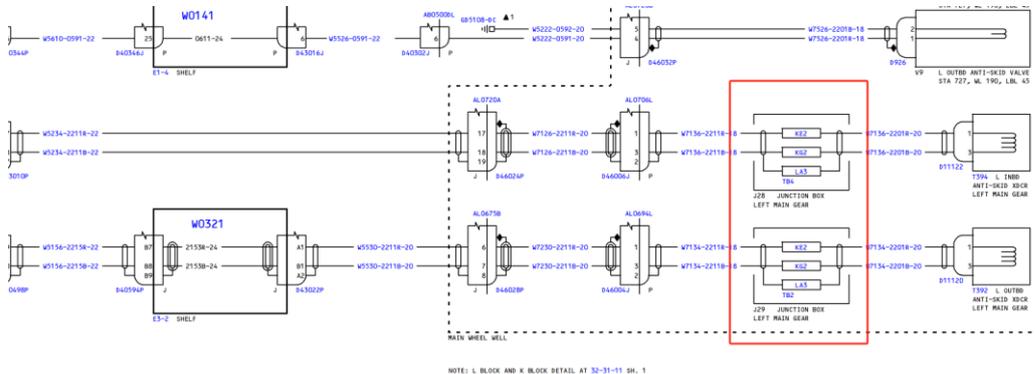
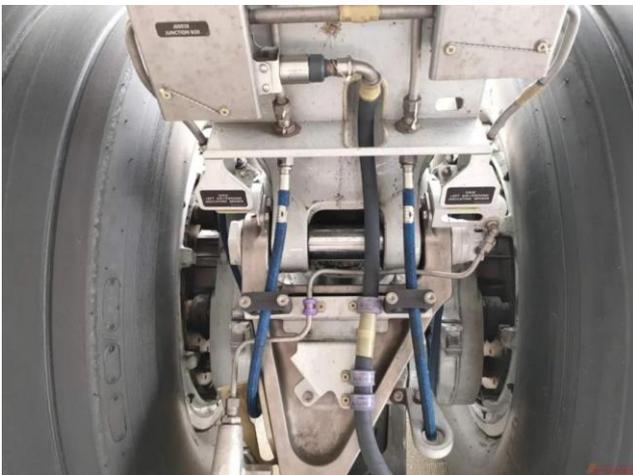
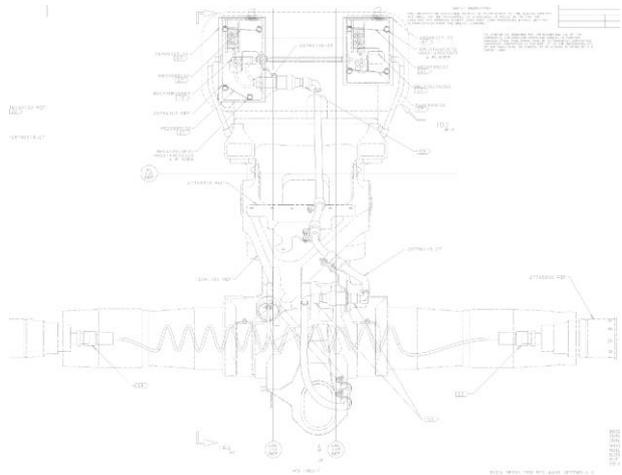
轮速传感器用于感受机轮转速，并将信号送至AACU用于防滞等系统的控制工作，其线束处于左右主起落架前端，由外部保护套管和内部导线组成，可保证安全的将电信号经由J28 J29接线盒向后传输。如下图所示，黑色套管包裹的即为轮速传感器线束，其中包含内、外侧主轮轮速两组轮速信号，从轮毂引出后，一路向上来到J28接线盒内的TB接线块，内侧主轮信号由J28再向外传输，外侧主轮导线则经过一小段横向保护管后，送至J29内TB接线块，再向外传输信号。
