# B737-800

## MAIN LANDING GEAR FORWARD TRUNNION PIN SEAL / TRUNNION PIN DAMAGE.

### Installation Post SB 737-32-1448

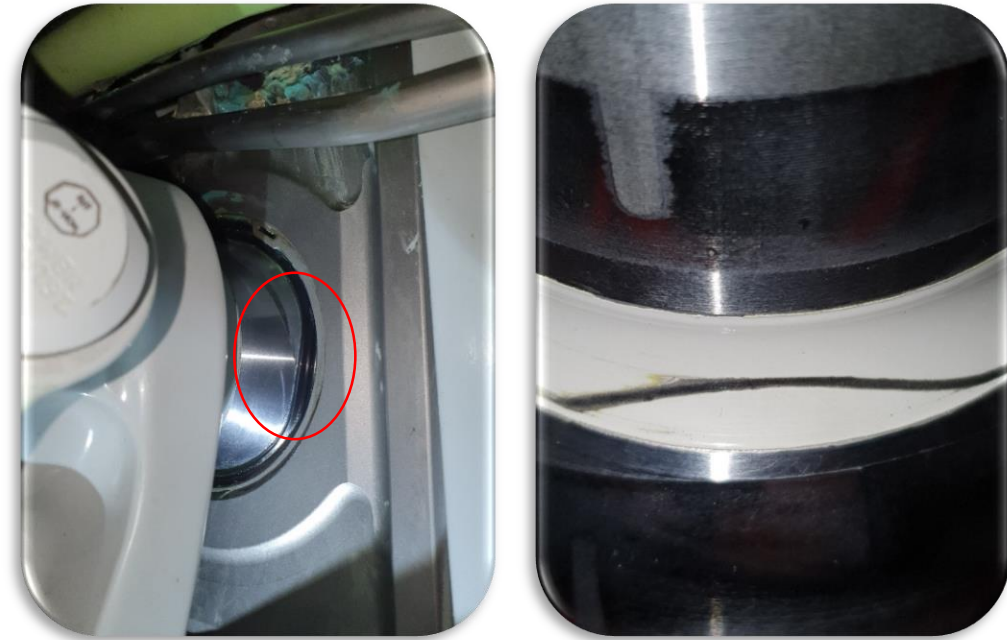
Both cases (three Main Landing Gears) are aircraft having the installation completed prior delivery to SAS.

YQ333

Serial: 41266 \_ TSN: 19568 \_ CSN: 12275

LH Main Landing Gear

YK699

Serial: 41258 \_ TSN: 20532 \_ CSN: 12551

LH / RH Main Landing Gears

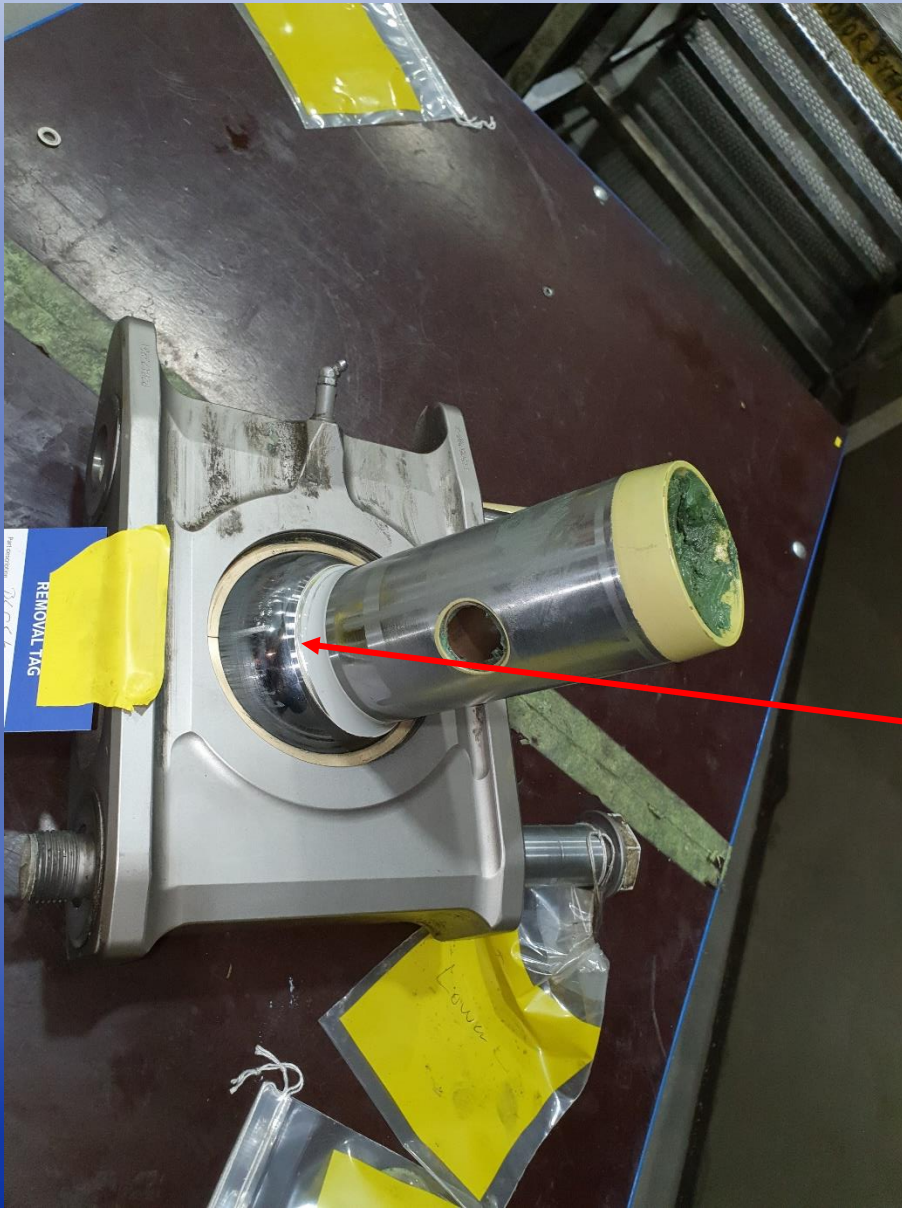
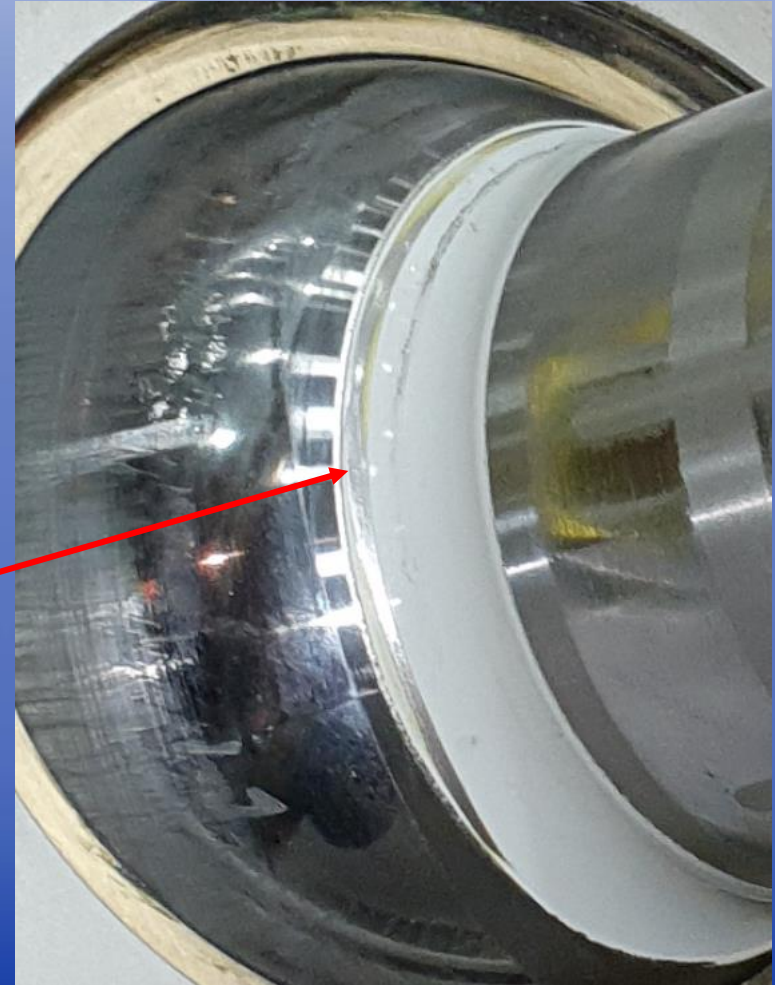
The inspection per AMM Task 57-16-01-200-801 checking for wear is performed without any remarks.

Ball joint checked for chrome wear and/or surface roughness without any remarks.
